Exhibit 2

Reasons why the determinations outlined in Exhibit 1 should be reversed.

Code sections referenced below are from the 2015 New York State Building Code unless otherwise noted.

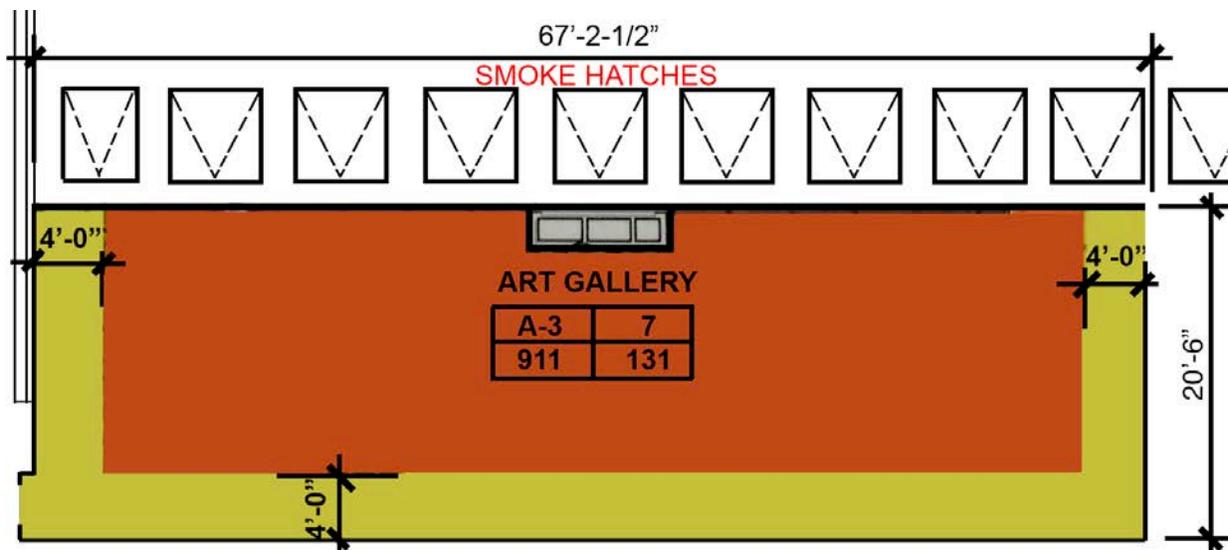
Explanation: The stated occupancy for the roof-top art gallery of 131 is found by using an incorrect gallery area of 911 square feet and an incorrect occupant load factor of 7 square feet per occupant (Figure 2). The *actual occupancy is 263*, based on an actual area of $67'-2-1/2" \times 20'-6"$ = 1,315 net square feet and an occupant load factor of 5. In this calculation, I have computed the gallery area by first subtracting 6 inches from the circulation zone edges and then subtracting 20 square feet for a utility enclosure on the north side of the gallery. This actual area includes the hypothetical egress pathways at the perimeter of the gallery space that are colored yellow on the architect's plans, sheet LSP-103 (Exhibit 4), apparently, and deceptively, to imply that they might represent something literally separated from the orange-colored main gallery space (Figure 2). In fact, the entire *actual* gallery area—i.e., both the orange and yellow zones drawn by the architects—must be accounted for when computing the occupancy of the space.

Figure 2. Portion of architect's roof plan showing the roof-top art gallery with fictitious circulation zones (colored yellow) that have been subtracted from the actual occupiable gallery area, along with a tabulation of occupancy group (A-3), occupancy load (7 occupants per square foot), gallery area (911 square feet), and number of occupants (131). Plan drawn by Jonathan Ochshorn based on architect's roof plan, sheet LSP-103. Colors, dimensions, and room data matrix appear in the original.

The architects inappropriately *subtracted* this yellow colored circulation pathway area from the actual gallery area and used the incorrect load factor of 7 to compute the fictitious values shown on sheet LSP-103, and reproduced in Figure 2, i.e., 911 square feet for the art gallery area and $911/7 = 131$ occupants. The architects, in their "Proposed Toilet facilities Calculations" shown on LSP-100 (Exhibit 4), use an even lower number: 93 occupants.

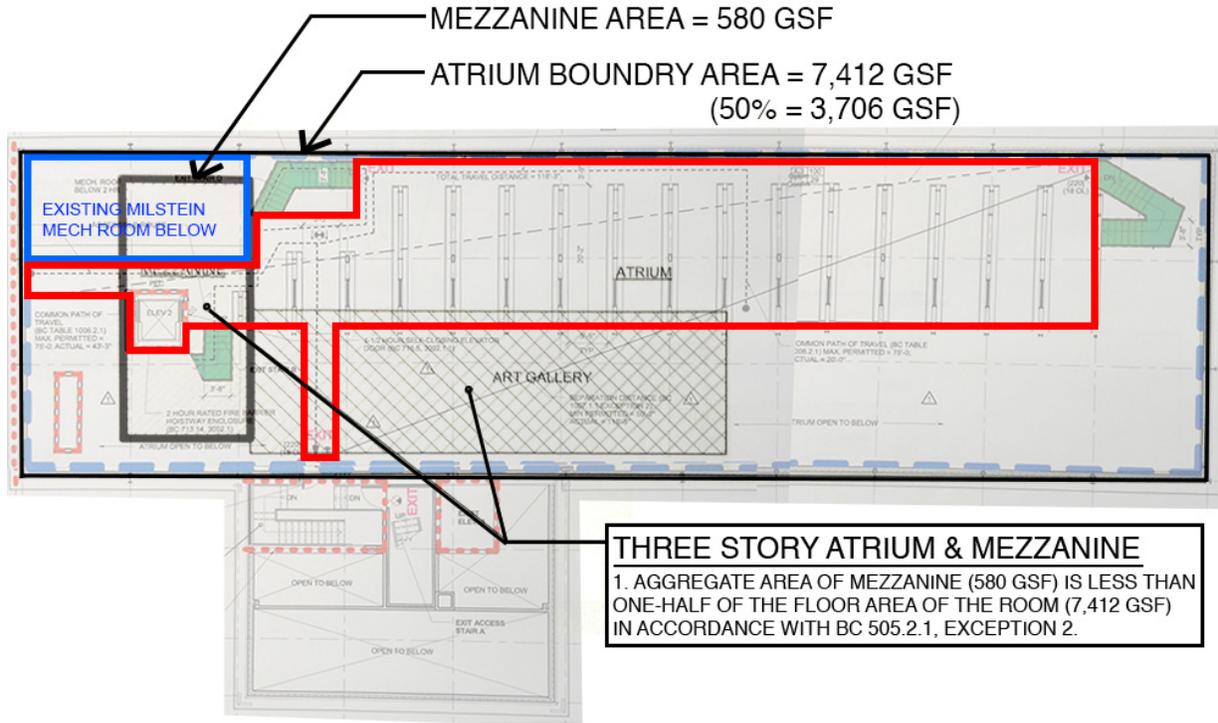
2
LSP-103 1/16" = 1'-0"

The enclosed area on the roof cannot be classified as a mezzanine. To be a mezzanine, it would have to be “an intermediate level or levels *between the floor and ceiling* of any story,” as the definition in Chapter 2 of the code requires it to be. Instead, it is *on top of* the ceiling of the fourth floor. The explanation of the architects, forwarded to me in an email from the college’s Director of Facilities, Frank Parish, dated Jan. 25, 2019, states: “The enclosed area at the roof level is a mezzanine to the fourth floor. The fourth floor is open to and part of the atrium.” The architects write in their “Mezzanine diagram” on LSP-103 (Exhibit 4, reproduced below as Figure 4) that the “aggregate area of the mezzanine (580 GSF) is less than one-half the floor area of the room (7,412 GSF) in accordance with BC 505.2.1, exception 2.” This room of 7,412 GSF that is shown on the architect’s diagram is labeled as the “atrium” rather than as the fourth story, although the boundary shown for the 7,412 GSF corresponds

neither to the fourth story nor the atrium. This statement reveals two principal errors. First, a mezzanine *cannot be in an atrium*, since a mezzanine is “an intermediate level or levels *between the floor and ceiling of any story*,” and an atrium is not a “story”; rather, an atrium is an “*opening connecting two or more stories*.” Second, the roof-top enclosed spaces cannot be a mezzanine within a fourth-story room or space since there are no double-height fourth-story spaces in which a mezzanine could be placed.

Figure 4. Mezzanine Diagram from sheet LSP-103 with the fourth-floor plan superimposed in order to clarify the relationship between the enclosed roof-top spaces (black rectangle) the fourth-floor bookstacks (bounded by a red line), and the third-floor mechanical room for Milstein Hall (bounded by a blue line). Text has been enlarged, red and blue boundaries added, and the 4th floor has been superimposed by the author. The black boundary line is in the original mezzanine diagram.

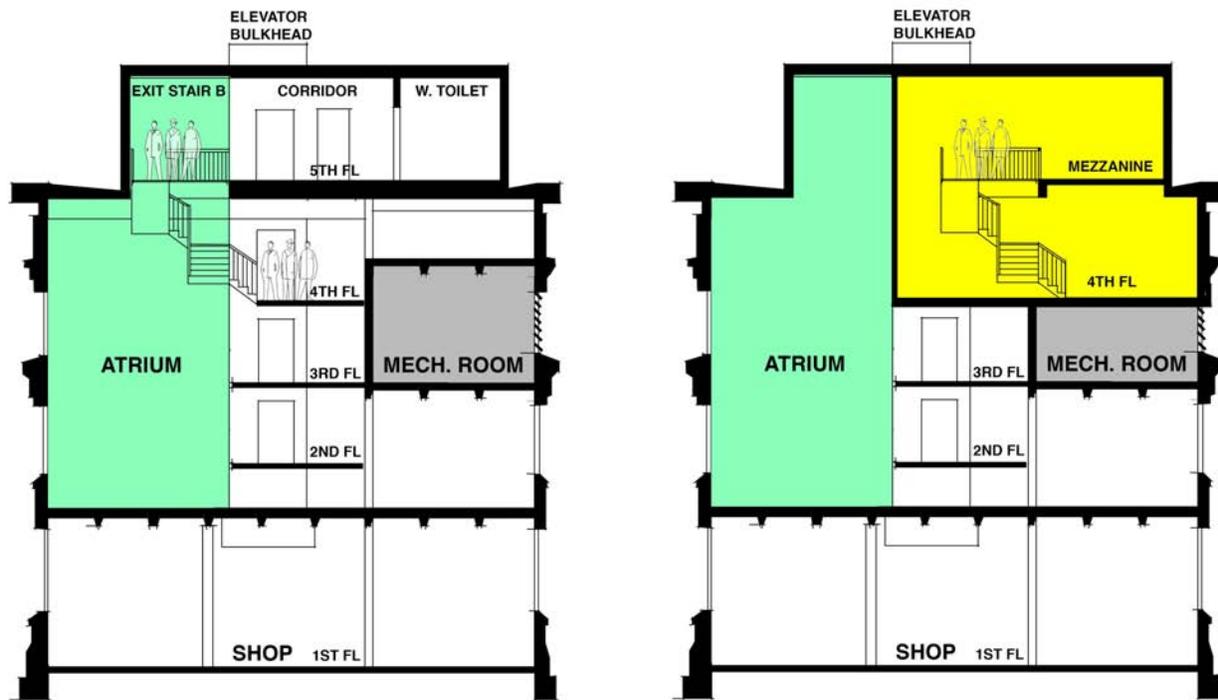
A schematic section through the roof-top enclosed space is shown in Figure 5 (left). This section clearly shows that there are no double height spaces in the fourth story within which a mezzanine could be placed. To be a mezzanine, the space would need to be configured within a double height space, as shown, for example, in the hypothetical section of Figure 5 (right). In other words, the architects are inappropriately using the *atrium* opening to demonstrate conformance with Section 505.2.1, rather than using an area within a fourth-floor room or space as the section requires. Both Figures 4 and 5 show that the story incorrectly labeled “mezzanine” (bounded by a black line in Figure 4) is only marginally *above* any fourth-floor room or space (bounded by a red line), and is not *between* the floor and ceiling of any fourth-floor room or space, as required by the code. The fourth story below the enclosed roof-top spaces is little more than a corridor, while the greater part of the enclosed roof-top spaces is directly above—not the fourth floor—but rather the ceiling of a third-story mechanical room. The exit access stairway (“Exit Stair B”) connecting the fifth-story roof-top spaces to the fourth story is *in the atrium*, not in any mezzanine, as can be clearly seen in Figure 5.

Figure 5. Schematic section through the as-built fifth-story roof-top enclosed spaces and atrium, which cannot be defined as a mezzanine (left); contrasted with a section showing a hypothetical example of a Code-compliant mezzanine within a fourth-floor room or space (right). Drawn by Jonathan Ochshorn.

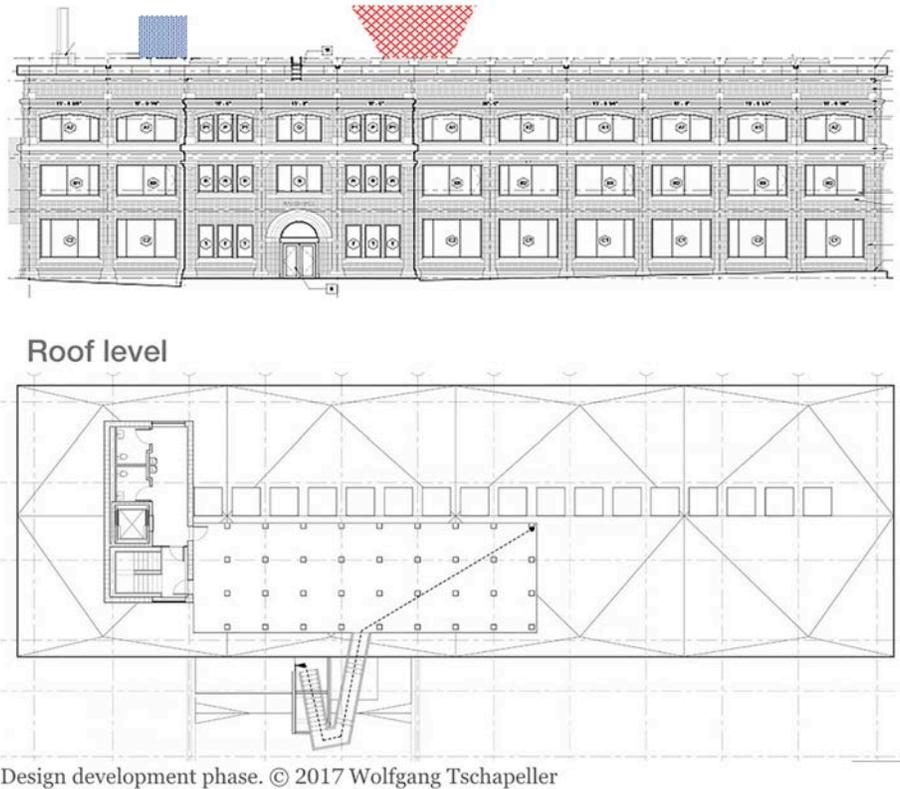
Figure 6. (top) Cornell’s elevation of the Mui Ho Fine Arts Library shows roof-top pavilions intended to be built every few years; (bottom) Cornell’s schematic roof plan is labeled “Experimental pavilion roofscape,” explicitly indicating their intention to use the outdoor roof deck to support enclosed, occupiable spaces that would constitute a fifth story.

Pavilions, even if temporary (i.e., “erected for a period of less than 180 days”), still need to follow the requirements outlined in Section 3103, including conforming “to the structural strength, fire safety, means of egress, accessibility, light, ventilation and sanitary requirements of this code as necessary to ensure public health, safety and general welfare.” In any case, whether “temporary” or exceeding the 180-day time limit, such covered structures would count as part of a fifth-story, since they are *on top of* the roof, and could not possibly be designated as mezzanines *between* the floor and ceiling of the fourth story below, as the definition of a mezzanine in Chapter 2 of the code requires. The current scheme, in fact, contains sprinkler and utility hook-ups *at the roof level* in anticipation of these future enclosed pavilions. For this reason, a designation of the current fifth-story bathrooms, corridor, and elevator as a mezzanine within the fourth story is not only improper on its own merits, but by implicitly suggesting that the intended future roof-top pavilions will also count as fourth-story mezzanines, Cornell is effectively inviting the Ithaca Building Department to acknowledge and agree, in advance, to that noncompliant vision.

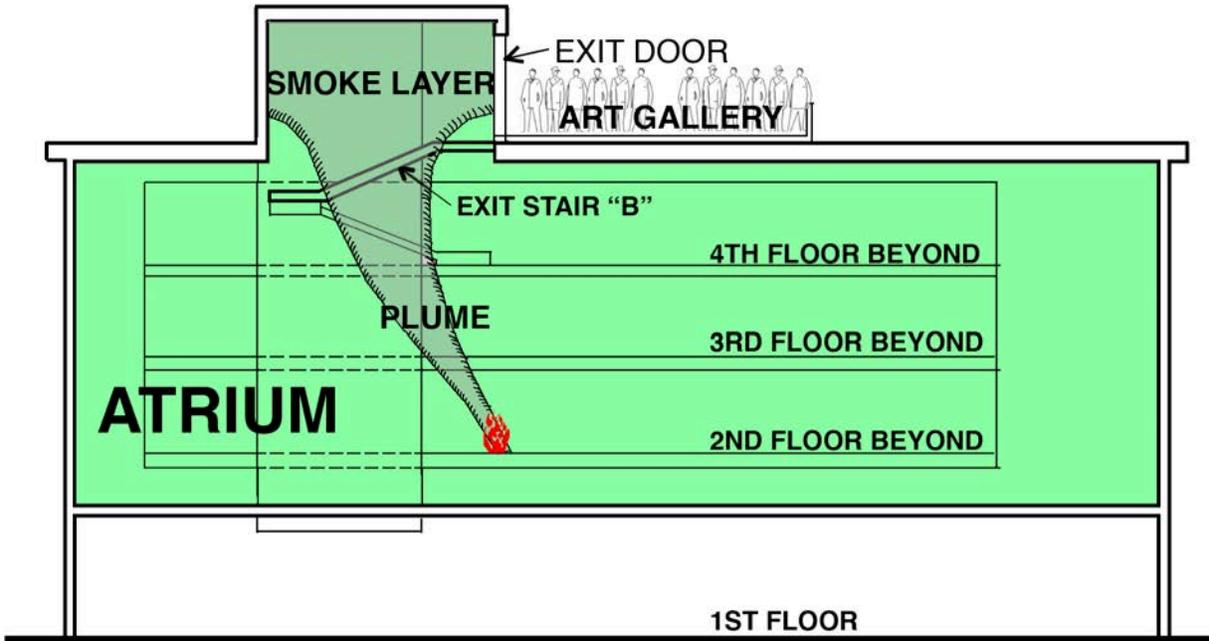
In addition to providing a 1-hour horizontal assembly between the atrium and the roof gallery, the part of the atrium that extends into the fifth story (see Figure 7 below) must also be separated from the adjacent outdoor roof gallery by a 1-hour fire barrier.

occupants. Second, since the atrium extends into the fifth floor (Figure 7), it will act as a primary smoke exhaust vent when the exit door from the roof-top art gallery is opened, even though this door is not labeled, or intended, as an exhaust vent. This smoke control system is entirely passive, with no mechanical exhaust; as a result, art gallery occupants attempting to exit through Exit Stair B will likely encounter toxic smoke emerging from the exit door, which is at the highest point in the atrium and therefore the most likely location for the hot smoke layer to migrate.

Figure 7. Schematic section through atrium showing how the smoke layer would migrate to the highest point of the atrium, directly in the path of egress from the roof-top art gallery through Exit Stair "B"

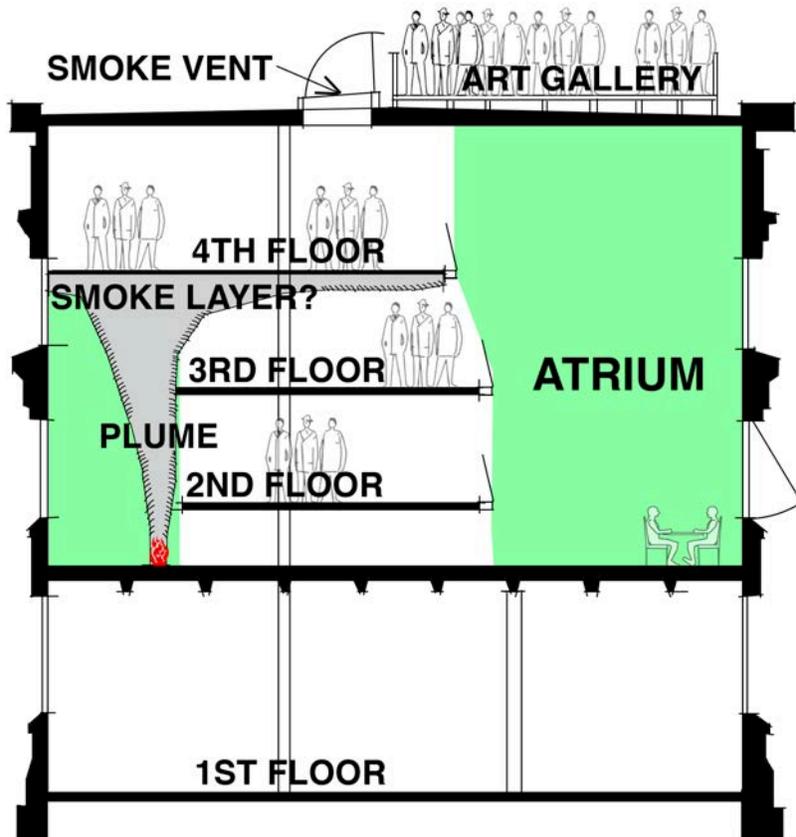
As described above, it is also uncertain, *since it wasn't part of the smoke control model*, what the time for evacuation from the roof gallery would be, and how that evacuation would take place with Exit Stair B potentially acting as a smoke exhaust vent at the highest point in the atrium. This is the stair that occupants would be most likely to use, since it is adjacent to the elevator which is the primary mode of entry *into* the roof-top gallery. In any case, it would certainly take far longer for all 263 occupants to egress from the roof-top art gallery than the 250 seconds that defines the "the tenability limit for the [fourth] floor" through which the roof gallery occupants must travel. Exit Stair B is not only unenclosed from the roof down to the second floor, but is also discontinuous, forcing those evacuating from the roof-top gallery using Exit Stair B to travel horizontally *through* the fourth floor—by now with the smoke layer making passage on this level untenable—before somehow continuing down Exit Stair B or D (both unenclosed) or across the fourth-floor bridge through the atrium space to enclosed Exit Stair A.

Figure 8. Schematic section through atrium illustrating scenario with fire location at north side of building that was not modeled in the smoke control report prepared for Cornell by GHD

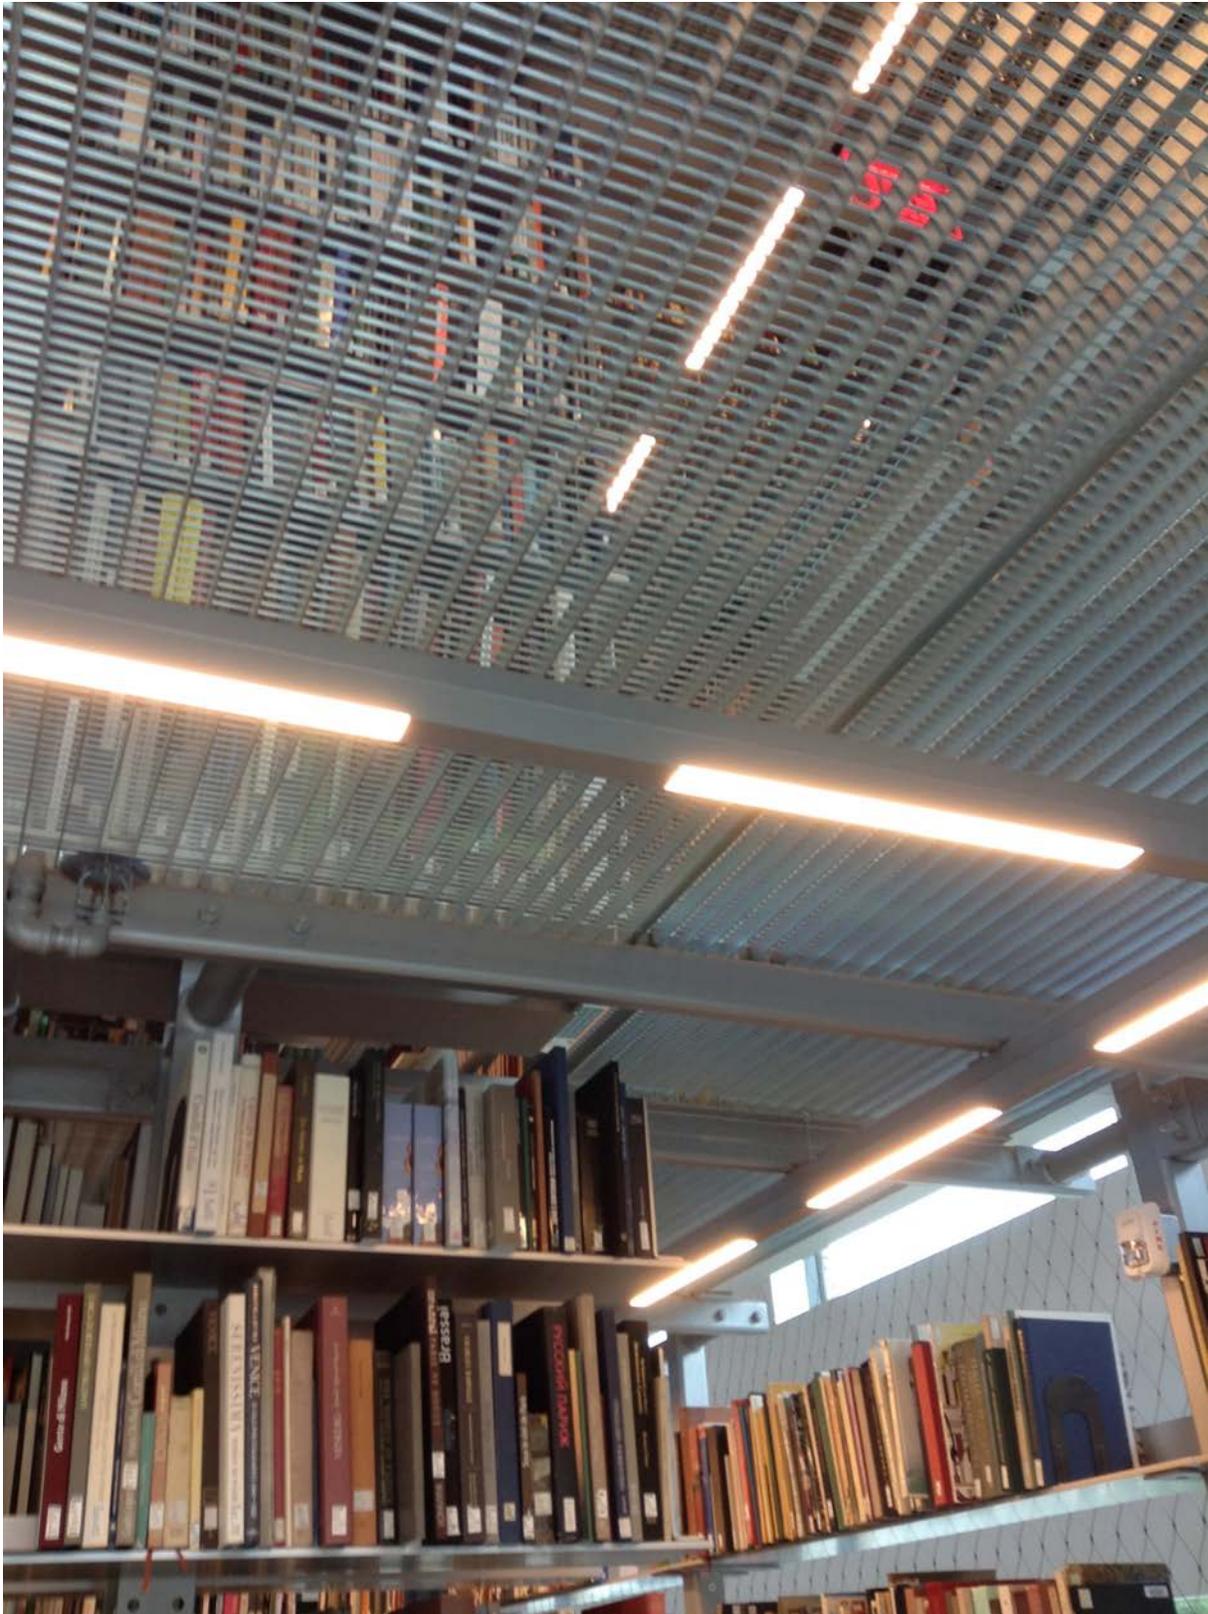
Explanation: Section 712 permits vertical openings in floor-ceiling assemblies only when they are “in accordance with one of the protection methods in Sections 712.1.1 through 712.1.16.” The three bookstack stories all have openings in their floor-ceiling assemblies, not only the “6-inch flues” below each bookstack, but also throughout the floor-ceiling construction. These levels do not provide assemblies that are “continuous without vertical openings” as required by Section 711.2.2, but rather consist of perforated (open) metal floor panels made with metal bars spaced one half inch apart (Figure 12). Section 712.1.9 (Two-story openings) states that “a vertical opening that is not used as one of the applications listed in this section shall be permitted if the opening ... does not connect more than two stories...” The bookstack floor perforations and larger openings under the bookstacks connect more than two stories and are therefore in violation of this section.

The fact that three bookstack stories are open to an atrium does not allow them to violate the requirements in Section 712 regulating vertical openings *between* stories. In fact, the whole point of fire-safe atrium design is to direct smoke—originating in an adjacent story that is open to the atrium—*into the atrium space* so that it can rise upwards through the atrium space and be safely exhausted at the atrium roof. The Rand Hall design, in contrast, does exactly the opposite: by having perforated, grated metal floors, in violation of Section 712, smoke will move literally *through the occupied floors*—which also serve as part of the exit access system—instead of directing smoke into the atrium where it can be safely exhausted. Yet even that simple requirement—to safely exhaust smoke through the atrium roof—is compromised in this building by placing occupied spaces on the roof immediately adjacent to the atrium smoke exhausts (see Violation #5).

Figure 12. Perforated floor panels violate basic principles of compartmentation by connecting more than two stories; larger “6-inch flue” openings also appear in each story under the bookstacks. Photo by Jonathan Ochshorn.
