OMA's Milstein Hall

Design Accountability: Evaluation of the Physical Environment

OMA'S MILSTEIN HALL

A CASE STUDY OF ARCHITECTURAL FAILURE

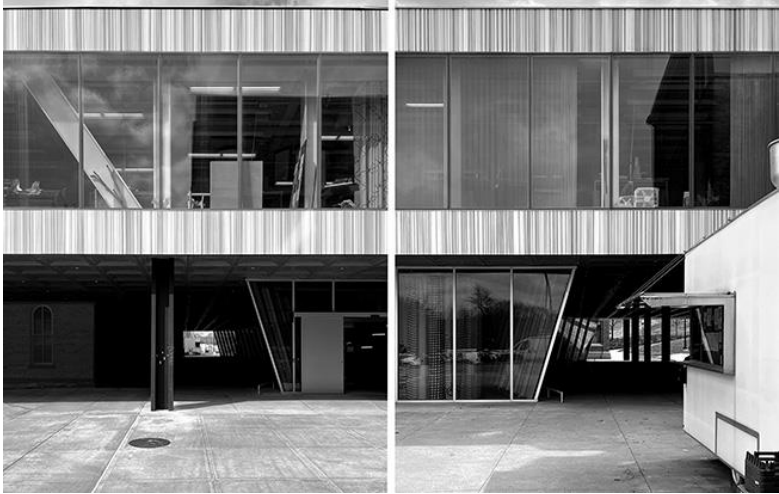
Figure 4.4. Milstein's arcade, viewed from the Milstein plaza (right) and from outside Rand Hall (left), remains dark and uninviting, even with soffit lights and integral curtain wall mullion fixtures turned on.

Figure 4.5. Some of the custom-designed LED lighting fixtures in the arcade that have been integrated into sloping curtain wall mullions turn themselves off for mysterious reasons, even after visits by puzzled electricians.

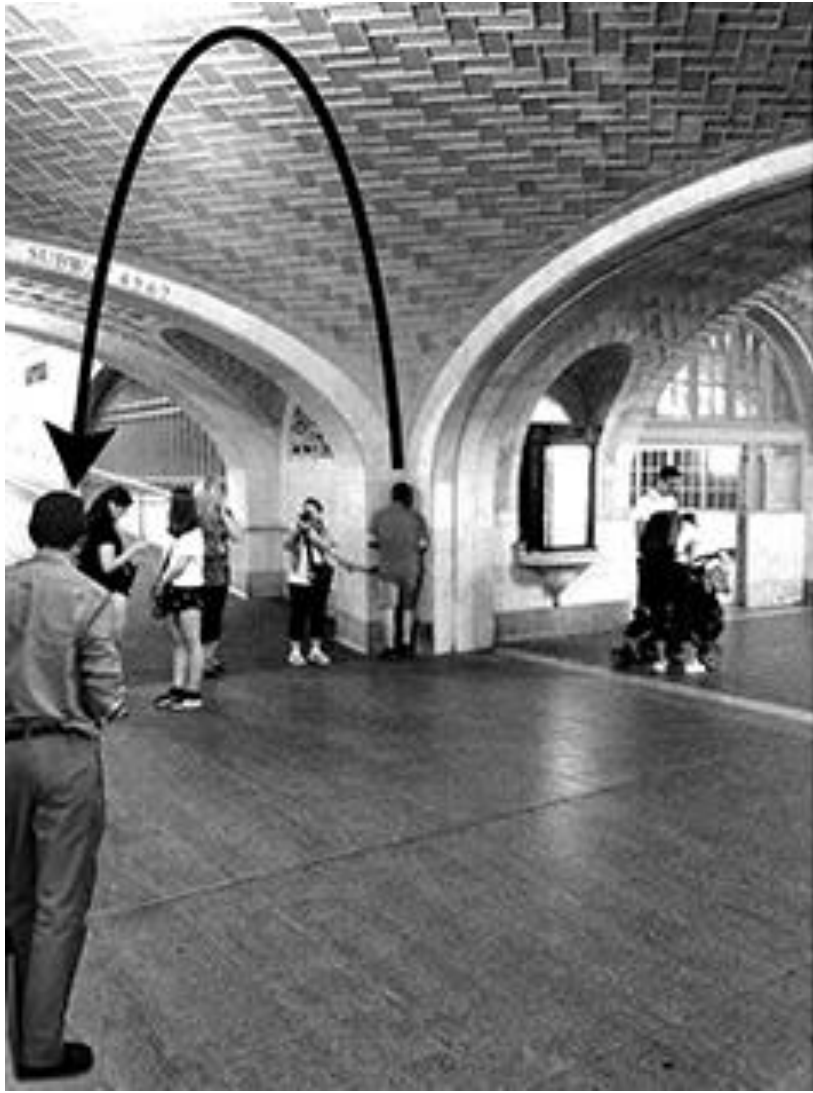
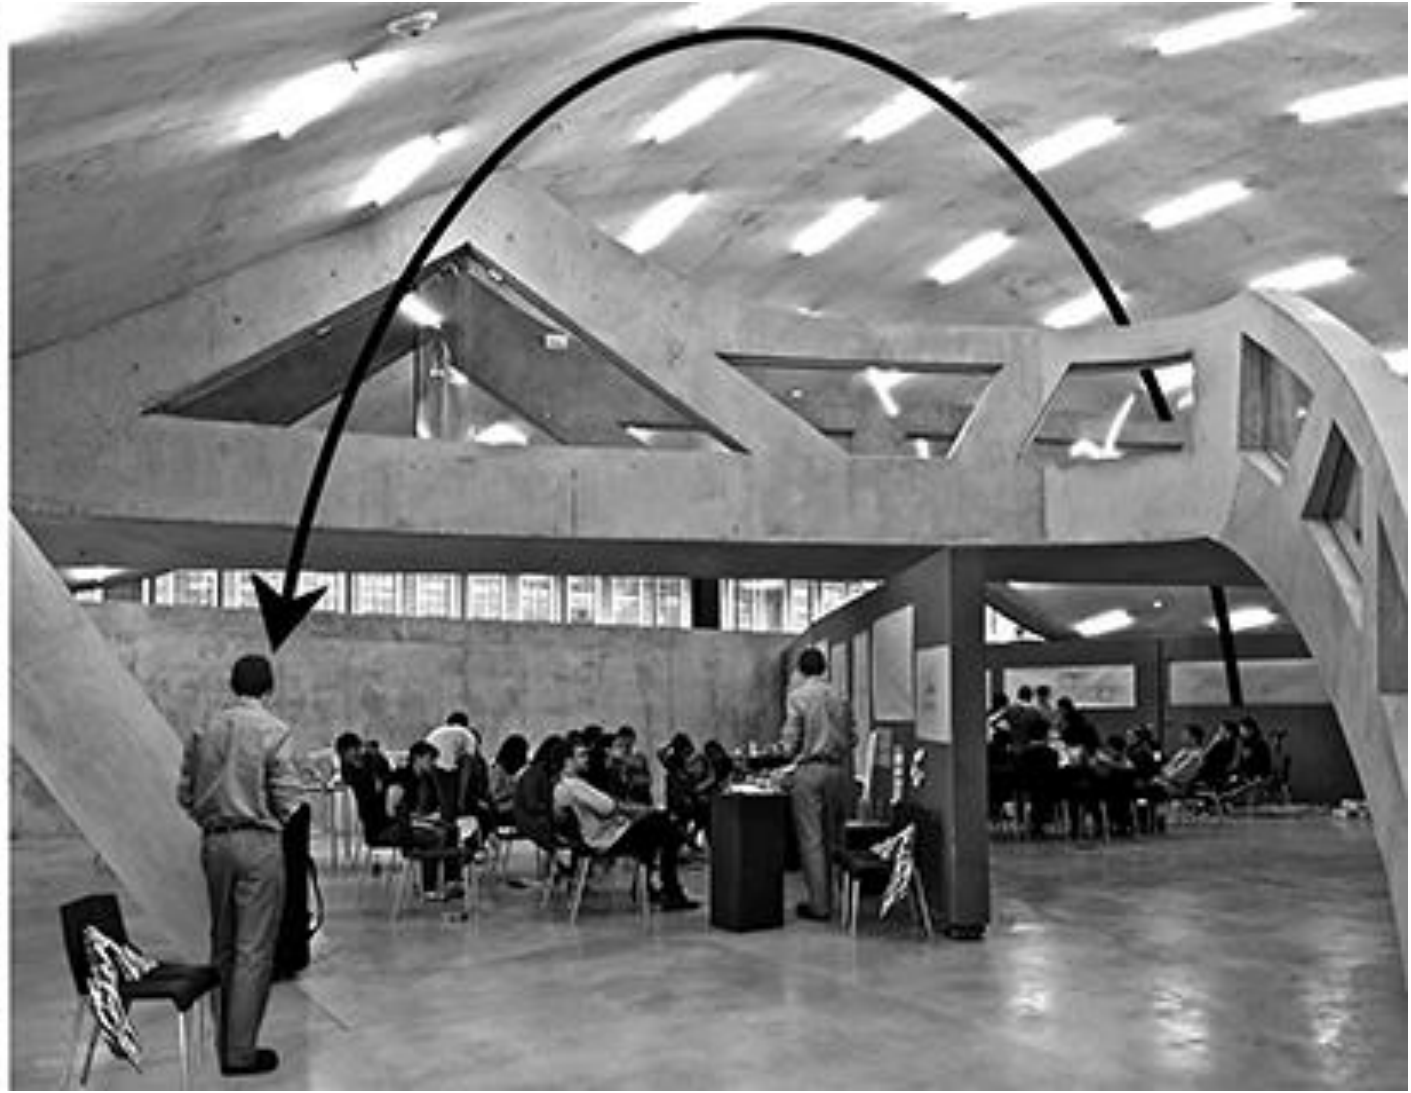
Figure 4.12. A Guastavino vault in Grand Central Station in New York City (left) acts as a "whispering gallery" in front of the Oyster Bar restaurant; the same effect makes conversation difficult in Milstein Hall's Crit Room (right), which was designed below a domical concrete surface.

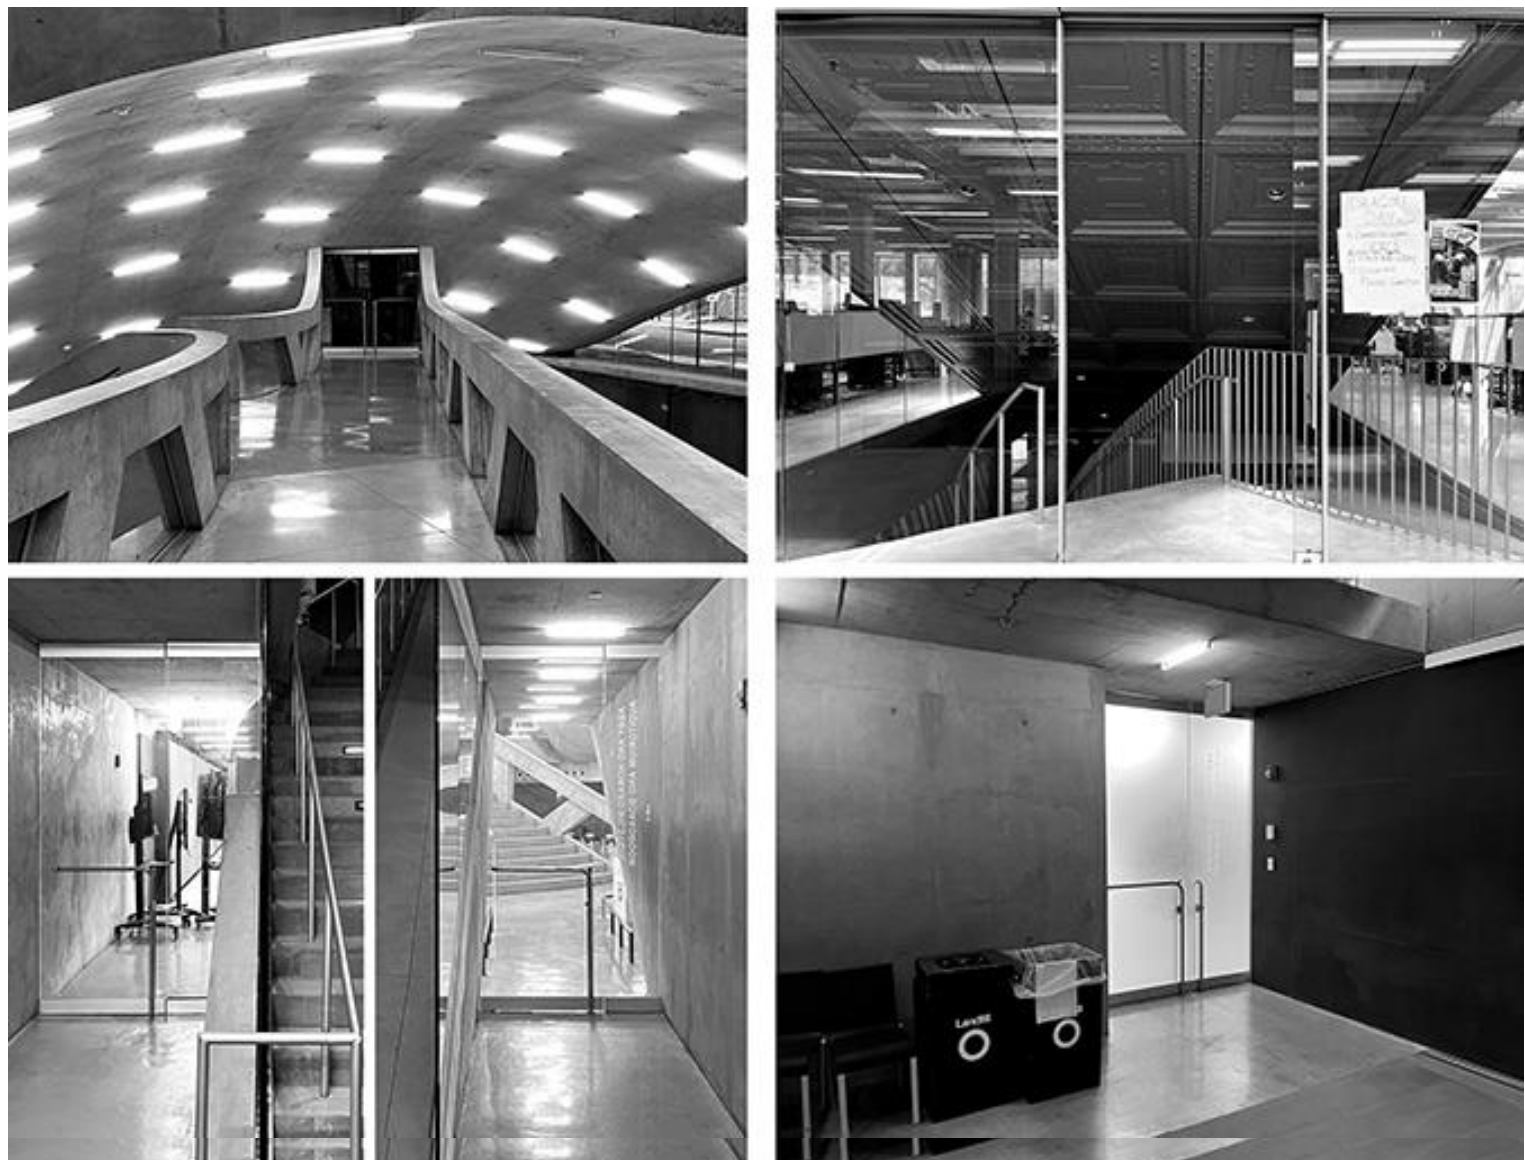
Figure 4.14. Glass doors provide no acoustic isolation for the auditorium. From top-left, clockwise: glass door from entry-level bridge; glass door from second-floor studios; glass doors into adjacent crit room; and glass door to corridor.

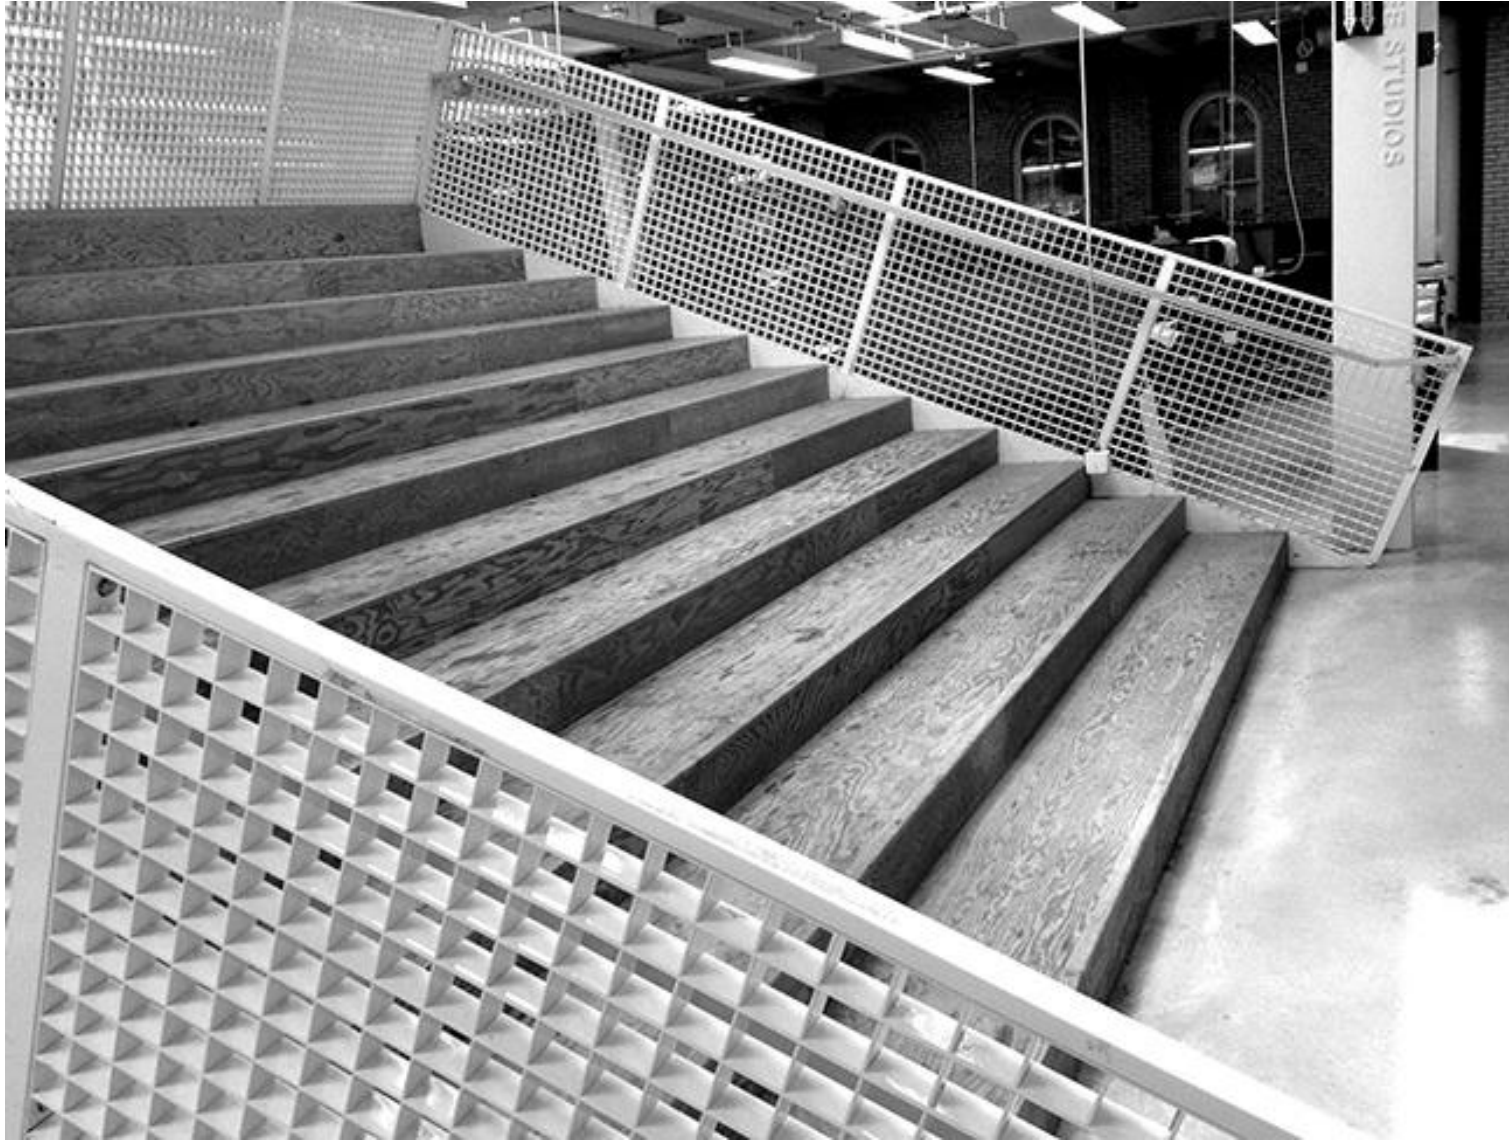
Figure 4.15. The "stepped auditorium" in Milstein Hall at Cornell University has no actual seats, and is neither visually nor acoustically separated from adjacent studio spaces.

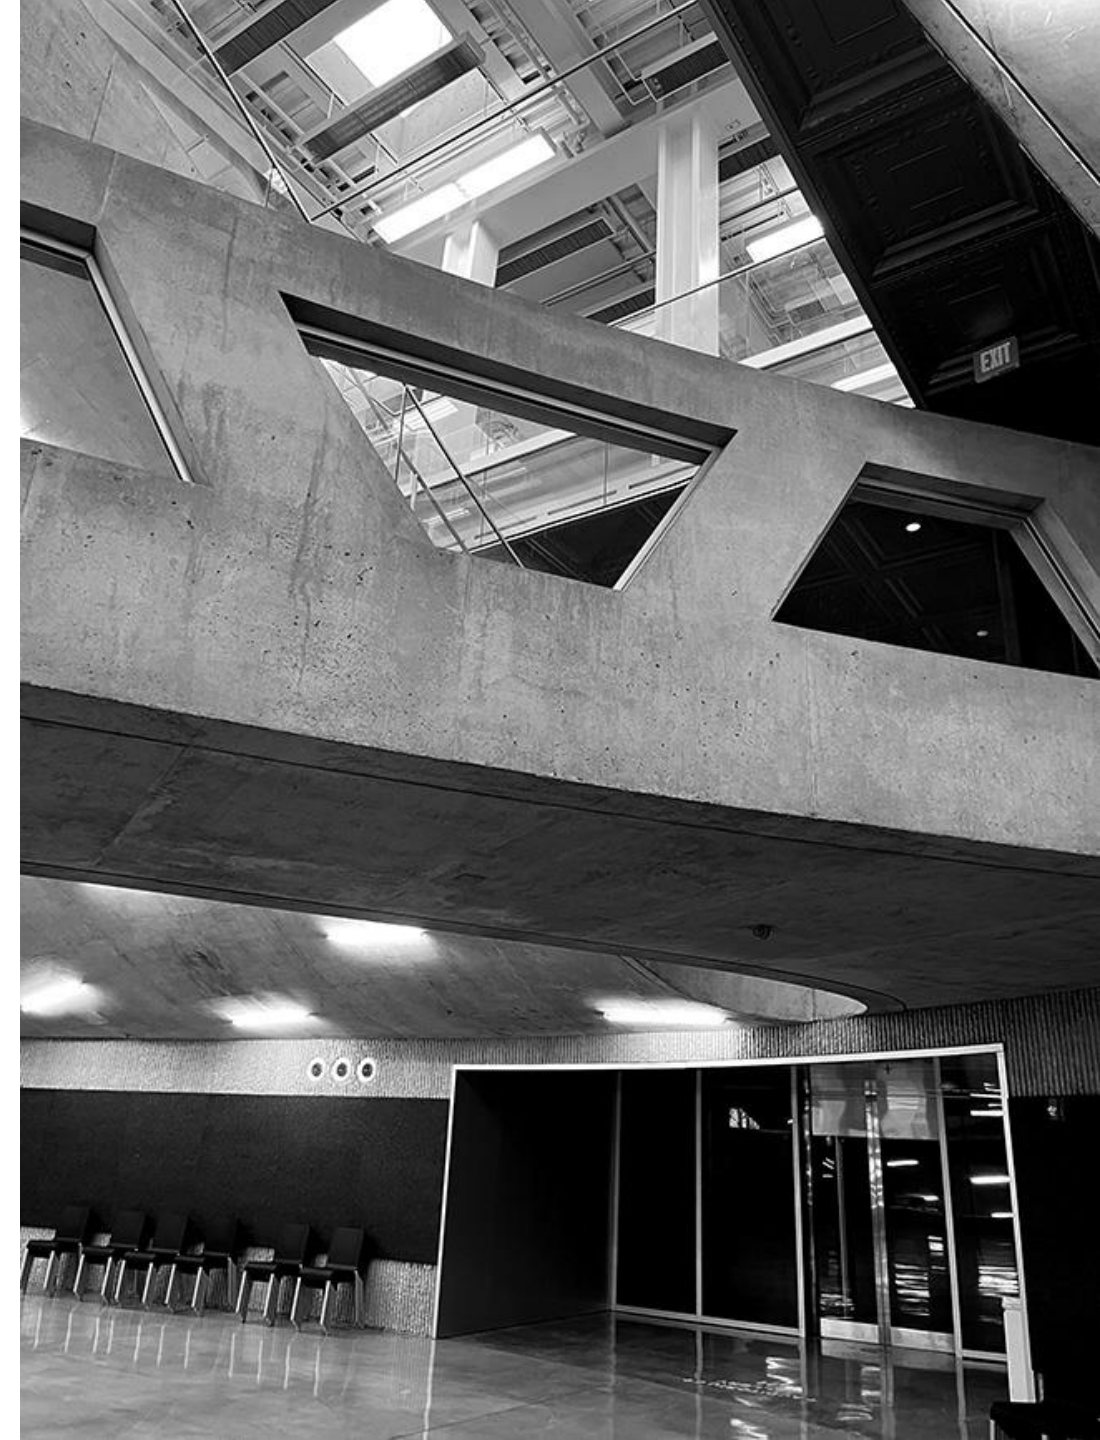
Figure 4.16. Lobby-Crit Room-studio interpenetration: The spatial excitement of interconnected spaces at three levels results in acoustical conflicts between circulation (over the trussed bridge at the entry level), second-floor studio spaces, and the Crit Room below.

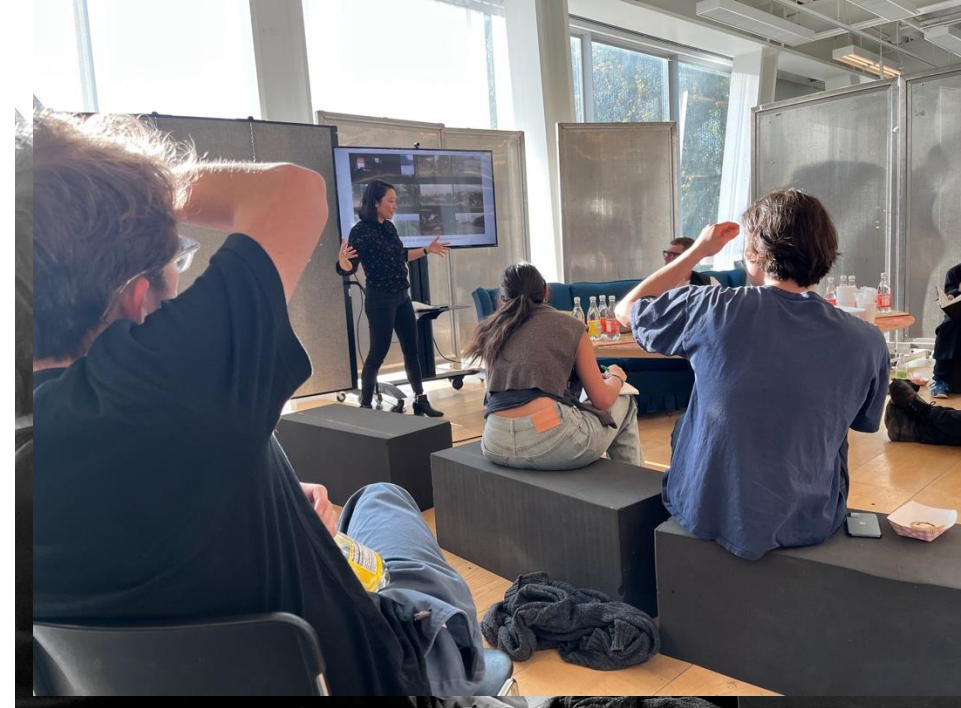
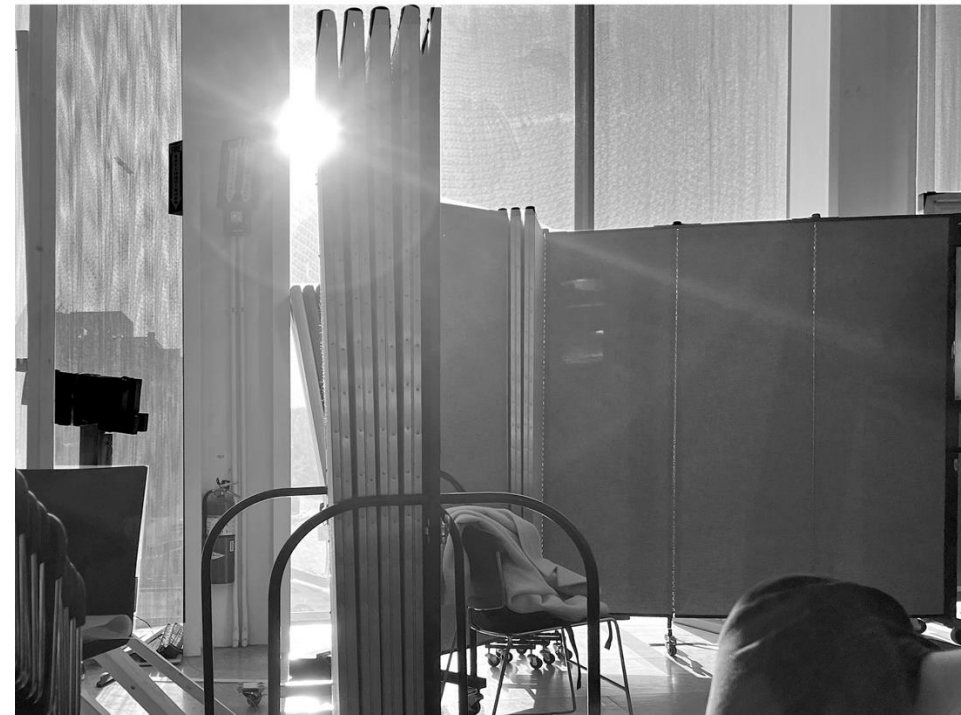
Figure 4.8. The special wood floor assembly area in Milstein Hall becomes uncomfortable and dysfunctional in late afternoon and early evenings as the western sun penetrates through the floor-to-ceiling glazing, even with curtains drawn and ad hoc barriers placed in front of the curtains. Students at this "Living Room" event held on April 19, 2023, with Nancy Lin and Curt Gambetta, shield their eyes (*top*) against the sun and its glare (*bottom*).

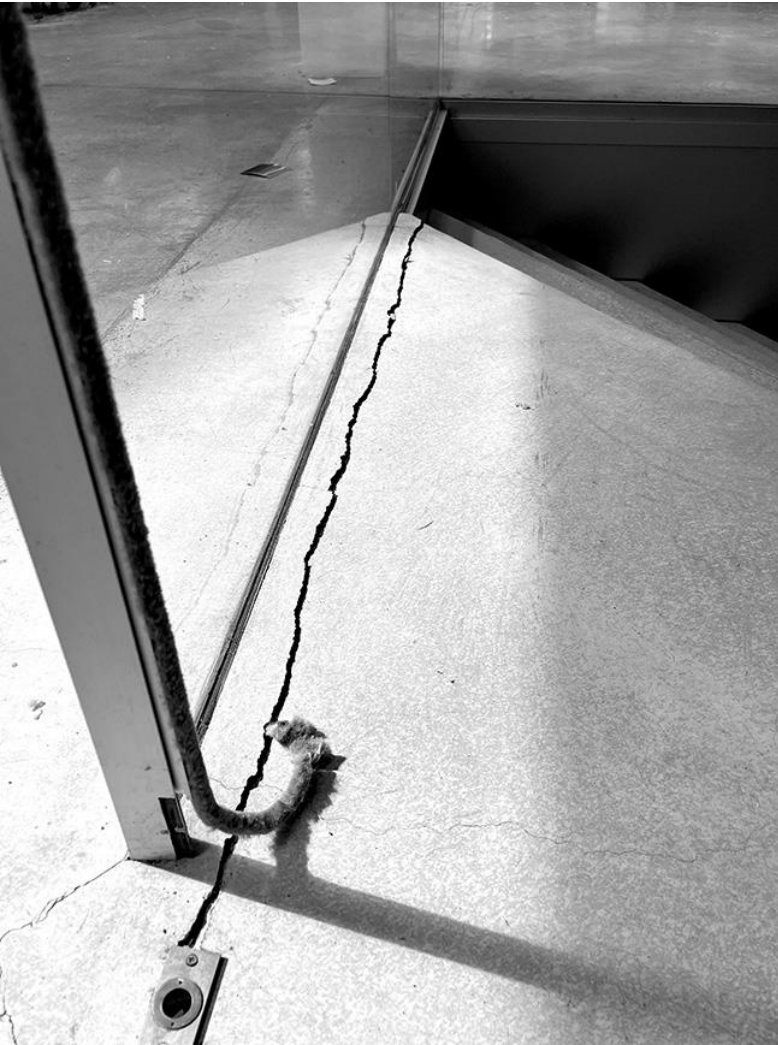
Figure 11.6. Curtain wall sill cover plates have partially or completely detached at the north side of Milstein Hall's lobby

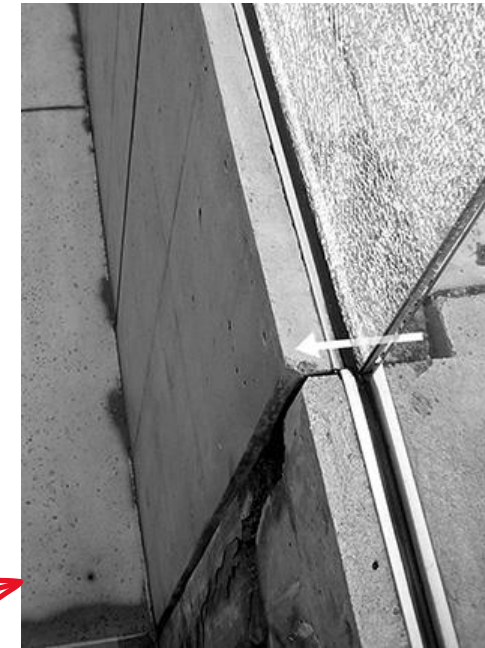
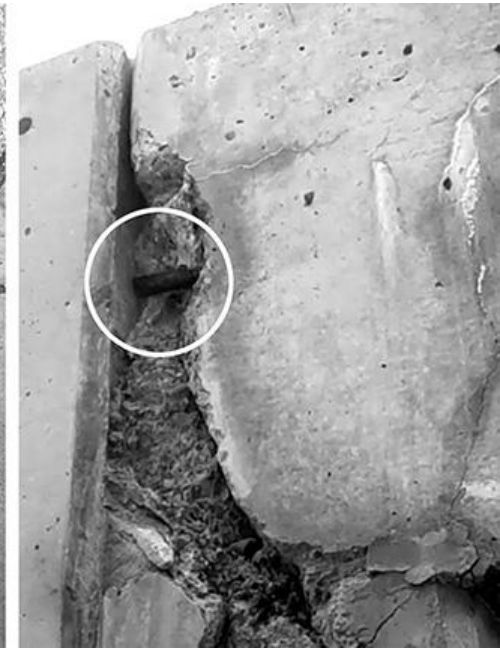
Figure 11.18. The glass guard panel between Milstein Hall's loading area and the accessible ramp from the parking lot (left), shown here in 2015, can be seen spanning over the joint between the displaced retaining wall and the building; spalling of the concrete could also have been triggered by corrosion of reinforcement, visible in the highlighted circle, placed between the retaining wall and the building (right).

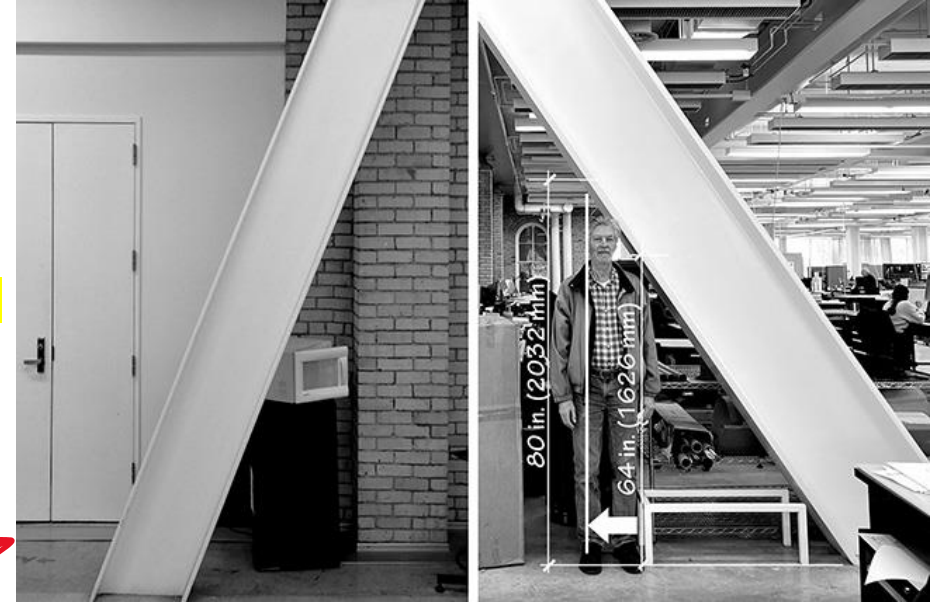
Figure 6.24. Cane-detection guards were added to the inclined reinforced concrete column in the Crit Room: before, simulated (left) and after (right).

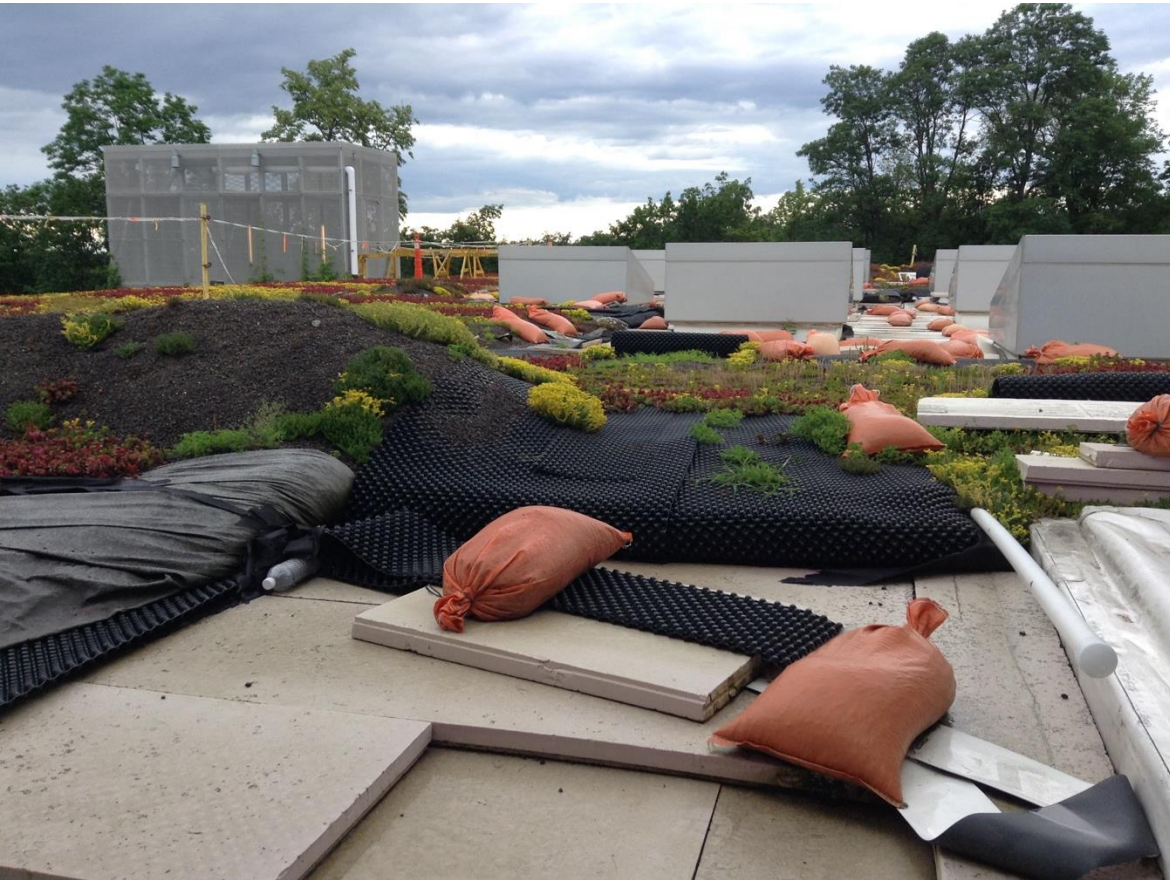
Figure 10.22. Leaks continued in 2015 (top right), triggering a major roof repair that lasted for at least two years.

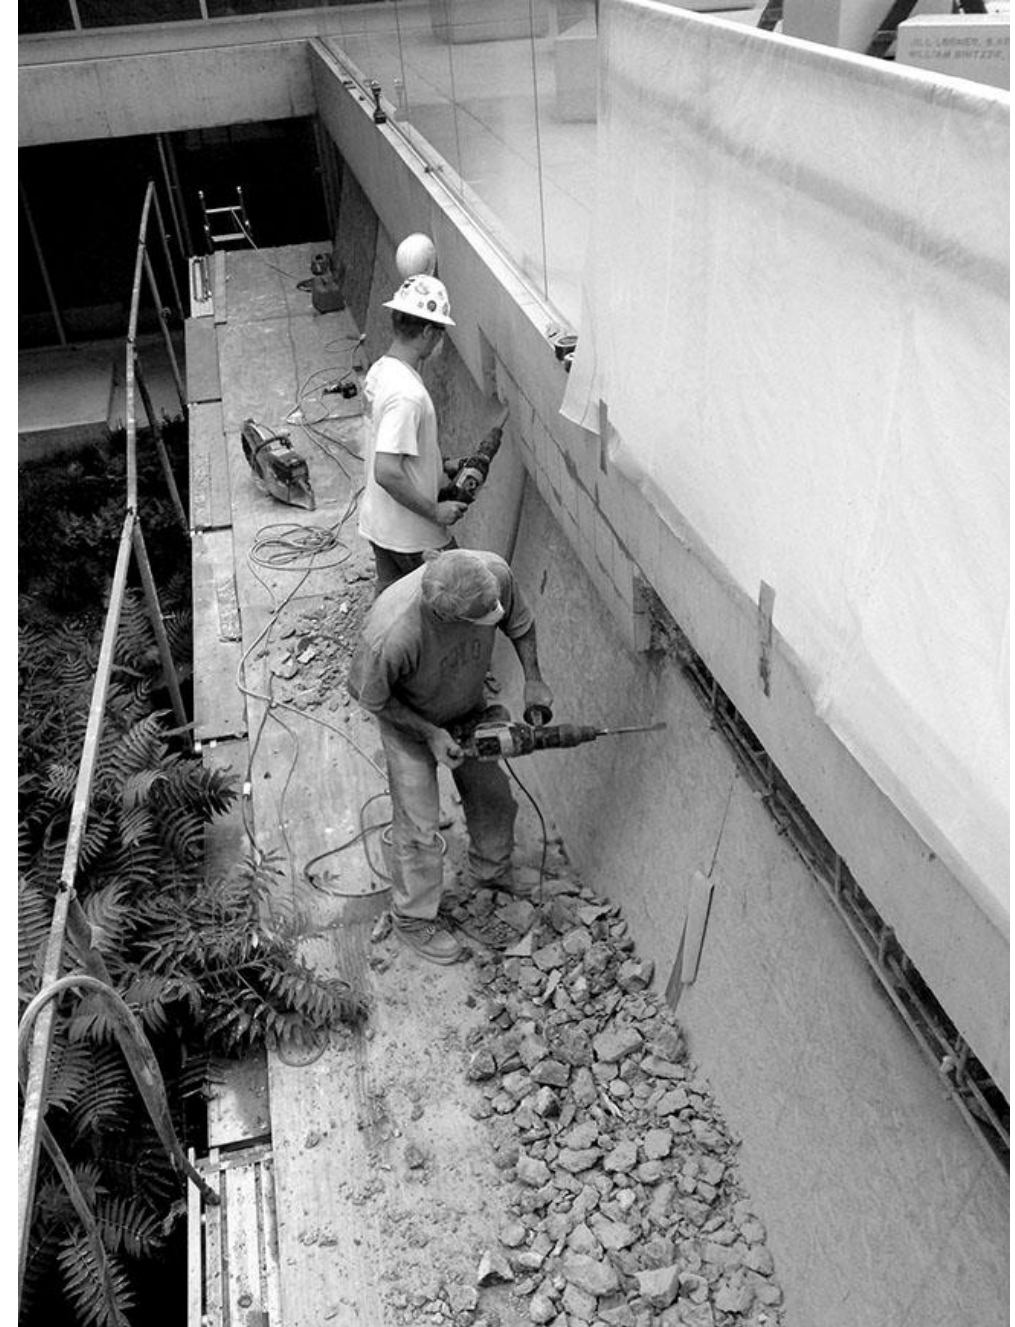
Figure 10.15. Workers remove most of the concrete fascia of Milstein Hall's Bibliowicz Gallery.

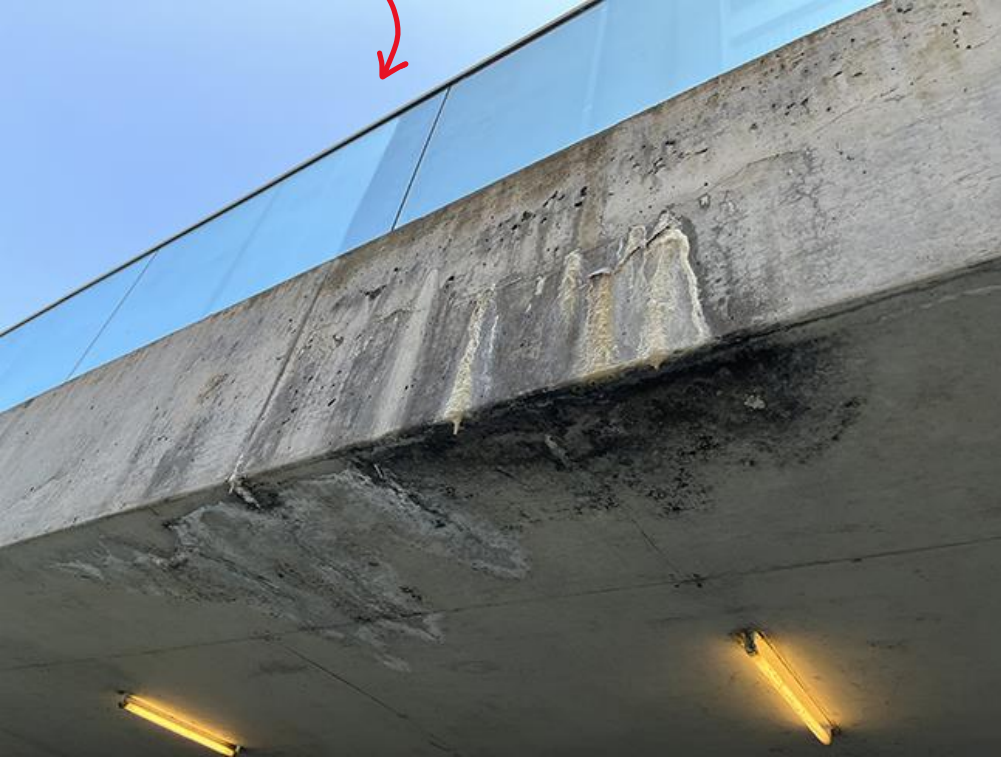
Figure 10.5. Efflorescence can still be seen on the soffit and fascia of the concrete deck supporting the loading area at Milstein Hall, more than a decade after its construction (image taken May 2023). Stalactites, possibly caused by dissolved cement stone, are an indication of a potential structural problem.
