OMA'S MILSTEIN HALL

A CASE STUDY OF ARCHITECTURAL FAILURE

JONATHAN OCHSHORN

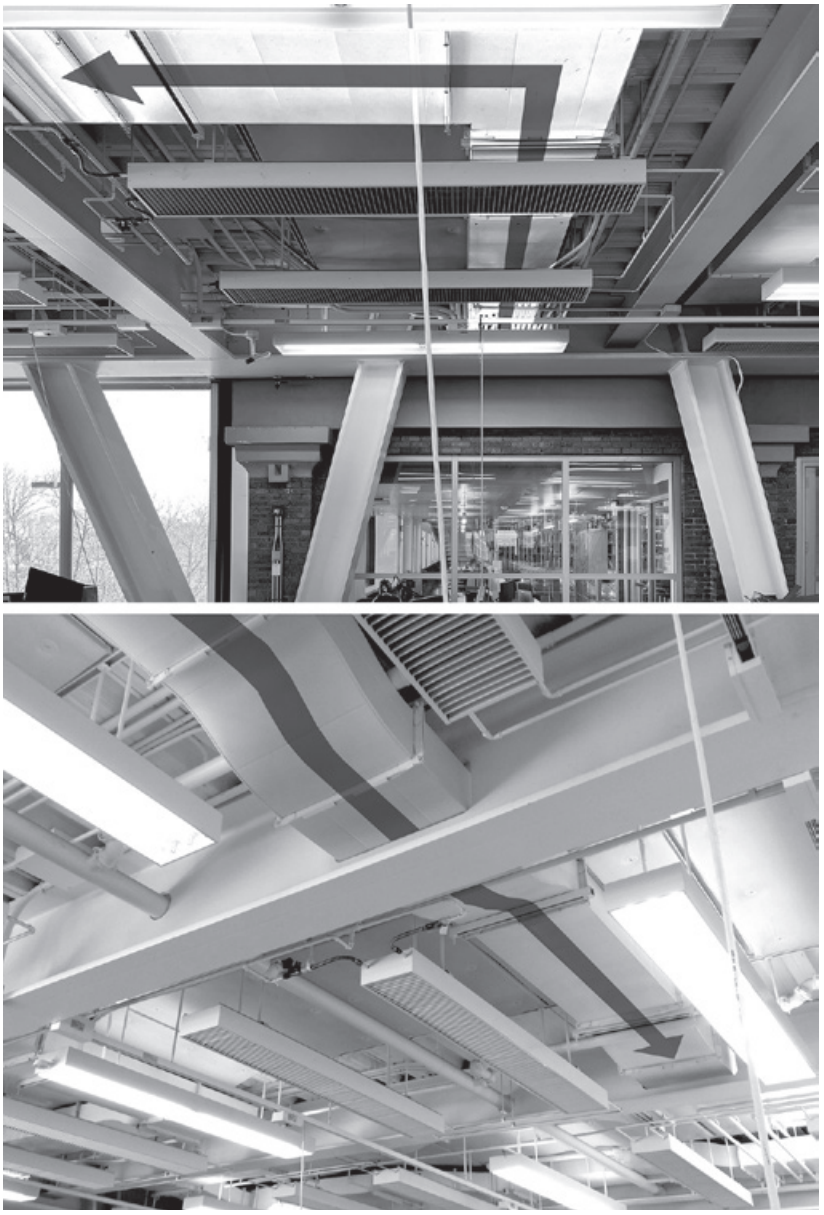
Furthermore, because this ductwork was threaded through holes in the webs of the structural beams, and because the system as a whole was designed for a large, undivided space, it becomes extremely difficult to

Figure 2.4. A duct for outside air distribution—labeled "A" in figure 2.3—is shown emerging from adjacent Rand Hall, where the mechanical room is located one level above (*top*). These ducts carrying fresh air are threaded through the webs of structural steel beams (*bottom*), making future alterations difficult. Light fixtures and matching chilled beams can be seen just below the ducts. Illustrative arrows added by the author.

modify, since a new pattern of ducts and sensors would not necessarily fit through the holes in the beam webs that were designed specifically for only one possible configuration (fig. 2.4). And like the fresh air system, the zoned heating and cooling systems cannot be reconfigured in any future subdivision of the second-floor studio space without essentially destroying the building (fig. 2.5).

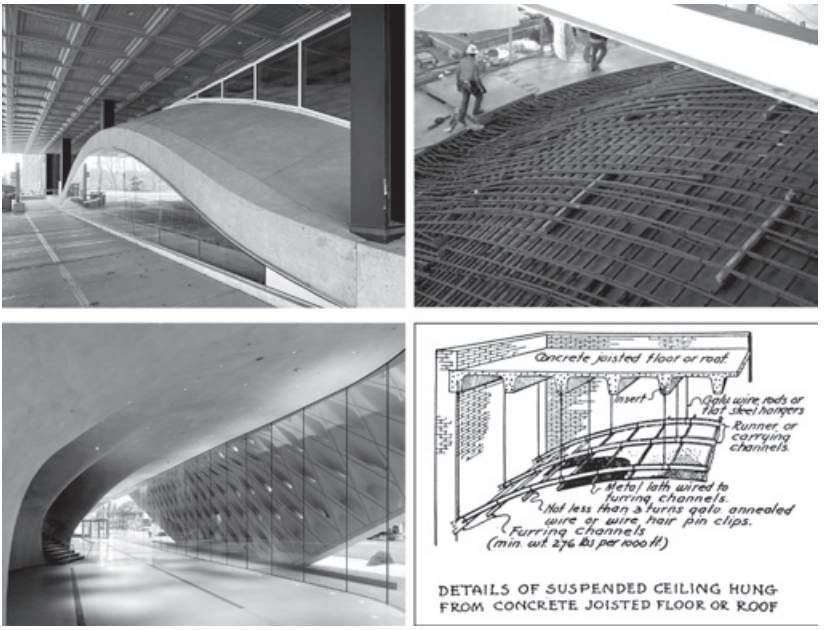
Complex and curved formal elements, like Milstein's dome, need not have been cast in concrete. The same geometry and expression can be achieved with less material, less money, and a greater ability to avoid conflicts between the structure and the building's electrical, mechanical, fire safety, and plumbing services. The Broad, an art museum in Los Angeles designed by Diller Scofidio + Renfro, achieves an equally complex formal expression of curved surfaces using plaster on lath—a technique often used in traditional construction—thereby avoiding all the constructional and functional complications seen in Milstein Hall (fig. 2.7).

Figure 2.7. The Broad Museum (*bottom left*) creates a complex curvature using lightweight metal framing, plaster, and lath, similar in principle to traditional plaster techniques (*bottom right)*; while Milstein Hall's dome achieves a similarly complex curvature (*top left*), but with far greater cost and complication, using cast-in-place reinforced concrete (*top right*).

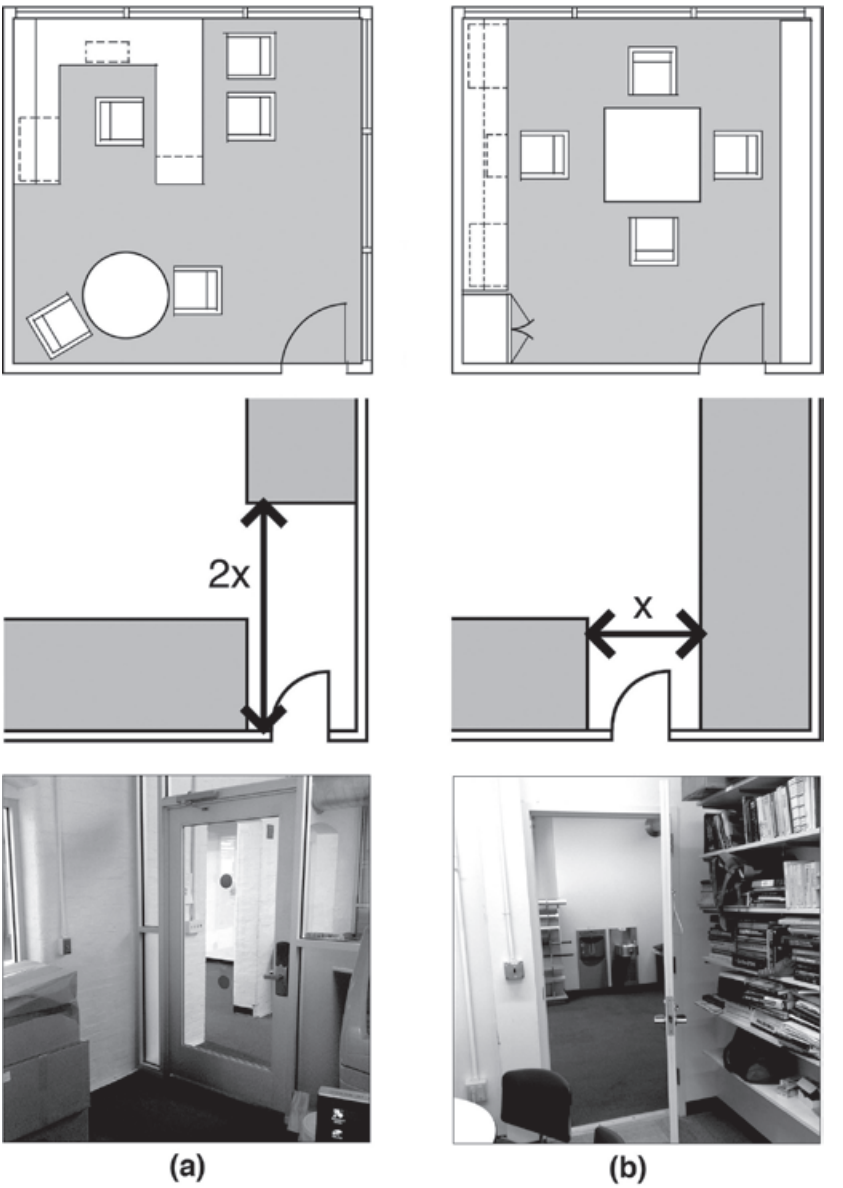
Design guidelines, even when legally codified, cannot possibly cover all of the ways in which rooms or spaces might become dysfunctional. For example, something apparently innocuous, like the position of the office door in the plan shown in figure 3.1*a*, would make it impossible to accommodate a bookcase like the one shown in figure 3.1*b*, whose door position anticipates the space necessary for that type of furnishing and thereby increases the room's functionality and flexibility. This can be seen in Sibley Hall, the building connected to Milstein Hall where I had an office for many years. In the digital fabrication lab across the hall from my former office (fig. 3.1*a*, bottom), large objects such as desks, printers, and laser cutters create an awkward and inefficient space as they converge in front of the door in the room's corner. In order to enter and exit the room through the corner door, twice as much perimeter floor area must be reserved for circulation space as would be the case if the door occupied a position further from the corner, allowing a typical desk or another piece of equipment to squeeze in (compare fig. 3.1*a* and fig. 3.1*b*, *middle* images). In my former office, on the other hand (fig. 3.1*b*, *right*), a door opening relatively close to the corner still allows for narrow bookshelves to efficiently occupy the space between door and perpendicular wall.

Figure 3.1. The position of a door in a room can affect its functionality, by allowing more or less use of wall space: A door placed at the corner (*a*) is less efficient than a door moved away from the corner (*b*); middle diagrams show schematically how more wall space becomes available in case *b* compared to case *a*; and photos at the bottom show two rooms representing these two door placement conditions.

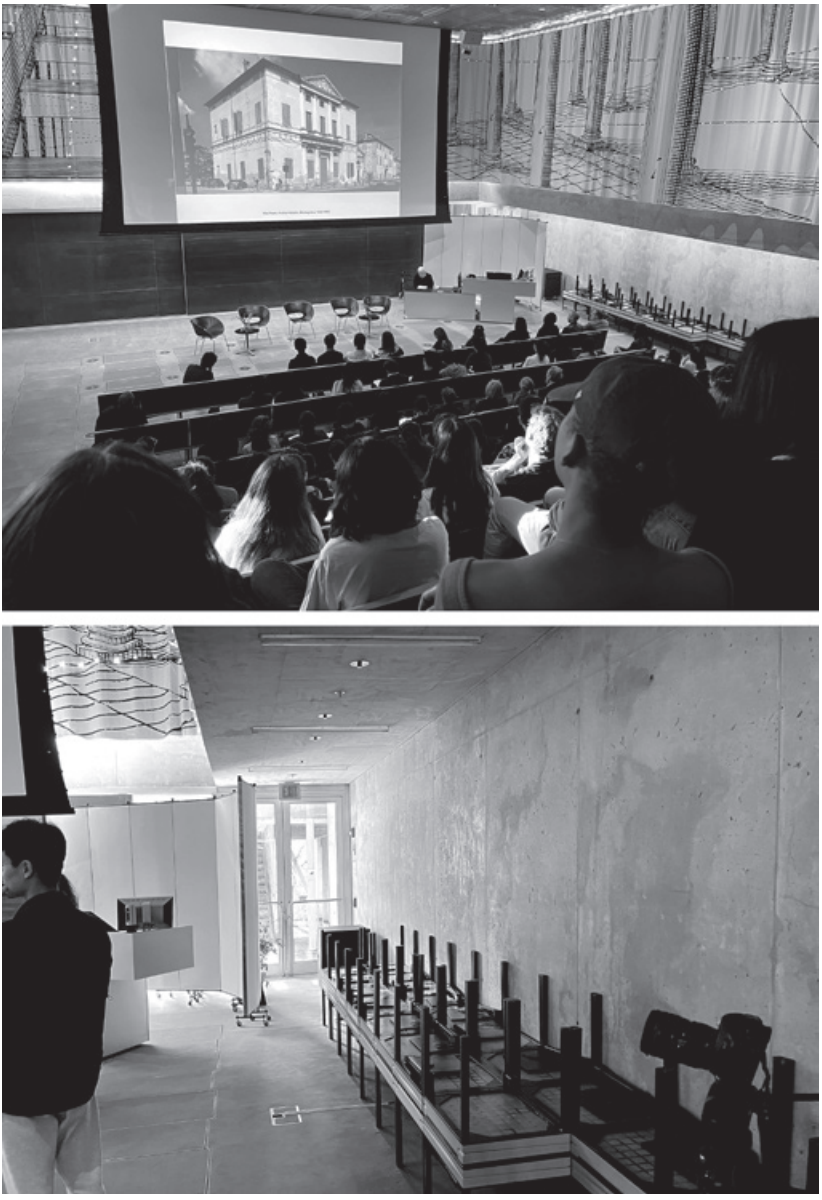
Figure 3.4. Position of an exit door in Milstein Hall's auditorium makes it difficult to productively use the space immediately adjacent to the side wall for either seats or required exit access. Peter Eisenman inaugurates the "Peter Eisenman Lecture Series" (*top*) on April 26, 2023, with a story about Colin Rowe and a certain Palladian villa projected on the screen, seemingly oblivious to the blocked exit door immediately to his left; the same blocked exit door is viewed from ground level (*bottom*).

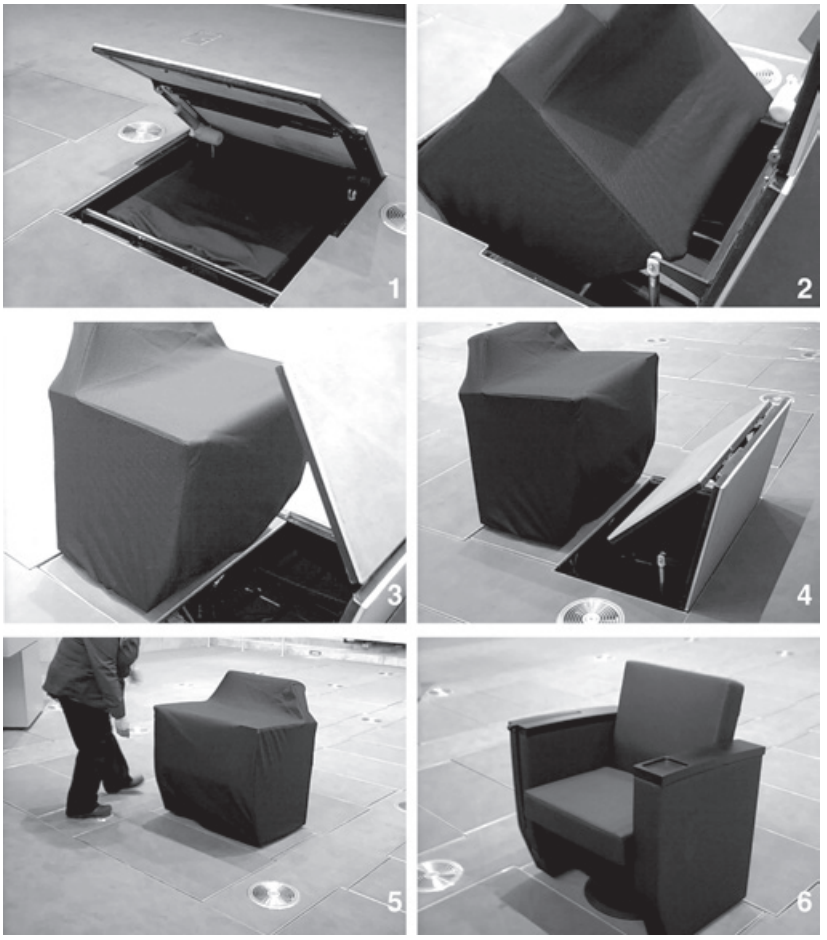
of Trustees—at the front of the auditorium. Aside from the bizarre politics that resulted in Milstein Hall's auditorium being used for Board meetings, the underlying premise behind the actual design of these seats is so strange as to defy all efforts aimed at comprehension (fig. 3.5). Suffice it to say that comfortable and motorized leather seats are stored *under the raised floor* of the auditorium for use only three times a year when the Trustees are in town, at which times complex motorized mechanisms

Figure 3.5. "Board of Trustee" seats mechanically rise out of their slumber at the bottom of Milstein Hall's auditorium.

are activated and the chairs rise out of their hidden spaces. In a quaintly anachronistic nod to the treatment of royalty (or perhaps to captains of industry), faculty and students—the common people at Cornell—are asked to use *ordinary chairs* that are moved in from some remote storage location when the Trustees leave Ithaca in their corporate jets.[2] But the complex mechanisms that raise and lower the Trustee chairs can easily break down: a panicky email was sent out to students and faculty in May 2013 ("Please note that no one should uncover or sit in the trustee seats for any reason") when some of the leather seats could not be returned to their hidden position, and it was necessary to leave them exposed to the *hoi polloi*.

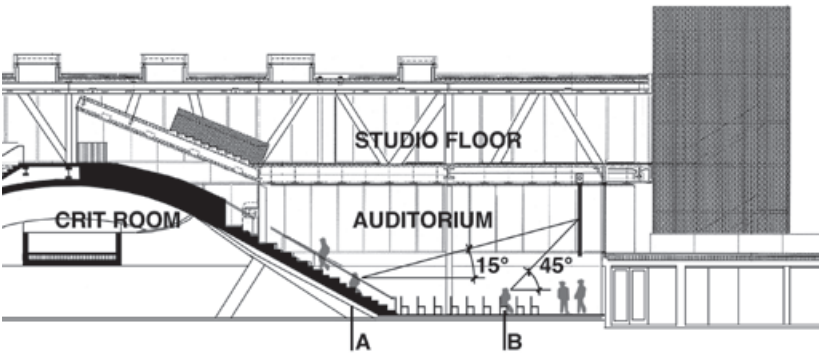
Figure 3.6. The seats at line "A" are the lowest acceptable seats in the auditorium, providing the maximum 15° inclined sightline to the midpoint of the screen; all seats below line "A," e.g., those shown at line "B," are uncomfortable and unhealthy.

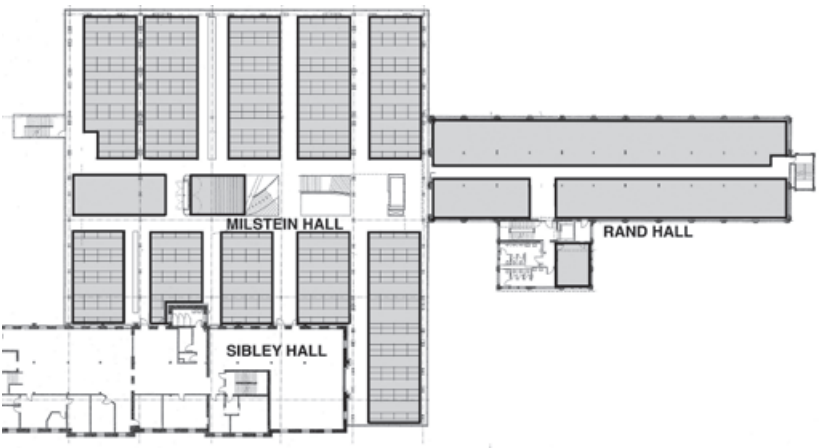
The potential flexibility of "bigness," in the case of Milstein Hall's studio floor, devolves into the pseudo-flexibility of waste. The space between trusses and glazing, while excessive, is hardly the primary reason for such gross inefficiency. As illustrated in figure 3.8, the programmed space on Milstein Hall's studio floor—including studio classrooms, assembly spaces (wood-floored studio lounge and small stepped auditorium), and worktables—constitutes barely over 55 percent of its 26,442 gross square feet (2,457 square meters), an inefficient and wasteful net to gross ratio. In contrast, the net to gross ratio in Rand Hall, when it served as studio and support spaces—before its conversion into the present Mui Ho Fine Arts Library—was over 80 percent.

Figure 3.8. Rectangles with gray tone outline programmed studio and support spaces in Milstein Hall and Rand Hall (when Rand Hall was used for such purposes, before its conversion into the Fine Arts Library). In computing the net to gross ratio for Milstein Hall, the required bathrooms and exit stairway in Rand Hall are included.

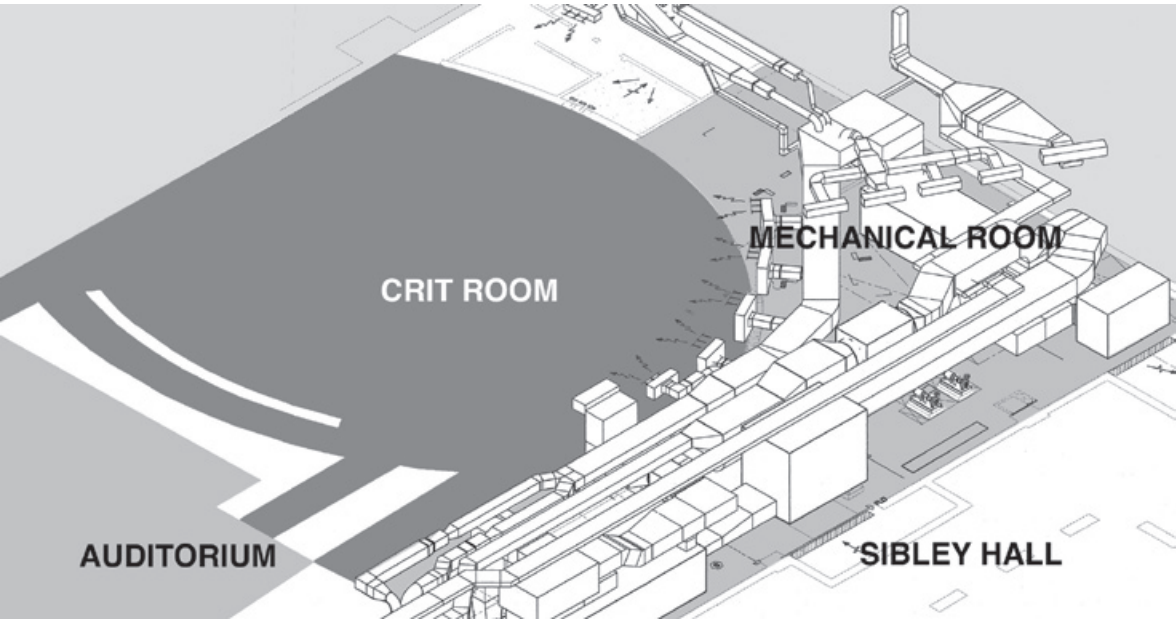
Milstein Hall is able to "pack" its nonorthogonal and domed Crit Room into the larger floor plan of the building because it tolerates wasted space on its curved boundary with the adjacent auditorium (fig. 3.11) and because its other neighbor is a mechanical room, whose

Figure 3.12. Mechanical 3-D diagram (adapted from the Milstein Hall mechanical working drawings by the author).

equipment has sufficient flexibility to accommodate the curve (fig. 3.12). In any case, with structural reinforced concrete loadbearing walls defining the boundaries of this curved space, there is little opportunity to make significant functional or spatial adjustments in the future.

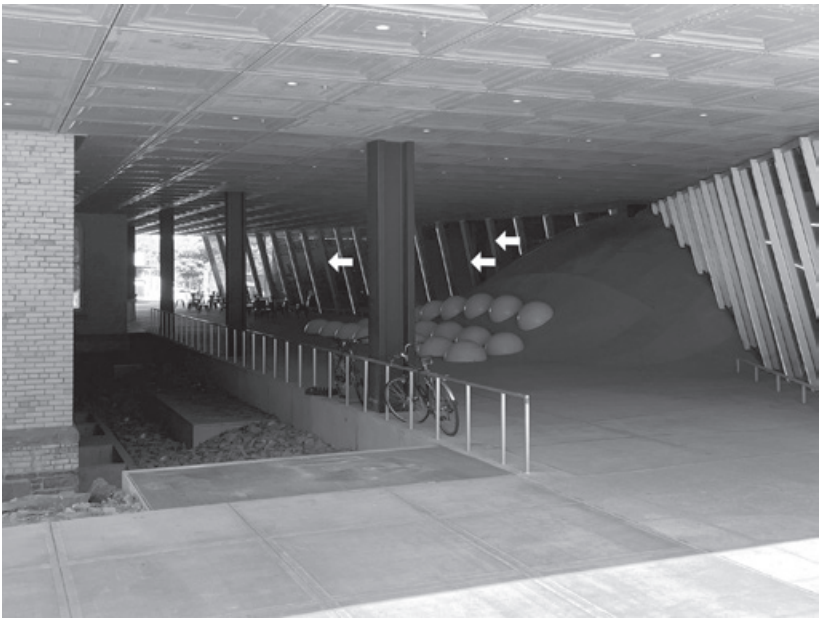
Figure 4.5. Some of the custom-designed LED lighting fixtures in the arcade that have been integrated into sloping curtain wall mullions turn themselves off for mysterious reasons, even after visits by puzzled electricians.

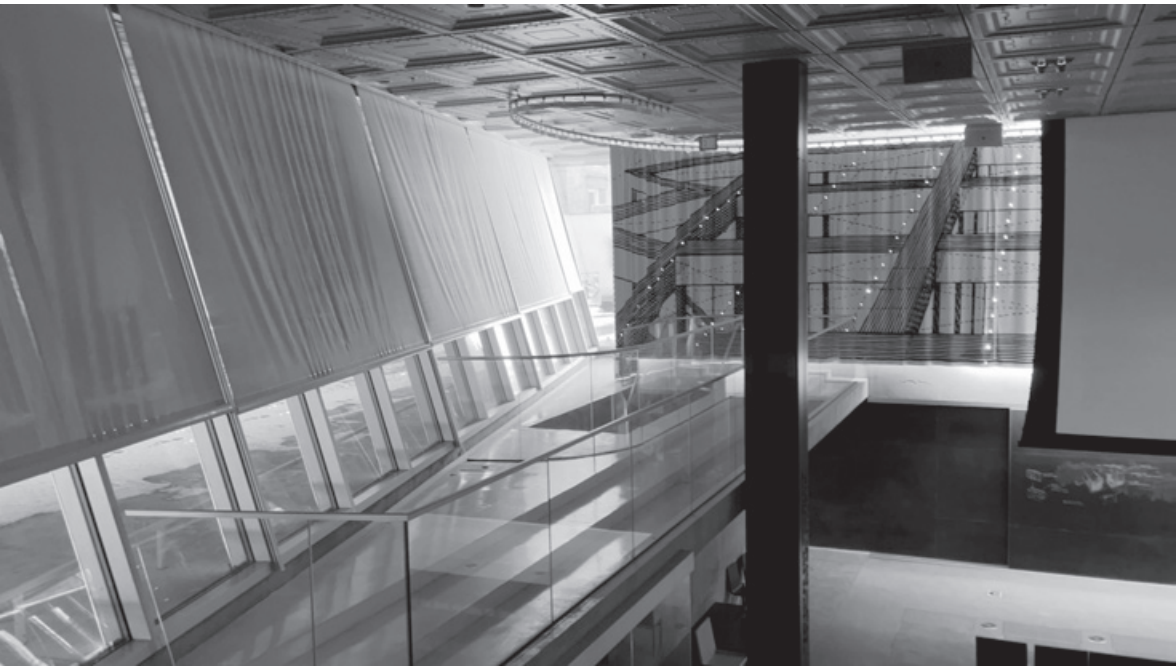
Figure 4.8. The special wood floor assembly area in Milstein Hall becomes uncomfortable and dysfunctional in late afternoon and early evenings as the western sun penetrates through the floor-to-ceiling glazing, even with curtains drawn and ad hoc barriers placed in front of the curtains. Students at this "Living Room" event held on April 19, 2023, with Nancy Lin and Curt Gambetta, shield their eyes (*top*) against the sun and its glare (*bottom*).

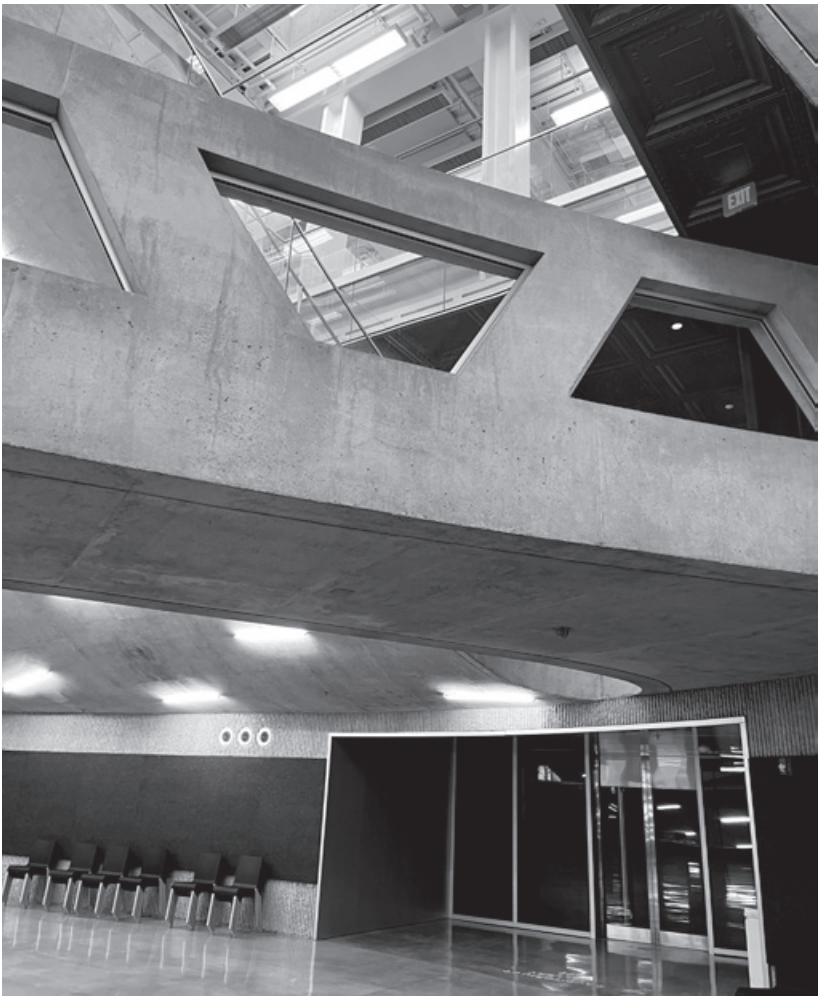
Finally, the same Crit Room that mimics the behavior of a whispering gallery also has no acoustical separation from vertically connected bridges and studio classrooms on the floors above, so that even ordinary circulation from the main building entrance, over the trussed concrete bridge, to the main auditorium or lower-level gallery interferes with ongoing design reviews (fig. 4.16).

Figure 4.16. Lobby-Crit Room-studio interpenetration: The spatial excitement of interconnected spaces at three levels results in acoustical conflicts between circulation (over the trussed bridge at the entry level), second-floor studio spaces, and the Crit Room below.

Fire barriers—basically fire-rated infill walls between the floor and ceiling of any given story—can be provided in order to separate different occupancies from each other, or divide a single occupancy into separate fire areas, but such fire barriers do not change the underlying construction type of the combined building, which remains that of a combustible wood-frame structure (Type VB). Where mixed occupancies are separated by vertical fire barriers and fire-rated horizontal assemblies in a single building, building codes stipulate that the sum of the ratio of proposed to allowable floor areas for each separated occupancy, in each story, be no greater than 1.0. However, this strategy of creating "separated occupancies" with fire barriers would not be feasible for the combined Milstein-Sibley-Rand Hall, since the combined ratios of proposed to allowable floor areas for the second floor would still come up short, and would, in addition, necessitate the construction of fire barriers and horizontal assemblies separating the Crit Room from studios above, something that might solve the acoustical issues illustrated in figure 4.16, but would also fatally compromise the design intent.

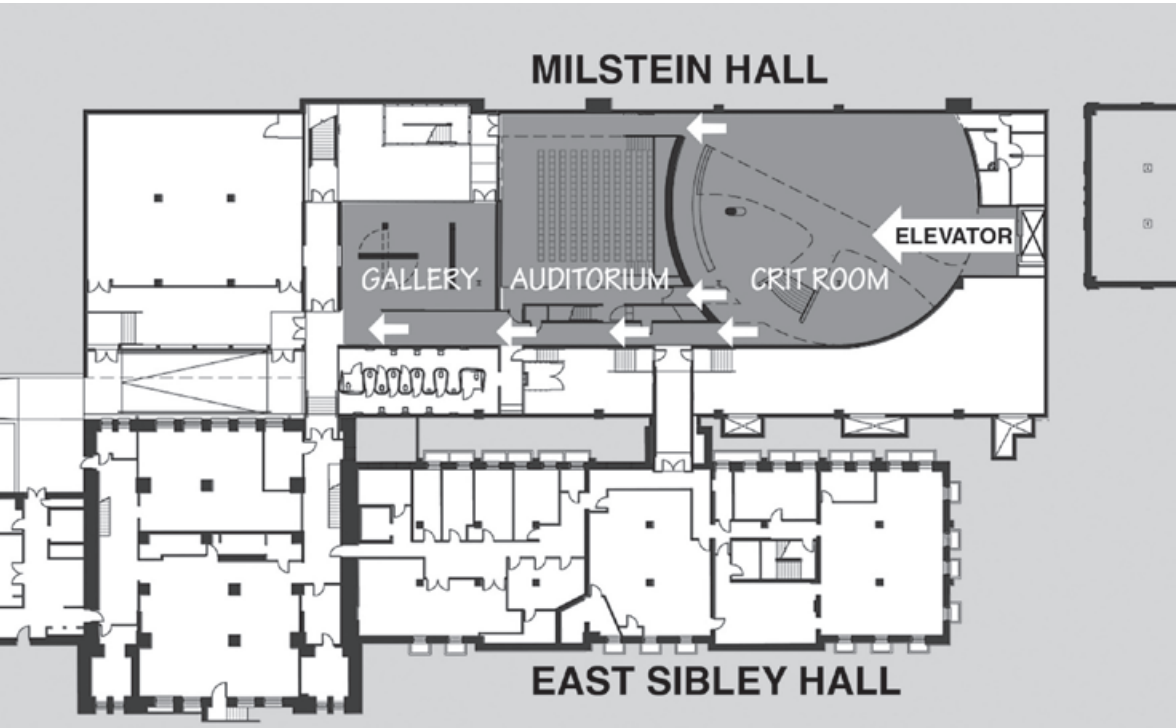
Milstein Hall's circulation system violates the essential requirement of acting as a "right-of-way" to provide "public" access to all the various rooms and spaces in the building. This is true not only because the entry-lobby-bridge has no visual or acoustic separation from studio and Crit Room spaces above and below, but, more fundamentally, because Milstein Hall's glass elevator has been designed so that users are forced to pass *through* the Crit Room in order to gain access to either the auditorium or the gallery at the lower level (fig. 5.1). The middle level of the auditorium can be accessed directly from the entry-level bridge without using the elevator, but this level does not provide an accessible path to the lectern or lower-level seating. These design decisions effectively preclude having independent events occurring simultaneously in the Crit Room and either the auditorium or the gallery.

Figure 5.1. Taking the elevator to the gallery or auditorium in the basement of Milstein Hall requires passing through the Crit Room.

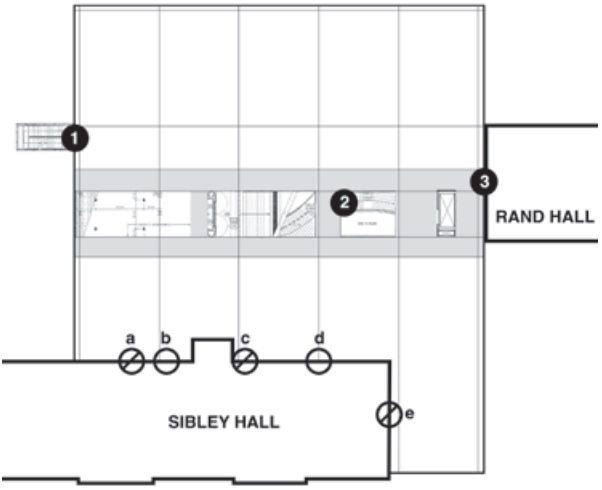
interior exit access stairway labeled No. 2 in figure 5.2, are not logically connected to the outdoor vertical circulation/egress stair labeled No. 1, which is offset to the north. Because the plan is "open," without fixed horizontal hallways or corridors, it is certainly possible to get from these parallel circulation aisles to egress stair No. 1, but the connection is awkward. Moreover, the discontinuity between the main horizontal circulation path and this required fire stair would make future subdivisions of the space more difficult since some sort of formal corridor would need to be created linking the main east-west exit access to this vertical exit.

Figure 5.2. Circulation patterns on the second floor of Milstein Hall are defined by required fire exits (No. 1 is an outdoor stair; No. 2 is an open exit access stairway; and No. 3 is an exit into Rand Hall) and by five connecting doors into East Sibley Hall (*a, b, c, d,* and *e*), two of which are open (*b* and *d*), two of which are locked at all times (*a* and *c*), and one of which—on the eastern wall of Sibley—has been removed (*e*).

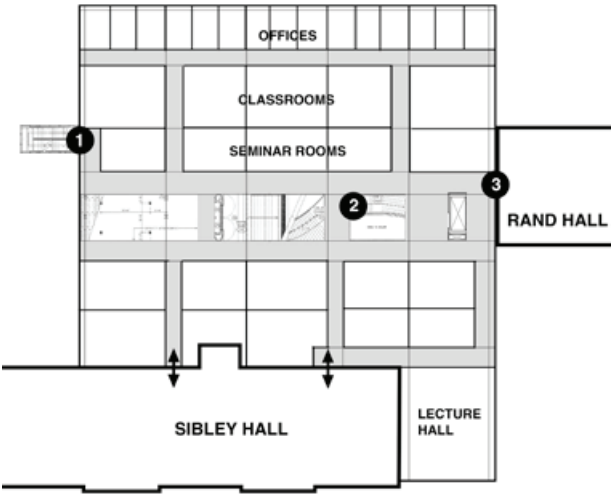
Figure 5.3. Milstein Hall's second floor shown subdivided into offices, classrooms, etc. The three required fire exits are labeled Nos. 1, 2, and 3; existing connections into Sibley Hall are shown with double arrows.

and at least three fire-safety concerns: the requirement to limit dead-end corridors to 50 feet (15 m); the requirement to limit common path of egress travel distances to 100 feet (30 m); and the need to configure large lecture rooms so that the distance between their two required exit doors is at least half the diagonal length of the room itself. Of course, other subdivisions of Milstein Hall's studio floor are possible, and might even be necessary—depending on specific programmatic needs that may arise in the future—but the basic constraints illustrated in figure 5.3 would remain.

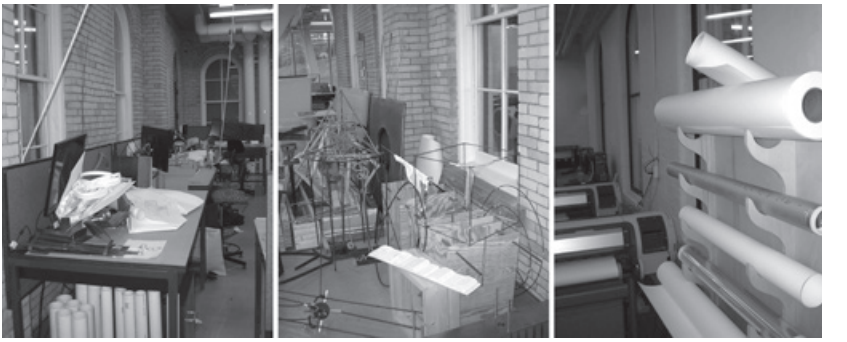
Figure 5.7. Combustible material placed in front of locked doors and windows in the fire barrier wall between Milstein Hall and Sibley Hall.

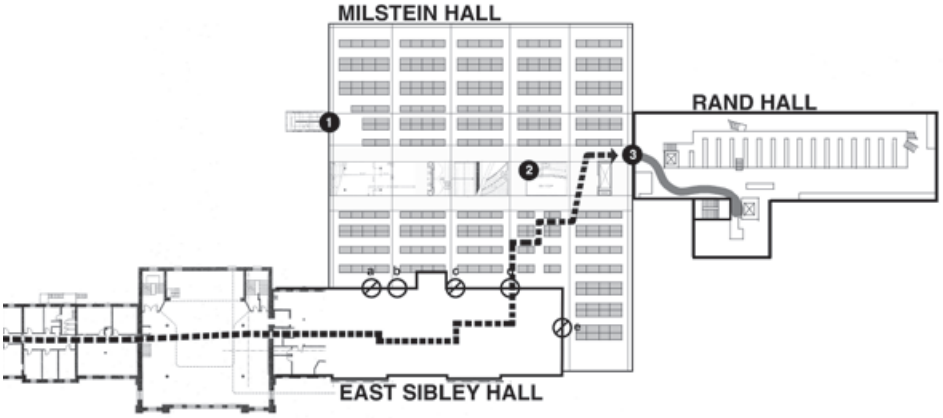
The awkward circulation from Sibley Hall, through Milstein Hall's second-floor studios, to the Fine Arts Library's "college-only" entrance is directly related to the flawed notion that abstract and schematic *plan adjacencies* constitute, and can be substituted for, an actual circulation system. As shown in figure 5.9, the path often taken by students and faculty coming from Tjaden Hall or West Sibley Hall (i.e., from the Departments of Art and City and Regional Planning) or even from East Sibley Hall (i.e., from the Department of Architecture) winds its way through the IT service room in Sibley Hall and then through "private" studio spaces in Milstein Hall, in order to gain access to the Fine Arts Library in Rand Hall.

Figure 5.9. Actual circulation patterns at the second-floor level, to gain access to the Fine Arts Library in Rand Hall, require maneuvering awkwardly through the IT service room in Sibley Hall and "private" studio spaces in Milstein Hall. Numbers (1–3) refer to required exits from Milstein Hall.

Exit No. 3 into Rand Hall (fig. 5.9) was not originally designed as a required means of egress from the second floor of Milstein Hall, but merely as a connection from one building to the other. This changed when the occupancy numbers for Milstein's second floor were recomputed—apparently to account for the increased occupancy of assembly areas like the wood-floored "studio lounge" (fig. 5.10)—and the path of least resistance (pun intended) was to use Rand Hall's existing interior

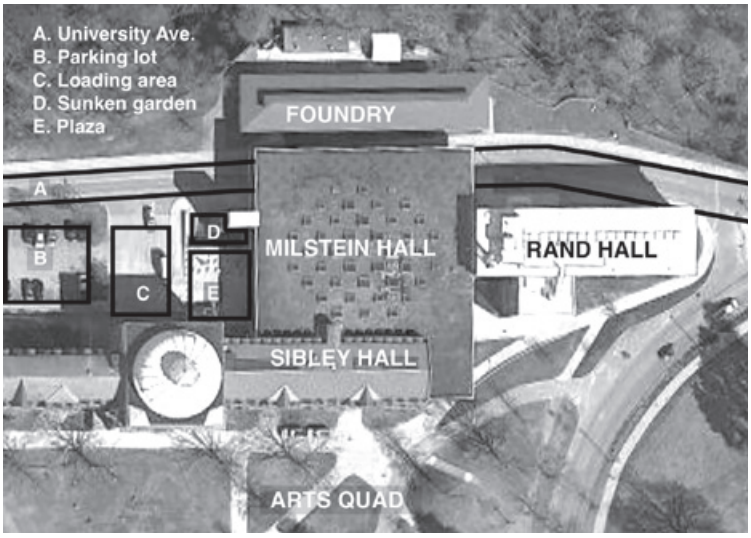
The idea that Milstein Hall created a public space ("plaza") adjacent to the Fall Creek Gorge is misleading on several counts and requires a short digression. First, the plaza *is* adjacent to four things on its four sides, but none of those things is the Fall Creek Gorge. As can be seen in the annotated Google Map satellite image (fig. 6.1), the plaza—labeled "E"—is

Figure 6.1. Milstein's "plaza" in relation to the Fall Creek Gorge.

actually adjacent to the following spaces: Sibley Hall to the south; a loading dock and parking lot to the west; a sunken garden and University Avenue to the north; and Milstein Hall to the east. Fall Creek does indeed exist north of University Avenue, but there is no functional connection between Fall Creek and Milstein Hall's plaza (fig. 6.2).

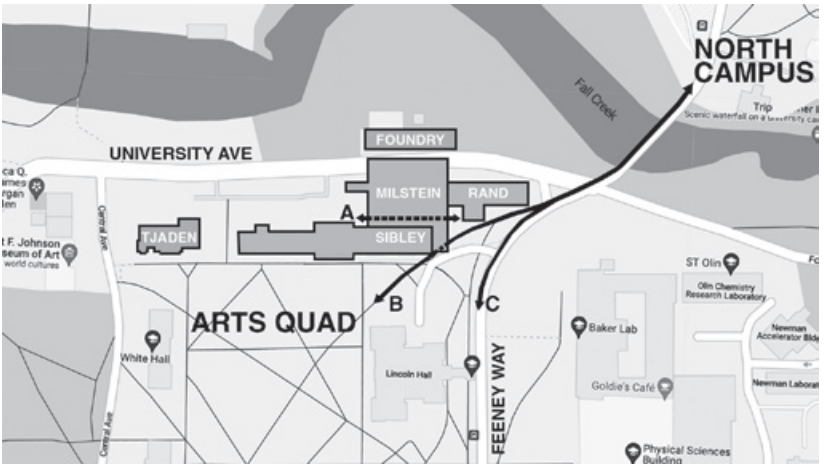
There are two primary reasons that the Duane and Dalia Stiller Arcade, located between Sibley Hall and Milstein Hall at ground level, is almost always empty. First, it doesn't provide a useful connection to anywhere in particular, so it is rarely used as a shortcut or path from somewhere to someplace else. The primary circulation paths at this end of campus—labeled "B" and "C" in figure 6.7—connect the Arts Quad (and also the rest of the campus, accessed via Feeney Way, formerly East Avenue) with undergraduate dormitories in North Campus. There is virtually no reason for anyone to circulate through the arcade, labeled "A."

Figure 6.7. Campus circulation in the vicinity of Milstein Hall: Path "A" is the Duane and Dalia Stiller Arcade; paths "B" and "C" connect North Campus dormitories with the Arts Quad and the rest of campus.

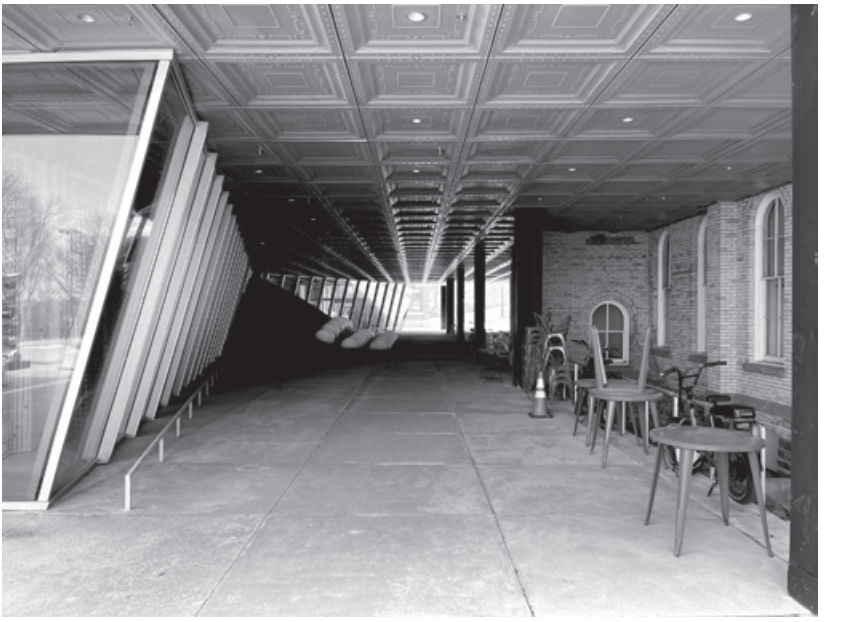
Second, it meets none of the criteria for being a successful outdoor space in its own right: it is dark and dismal, it is freezing in the winter, there is often no seating (the infantile plastic "bubbles" set into the concrete dome might work in a nursery school setting, but are inexplicable in the context of a major research university), and there is no compelling

Figure 6.8. The arcade in Milstein Hall, with seating bubbles visible in the background, is almost always empty.

activities visible in the adjacent buildings, and—as a result—with no particular reason for anyone to enter (fig. 6.8). The images in figure 6.9 and figure 6.8 show the two arcades at the same time on the same day (Tuesday, March 21, 2023, at noon), but this contrast in functionality could be demonstrated on virtually any day and any time when students are on campus.

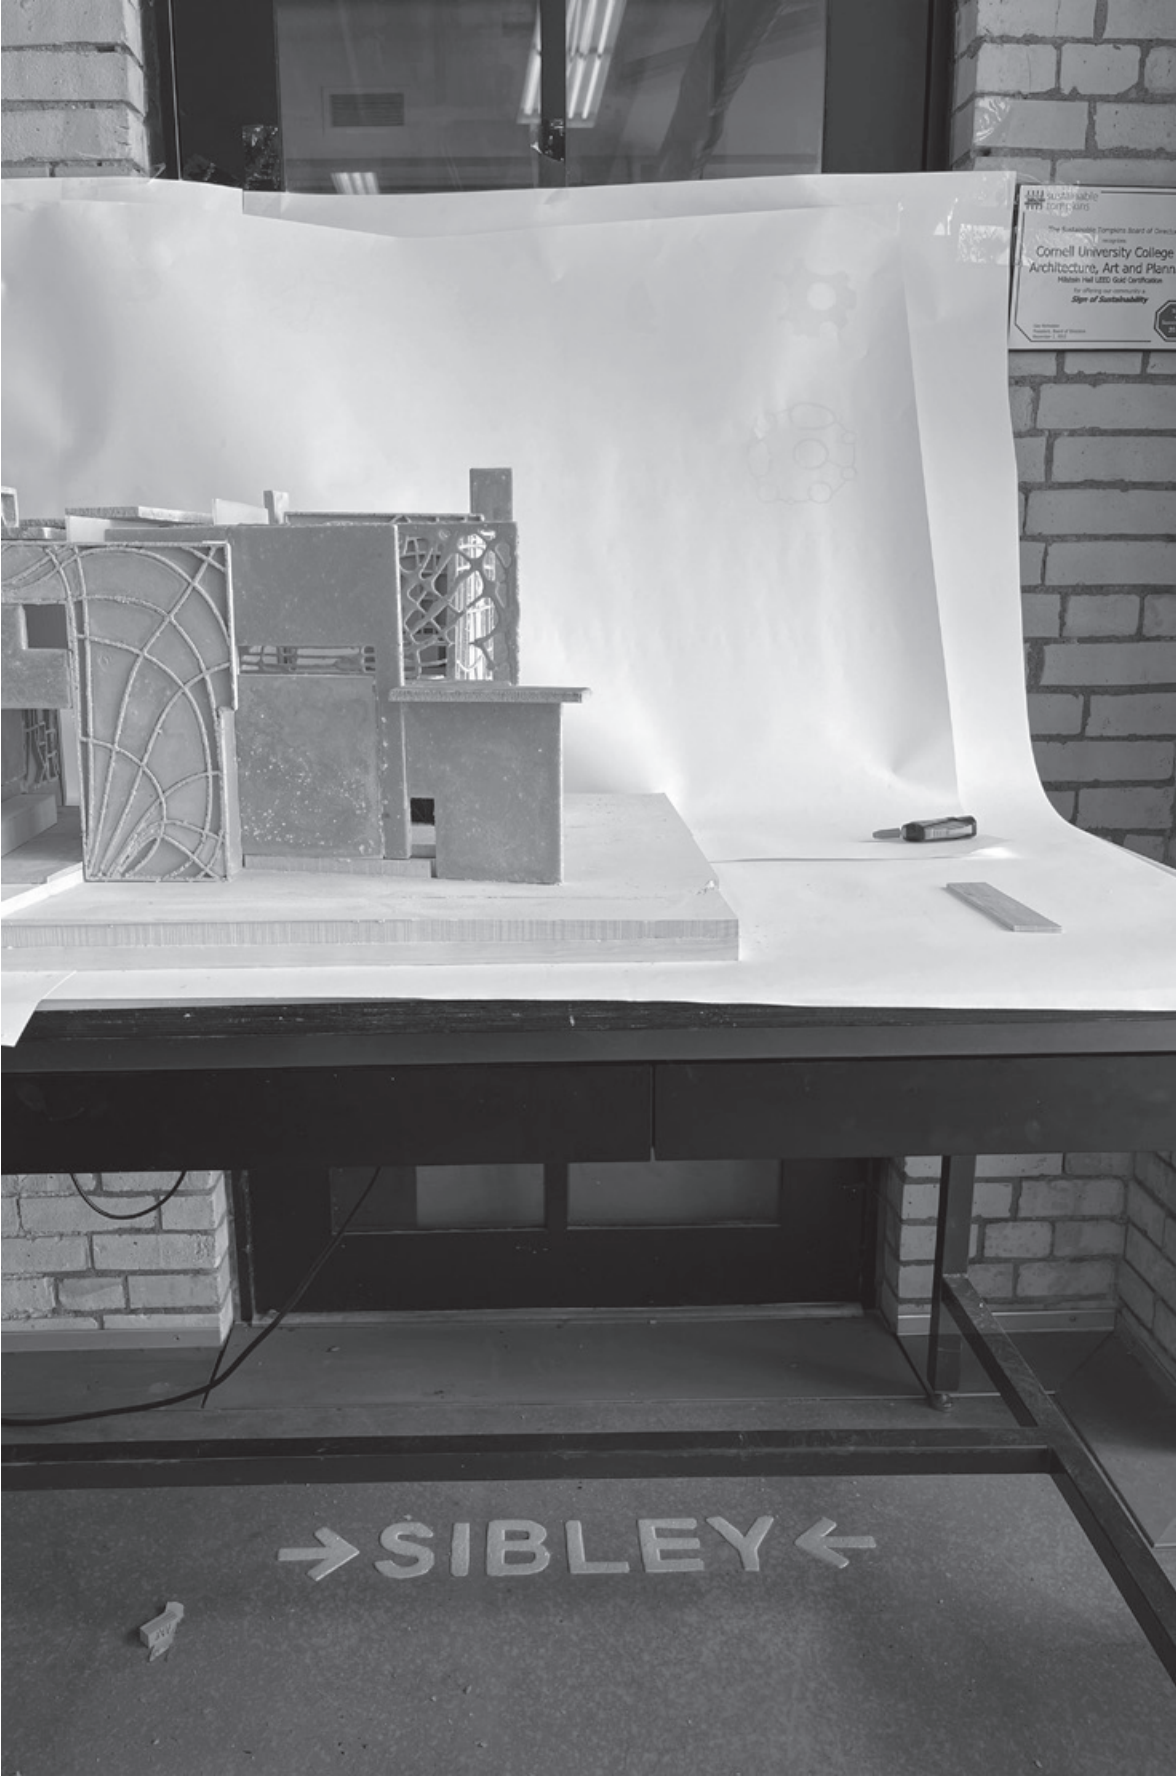
auditorium and gallery. These signs were subcontracted to 2x4, a "global design consultancy headquartered in New York City," whose mission is to "identify and clarify core institutional values and create innovative, experiential, participatory and visually-dynamic ways to engage key audiences worldwide."[17] Given this mission, one can only wonder how the college's "core institutional values" were translated into floor-mounted signs torched directly onto Milstein Hall's concrete floors, where they are stepped on, abused by cleaning protocols, and—as a result, in many instances—damaged or destroyed (fig. 6.12). The permanence of these torched-on letters becomes particularly absurd in the context of Sibley Hall's locked doors (fig. 6.13).

Figure 6.13 (facing page). Torched-on directional signs point to a permanently locked door to Sibley Hall.

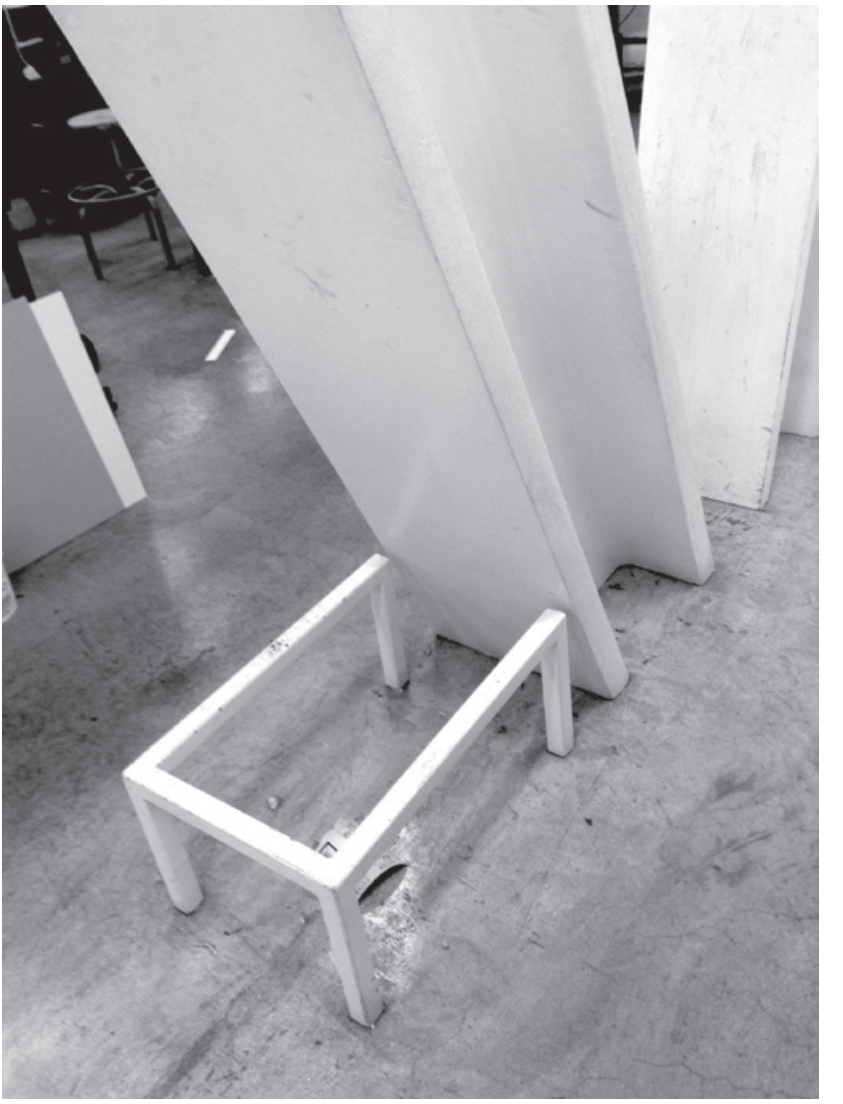
assemblages resembling wire-frame renderings of rectangular solids—that are permanently anchored into the floor slab (fig. 6.20).

Figure 6.20. Typical cane-detection guard at inclined (protruding) structural element in Milstein Hall.

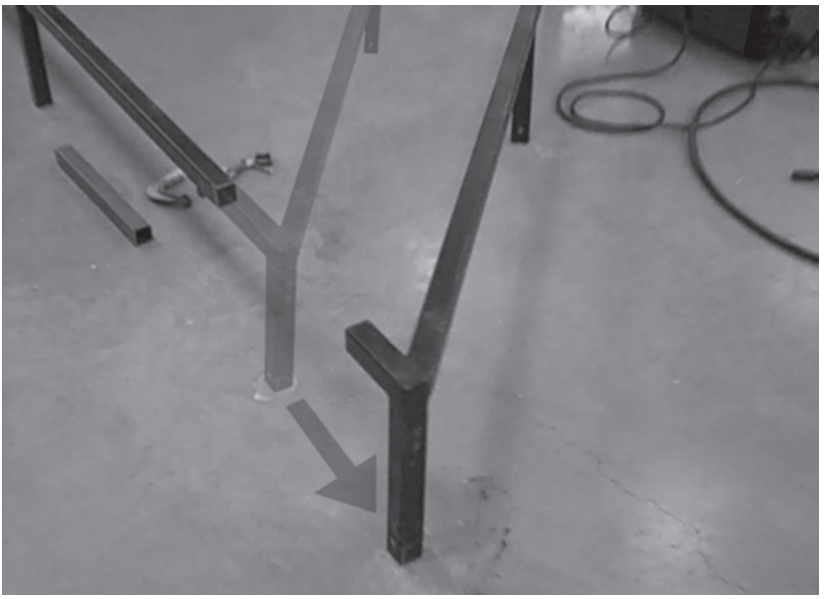
Figure 6.22. This photo, edited with Photoshop, shows how a cane-detection guard in the Crit Room needed to be cut and extended after the building was occupied.

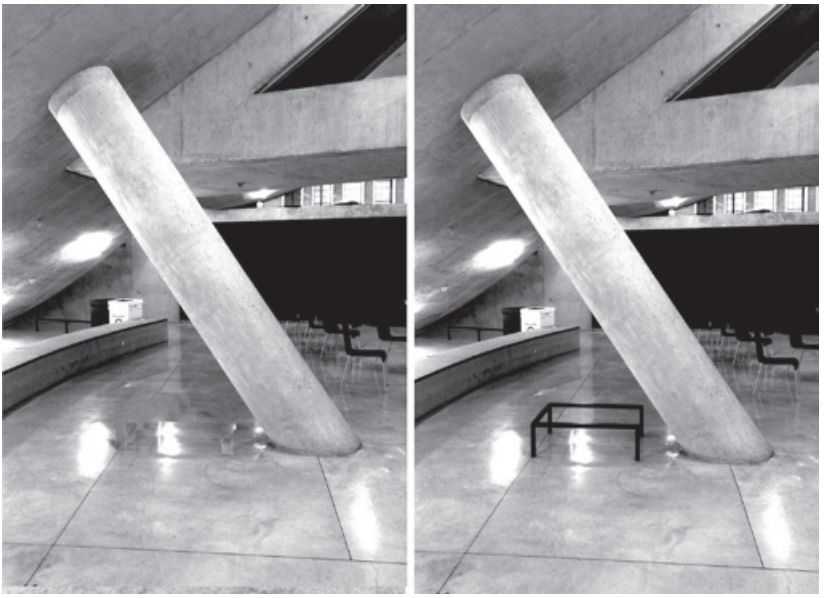
Figure 6.24. Cane-detection guards were added to the inclined reinforced concrete column in the Crit Room: before, simulated (*left*) and after (*right*).

Several cane-detection guards were not specified at all, as part of the original design for Milstein Hall, but were installed after the building was built and occupied, apparently as a result of my complaints. Figure 6.23 shows how cane-detection guards were added to the sloping curtain wall in the arcade; figure 6.24 shows how cane detection guards were added to a sloping concrete column in the Crit Room. There are published images showing these sloping (protruding) elements *before* guards were installed (avant-guard?),[27] but I have chosen to simulate the original conditions by editing my own "post-guard" photos, finding this photoshopping process more pleasurable than arranging permissions with the copyright holder.

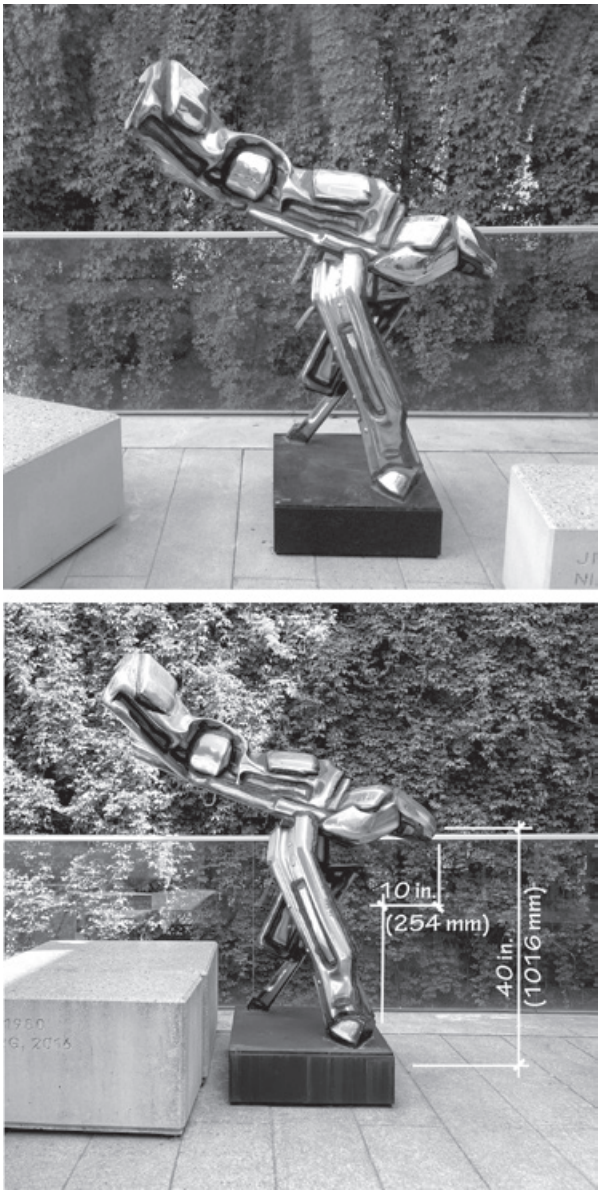
Figure 6.25. Sculpture as protruding object. A sculpture by Jason Seley was placed on Milstein Hall's concrete deck, creating a protruding object hazard (*top*); eventually, the issue was "resolved" by moving two of the plaza's concrete benches below the protruding part of the artwork, which created a cane-detection guard on one side of the sculpture, but not on the other side (*bottom*), where the welded car bumpers still protrude 10 in. (254 mm) into the circulation zone.

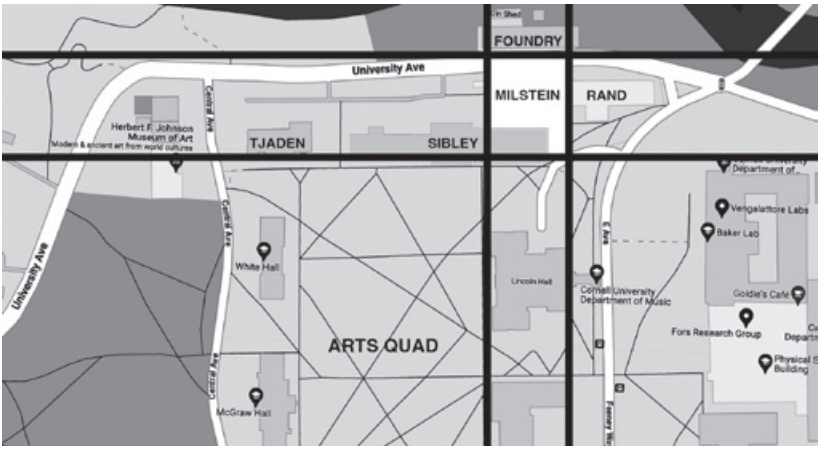
The underlying diagrammatic cartoon from which much of Milstein Hall's dysfunction originates can be understood by examining a campus site plan (fig. 7.1) in which an east-west zone is delineated such that it brackets the primary buildings of the college (Tjaden, Sibley, and Rand

Figure 7.1. I've interpreted the diagrammatic basis for Milstein Hall's siting on this campus plan: an east-west zone brackets the primary buildings of the college (Tjaden, Sibley, and Rand Halls as well as the art museum to the west); while a north-south zone conceptually ties the college's Foundry structure to the eastern buildings of the Arts Quad. Milstein Hall occupies the intersection of these two zones.

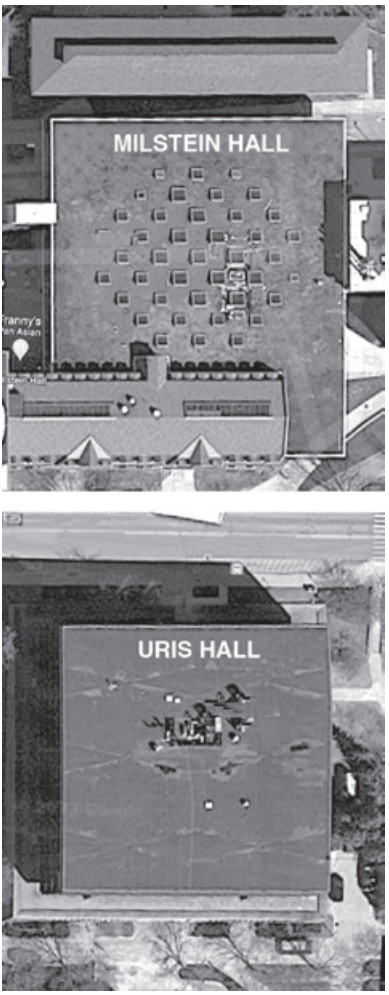
The geometry of Milstein Hall's second-floor plate, filling up the diagrammatic space shown in figure 7.1, makes it difficult to use the building for typical classroom, office, and related functions. Only a few Cornell campus buildings have similar dimensions (fig. 7.2), and in those buildings—like Uris Hall, designed by Pritzker Laureate Gordon Bunshaft of S.O.M.—the deep floor plan leaves many offices and classrooms

Figure 7.2. Milstein Hall (*top*) and Uris Hall (*bottom*) on the Cornell University campus are of similar size and shape, as can be seen in these Google Map satellite views taken at the same scale and orientation.
