OMA'S MILSTEIN HALL

A CASE STUDY OF ARCHITECTURAL FAILURE

JONATHAN OCHSHORN

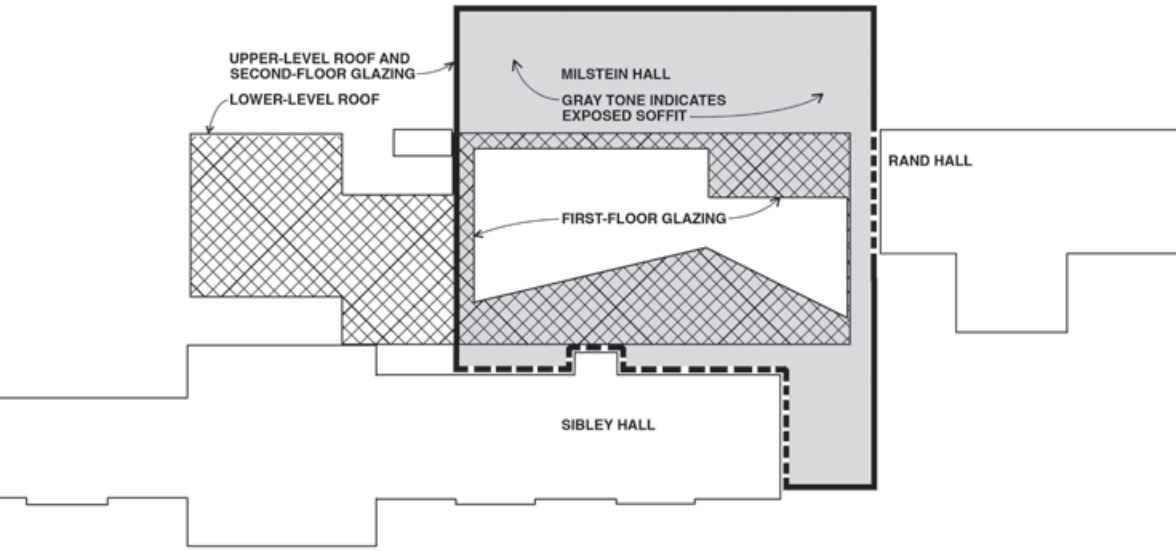
of conceptual east-west and north-south zones shown in figure 7.1, the architects then make the building as energy-inefficient as it is physically possible to do, wrapping the entire perimeter at all levels with "floor-to-ceiling windows," irrespective or orientation or function. More problematic, from an energy perspective, is the decision to lift the second-floor studio into the air to align with and connect to the second floors of Sibley and Rand Halls, while depressing the lower level into the ground to align with the basement of Sibley Hall (Rand Hall has no basement). Aside from a small portion of below-ground basement ceiling/roof area and upper-level soffit that is enclosed by the glazed perimeter of the auditorium and entry mezzanine, the enormous expanse of second-floor soffit and basement ceiling/roof area becomes exposed to the weather, along with the green roof, punctuated by skylights, over the second-floor studios. And, as the architects note with approval, not only the auditorium but also Milstein Hall's second-floor studios are surrounded by "floor-to-ceiling windows," except where Milstein Hall's second floor connects with Sibley Hall and Rand Hall (fig. 7.4).

Figure 7.4. Surfaces of Milstein Hall that are exposed to the weather: The black perimeter line bounds the upper studio level, defining the roof; the gray-toned area within the black perimeter line represents the exposed second-floor soffit; the cross-hatched area represents the exposed roof of the basement, which extends under the outdoor plaza and loading area to the west of the main part of the building.

Traditional or vernacular wisdom suggests that, in Ithaca's severe climate region, architects should employ the opposite strategy for a building's massing. Rather than articulating and separating the building's constituent parts, thereby maximizing the surface-area-to-volume ratio, they should "use a compact design with a *minimum* surface-area-to-volume ratio."[12] Yet as a result of OMA's complex form-making, Milstein Hall's volume of 723,795 cubic feet (20,496 cubic meters) corresponds to an incredibly large exposed surface area of 73,984 square feet (6,873 square meters).[13] To show how these numbers compare to a hypothetical building with a more rationally configured geometry, we can take Milstein Hall's volume but organize it within a normative 3-story building with an occupiable basement (similar to many of Cornell's traditional campus buildings). Giving this hypothetical building a width of 64 feet (20 m)—the "optimal" width for a campus building proposed by Stewart Brand that was discussed earlier—and using Milstein Hall's basic floor-to-floor heights, we get, for the same volume of 723,795 cubic feet (20,496 cubic meters), a reduced total exposed surface area of 36,639 square feet (3,404 square meters). In other words, a rationally configured geometry with the same volume as in Milstein Hall would have *half* of Milstein Hall's exposed surface area, making it far more energy efficient. Of course, this hypothetical version of Milstein Hall would also be far more *functionally* efficient and flexible.

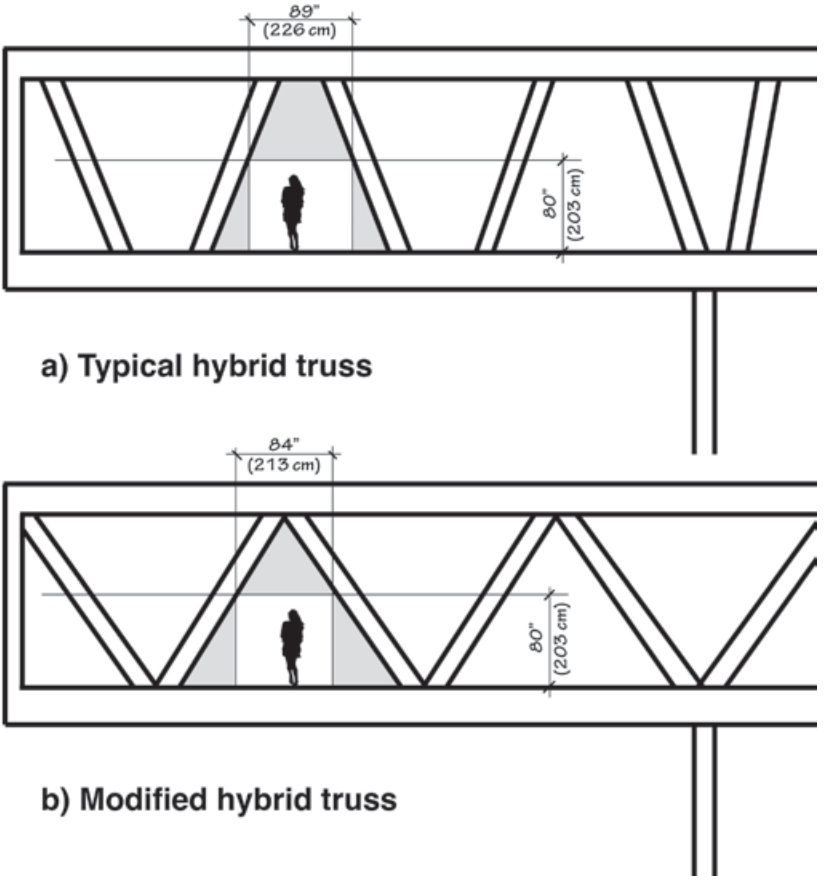
Figure 7.5. Milstein Hall's typical hybrid trusses (*a*) provide about 89 inches (226 cm) of space for circulation over the cantilever; a modified and more structurally efficient design (*b*) would provide about 84 inches (213 cm) of space—virtually the same amount.

None of this is true. The argument starts with the premise that "all the studios" have been placed into "one single linking space." In fact, numerous architecture studios are assigned to spaces outside of Milstein Hall—some are on the third floor of East Sibley Hall, and the rest are in the college's New York City and Rome facilities. The entire justification (putting "all the studios into one … space") for this audacious cantilever is bogus. The argument continues by claiming that the distortion of the truss into a "hybrid" rigid frame is a result of "circulation problems created by these trusses." In fact, one can circulate quite easily through a normative truss, as shown in figure 7.5.

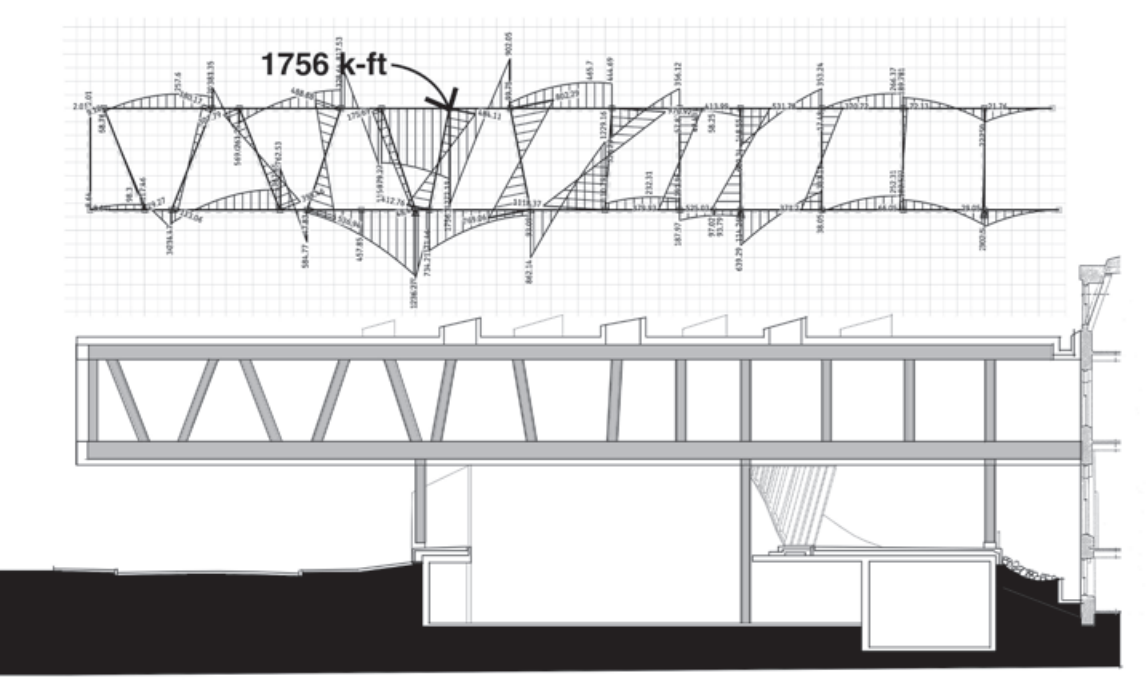
a) Typical hybrid truss

As can be seen in figure 7.6, the maximum bending moment in the hybrid truss, resulting from this cascading series of bad decisions and bogus explanations, is more than three times the equivalent value in a hypothetical and slightly *less illogical* hybrid truss where diagonals in the cantilevered section, still rigidly connected, are made to intersect at common nodes along the top and bottom chords. And while my modified structural model and load assumptions are simplified compared to the actual structural design, the conclusions can be taken as sound.[16]

Figure 7.6. Making simplified assumptions about the structural geometry and loads, one can see that (*a*) Milstein Hall's "clever hybrid solution" produces bending moments that are more than three times greater than (*b*) a modified version with more rational deployment of diagonal members over the cantilever.

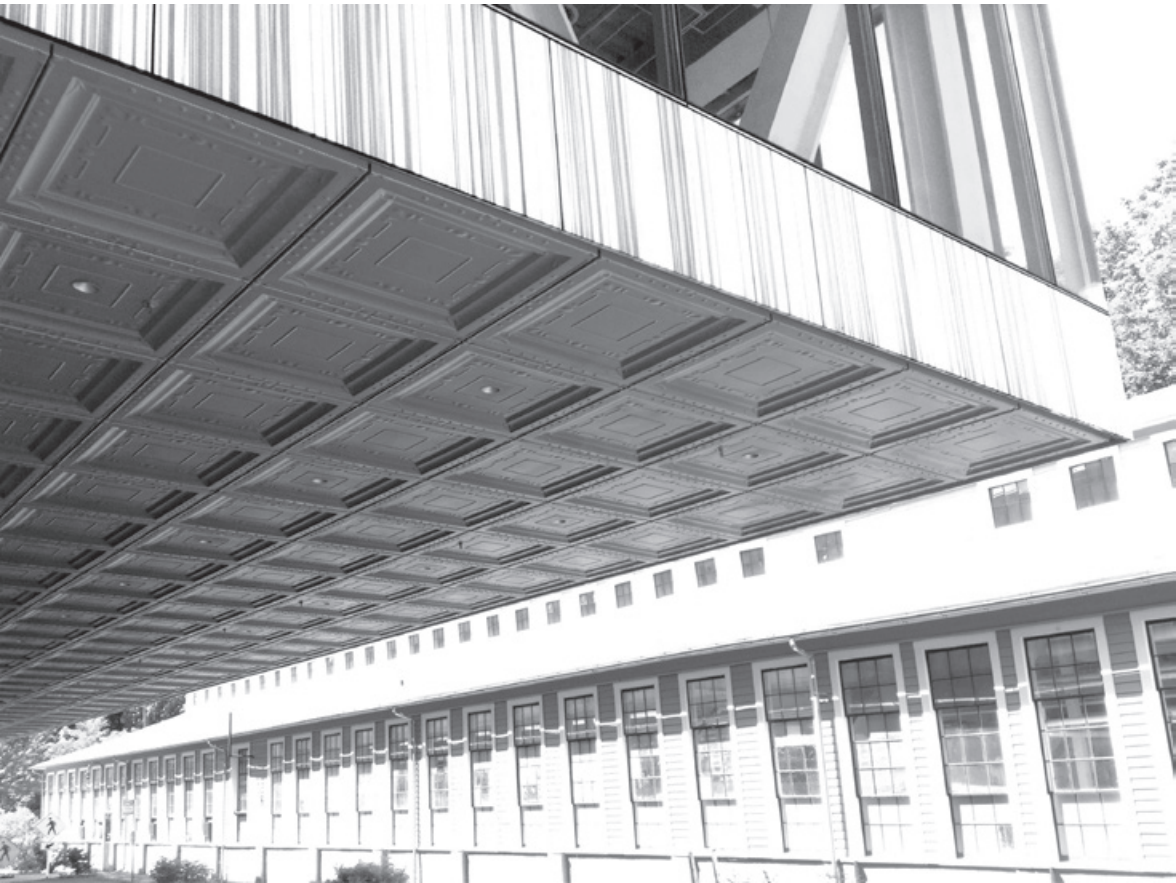
Tin ceilings were invented in the U.S. in the late nineteenth century as "a more affordable and more durable option to intricate plasterwork that was popular on European ceilings in the late 1800s."[22] In Milstein Hall, the ceiling/soffit panels certainly work as eye candy, but fail to take advantage of their ambiance—whether construed as nostalgic or ironic—to enliven Milstein Hall's covered outdoor spaces. Instead, unlike so many restaurants, bars, and other commercial establishments

Figure 7.7. Milstein Hall's stamped aluminum soffit panels reference traditional Victorian tin ceilings. Image shows the cantilevered portion over University Avenue facing the Foundry.

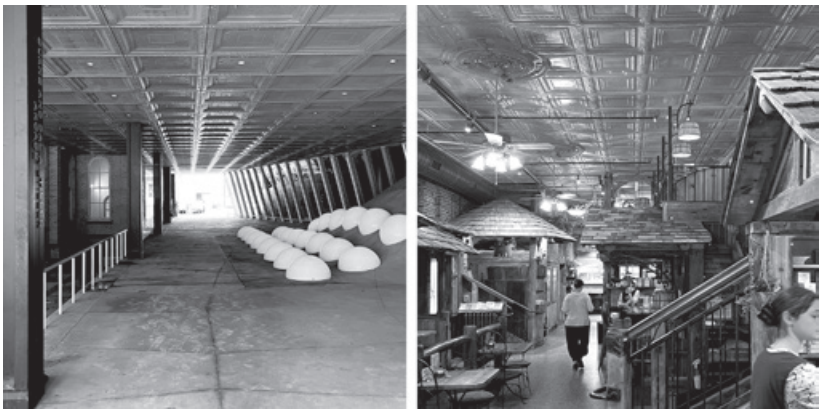
that have embraced their Victorian-era tin ceilings, the spaces under Milstein Hall's stamped aluminum panels remain largely empty and dysfunctional (fig. 7.8).

Figure 7.8. The spaces beneath Milstein Hall's faux-Victorian soffits, in particular the arcade (*left*), remain largely empty and dysfunctional; the ceiling tile design is modeled after a type of pressed tin ceiling, shown here in Ithaca's historic "Andrus Printing / Home Dairy / Firebrand Books Building" (*right*), that was invented in the U.S. in the late nineteenth century.

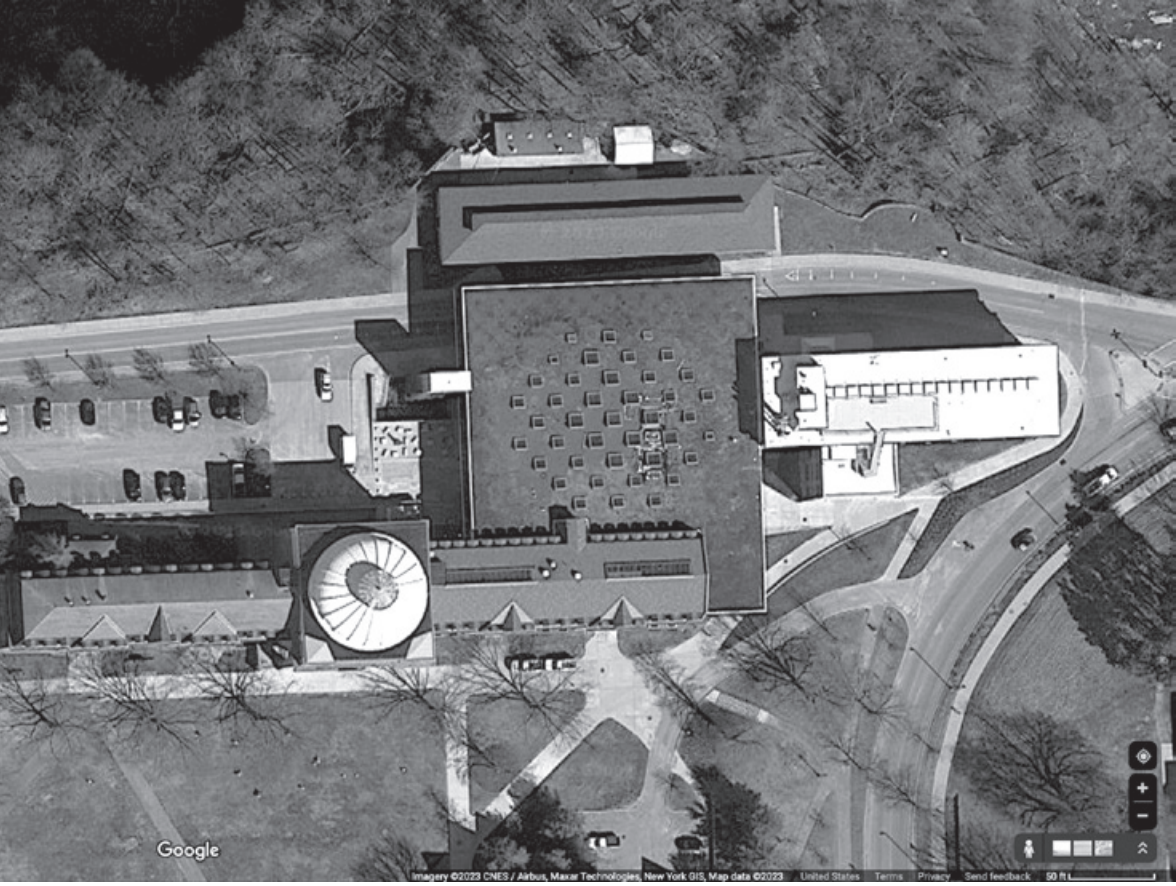
Figure 7.9. This Google Map satellite image shows how the "graphic pattern" of circles created by colored sedums on the vegetated roof of Milstein Hall has been virtually obliterated, both by natural processes and by maintenance; see also figure 6.6.

Characterizing the roof of Milstein Hall as a "facade" is problematic for a number of reasons, some of which have been discussed previously. First, the roof is barely visible, and—when it is seen at all—it is seen obliquely, e.g., from the third-floor studios in Sibley Hall, rather than frontally. On this basis alone, the term "facade" seems inappropriate. Second, the "graphic pattern" painstakingly created with circles of colored sedums has been virtually obliterated, both by natural processes and by maintenance (fig. 7.9).

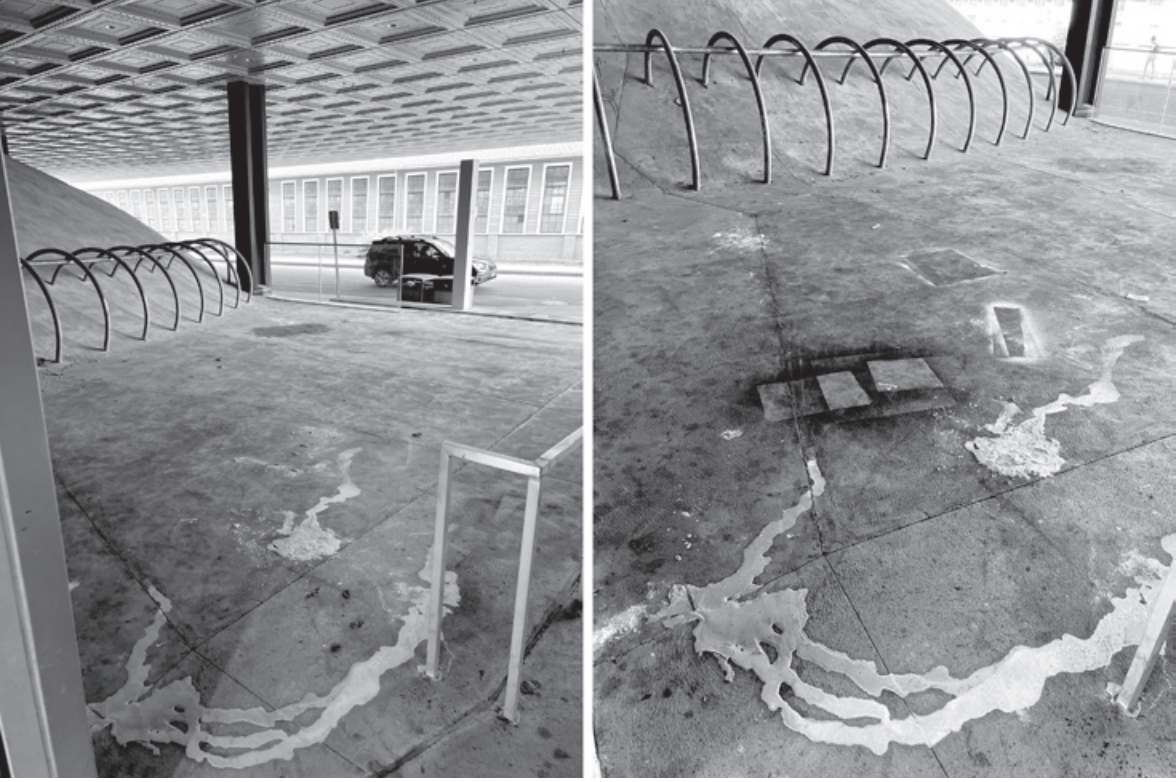
Figure 7.10. These Milstein Hall images of the covered outdoor space across from the Foundry were taken about a month apart in April (*left*) and May (*right*) 2023; one can see the addition of spray paint to the illicit composition that was already in place on the concrete surface: a work in progress!

the stamped aluminum soffit under the second-floor studio. The first of these spaces consists of a flat concrete surface off University Avenue, across from the Foundry, that morphs into the Crit Room's domed ceiling where it supports some circular bike racks, but certainly no "boundless studio space." Students do use the space occasionally and inappropriately, for spray painting models and for whatever else may have caused those white Giacometti-like residues (fig. 7.10).

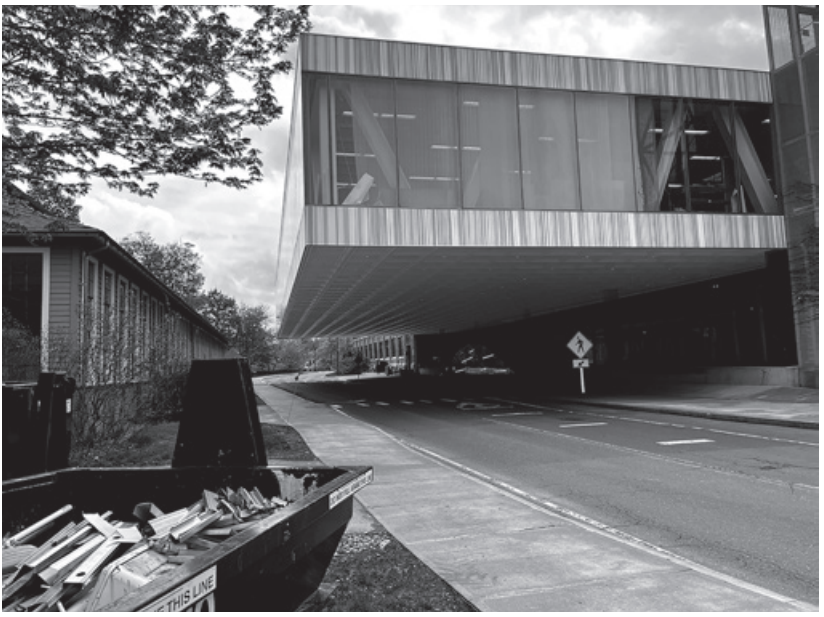
Figure 7.11. The outdoor covered space below Milstein Hall's primary cantilever functions as a road and sidewalk—nothing else.

The second of these covered spaces is the largest of them all, and the most useless: this is the portion of University Avenue that runs below Milstein Hall's cantilevered second-floor studios (fig. 7.11). Clearly, it does not, and cannot, function as anything other than a road and sidewalk—certainly not as "boundless studio space [for the construction of] large-scale prototypes, models, and sculptures."

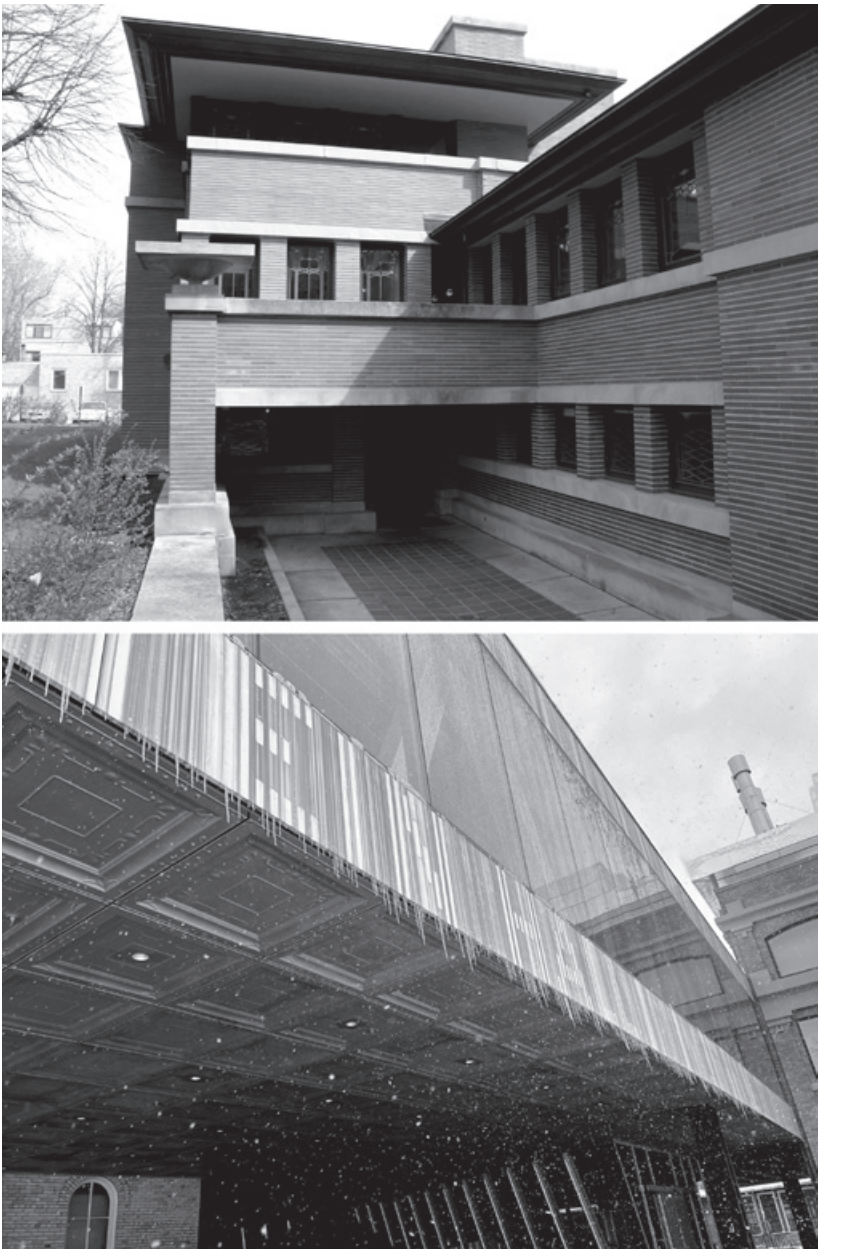
Figure 8.1. While leaking roofs are not unknown within Frank Lloyd Wright's oeuvre, the likelihood of water issues on exterior walls or windows of his Robie House is dramatically reduced by the use of roof overhangs (*top*); the exterior facade of Milstein Hall, on the other hand, forms icicles as snow striking the surface melts and then freezes (*bottom*).

radiant heat originating in the concrete floor slab (near the top of the stone panels) works its way through various insulation layers via thermal bridges—and then freezes (at the bottom of the stone panels) where the stone is colder. Such icicles, especially if they become bigger, pose a threat to pedestrians circulating directly under this cantilevered corner of Milstein Hall (fig. 8.1 *bottom*).

As discussed in the section on thermal bridging (fig. 8.1), Milstein Hall has problems with icicles that form on its facades through the same process associated with classic ice damming. Aside from energy inefficiency implied by the thermal bridging, icicles are also quite dangerous: they can "start crashing down to the ground below and can cause injuries" according to emergency medicine physician Tom Waters, MD. The doctor adds that "if an icicle hits you in the head, you may see an alarming amount of blood at first. That's because the scalp contains a lot of blood vessels. But it's important to remain calm and get the bleeding under control with direct pressure."[5]

Roof overhangs could also reduce the probability of icicles forming on an exterior wall. In this case, the formation of icicles requires two things: on the one hand, a portion of the wall needs to be warm enough to melt wind-driven snow while a lower portion of the wall needs to be cold enough to freeze the melted water, causing icicles to form. On the other hand, wind-driven snow must be able to reach the wall surface. Now compare the use of overhangs on Frank Lloyd Wright's Robie House with the lack of overhangs on Milstein Hall. While leaking roofs are not unknown within Frank Lloyd Wright's oeuvre, the likelihood of icicles forming on the brick walls of the Robie House is dramatically reduced by the use of roof overhangs (Figure 8.1 *top*). On the exterior facade of Milstein Hall, on the other hand, icicles can form through the same process associated with classic ice damming. Snow melts on floor-to-ceiling glass panels, or perhaps on stone cladding panels—where

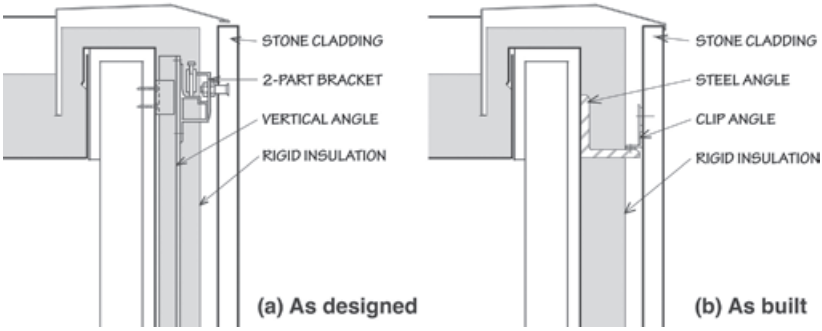
Figure 9.1. The original design (*a*) shows an adjustable 2-part bracket system which minimizes thermal bridging; the detail as built (*b*) replaces this "hi-tech" system with a "low-tech" assemblage of angles and clip angles which interrupt the continuity of the rigid insulation, creating a significant thermal bridge.

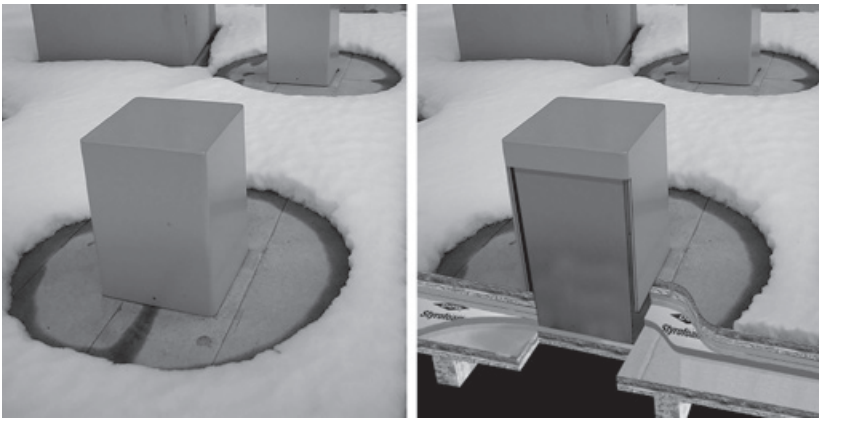
Figure 9.5. Bollards placed over Milstein Hall's below-grade heated space penetrate all three layers of below-grade rigid insulation, causing unimpeded heat loss from those below-grade spaces (*right*, photoshopped cut-away image—waterproofing and drainage layers not shown); the circular areas of melted snow around each bollard (*left*, original photo) attest to the heat loss through the bollards from the occupied space below.

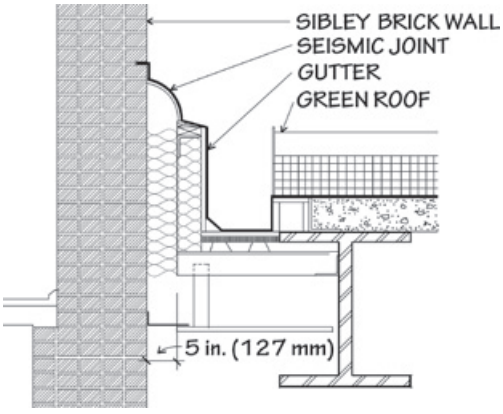
not pound into each other during a seismic event (fig. 9.6). The seismic joint, as built, appears to be different from the detail, in that no curved profile is evident (fig. 9.7). It is difficult to say what exactly was fabricated and installed, and in what manner it was designed to accommodate movement, if at all.

Figure 9.6. The 5-inch-wide seismic joint as detailed between Milstein and Sibley Halls (similar for Rand Hall).

not stuffed with batt insulation as shown in the detail. I had emailed the College of Architecture, Art, and Planning's project liaison in November 2009, remarking that "…the 5-inch space immediately below the curved expansion joint cover is filled with 'batt insulation,' but not otherwise protected against vapor intrusion from the interior space below… It may be that, even without humidifying the Milstein space, there would be high enough relative humidity (generated by building occupants) that such air, working its way up into the insulation, would reach the colder surface of the expansion joint cover and condense, wetting the insulation, and potentially causing other nasty problems during the winter months." The project manager replied in January 2010 that he "has looked at the issue … and discussed it with team members. It is still a bit on the back burner since we have so many other pressing issues that need to be dealt with immediately. Be assured that we will close the loop with you on this issue." Well, he never "closed the loop" with me, but I was told much later that the seismic joints were, in fact, uninsulated, constituting one more thermal bridge in the building. This can be seen at the intersection of Milstein and Rand Halls (fig. 9.8), which has no cover plate hiding the thermal bridge, unlike the situation at the intersection of Milstein and Sibley Halls, where a metal plate covers the joint.

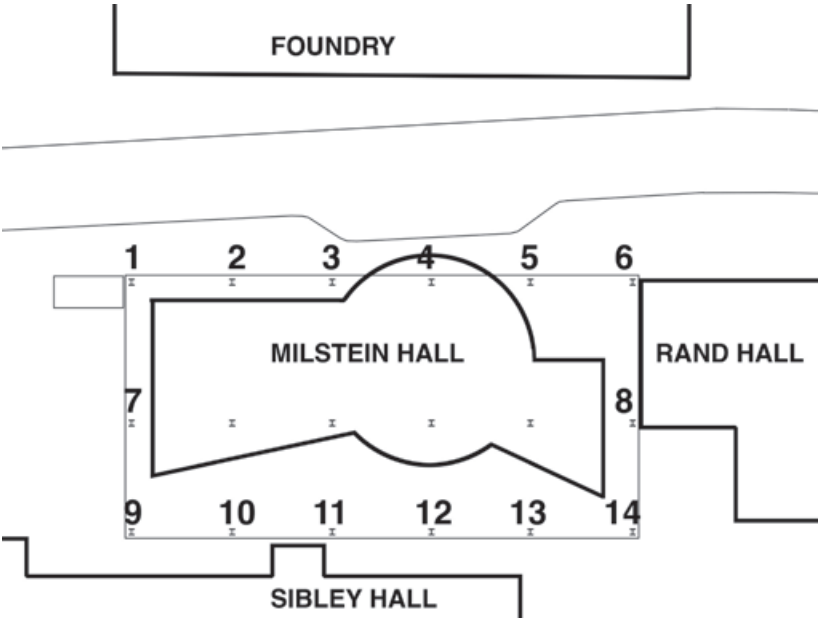
Thermal bridging, caused by steel columns that penetrate Milstein Hall's insulated soffit below the second floor, is not inconsequential. Even without a sophisticated thermal analysis, one can make a rough estimate of the energy penalty by comparing the heat loss *with* studio floor column penetrations to the heat loss through an insulated floor without column penetrations.

As can be seen in figure 9.11, there are fourteen exterior columns holding up the second-floor plate; each of these W14×605 wide-flange

Figure 9.11. This schematic first-floor plan shows all 18 first-floor columns that support the large second-floor plate. Of these 18 columns, only four are within the building enclosure at the first-floor level; 14 are outside and contribute to thermal bridging.

shapes has a cross-sectional area of 178 square inches (0.115 square meters). The column labeled No. 4 in the plan appears to be inside the first-floor enclosing walls, but is actually exposed to the elements above the concrete dome and so contributes to thermal bridging—not only with respect to the second-floor studios, but also the Crit Room space below (fig. 9.12).

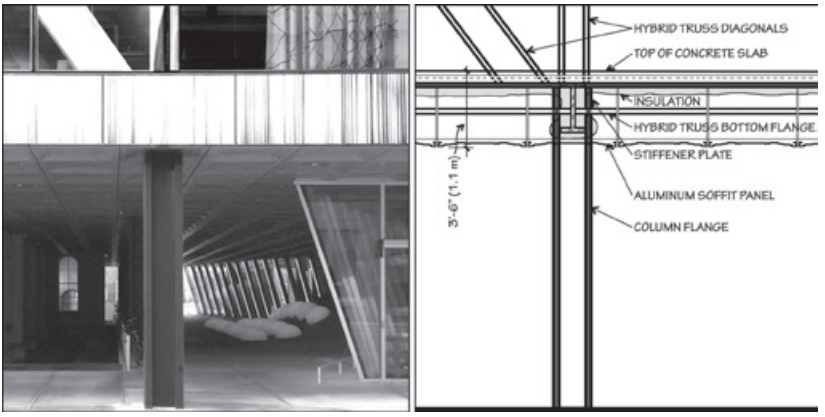
Figure 9.13. Milstein Hall's exterior columns, painted black as if to make them disappear, are all uninsulated (*left*). A schematic section (*right*) shows how the columns, and matching stiffener plates in the bottom chord of the hybrid truss, penetrate the insulation under the second-floor composite steel-concrete deck. Steel flanges that penetrate the insulation, creating a thermal bridge, are shown with a dark tone.

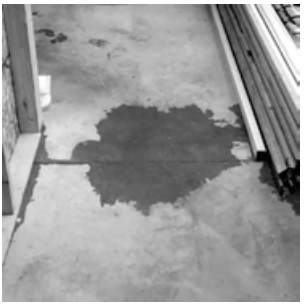
Figure 10.1. Water was leaking into the lower level of Milstein Hall in September 2011, just before it was occupied, in a corridor next to the gallery.

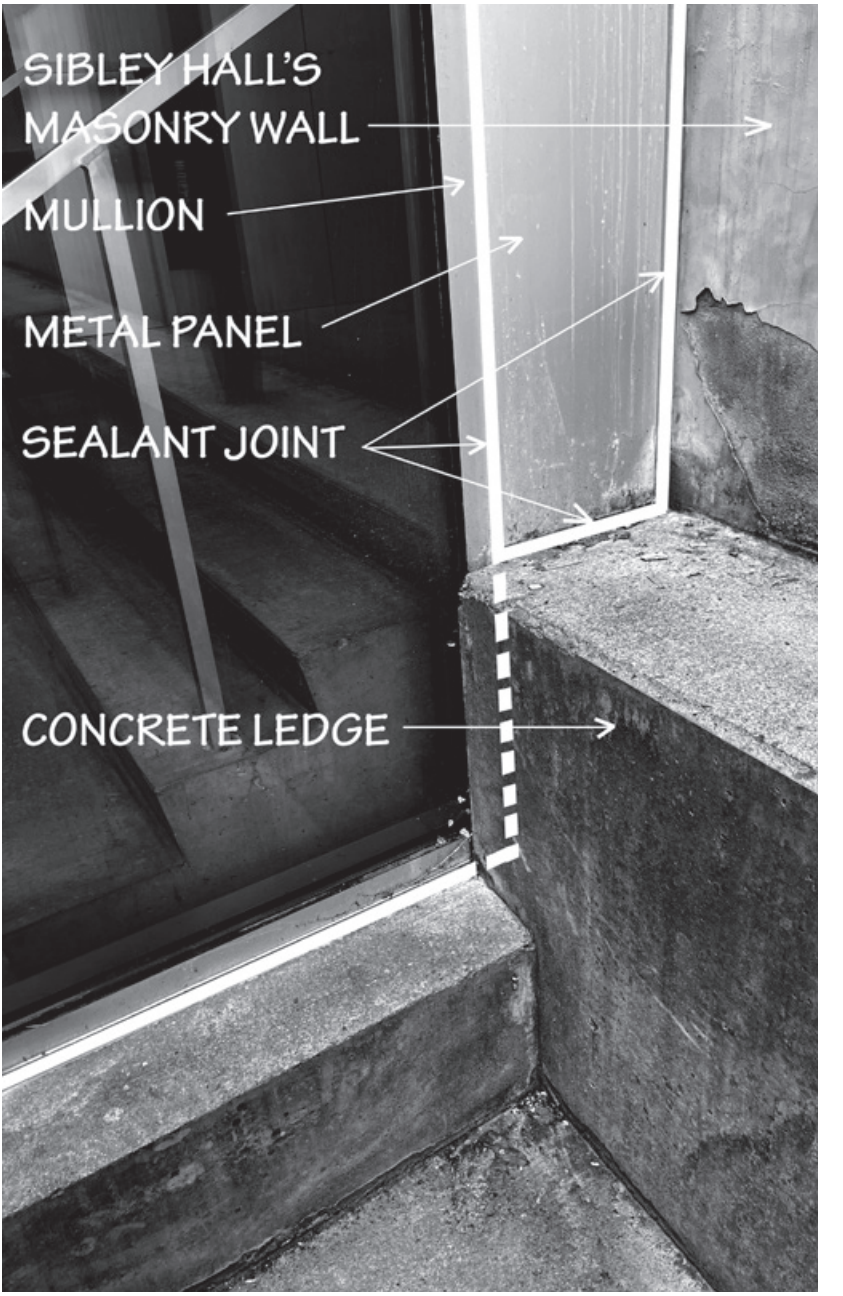
Figure 10.3. Intersection of Milstein and Sibley Halls at basement stair landing, May 2023: trying to create a water control layer by relying on sealant joints, especially at the intersection of concrete or masonry surfaces, is likely to fail.

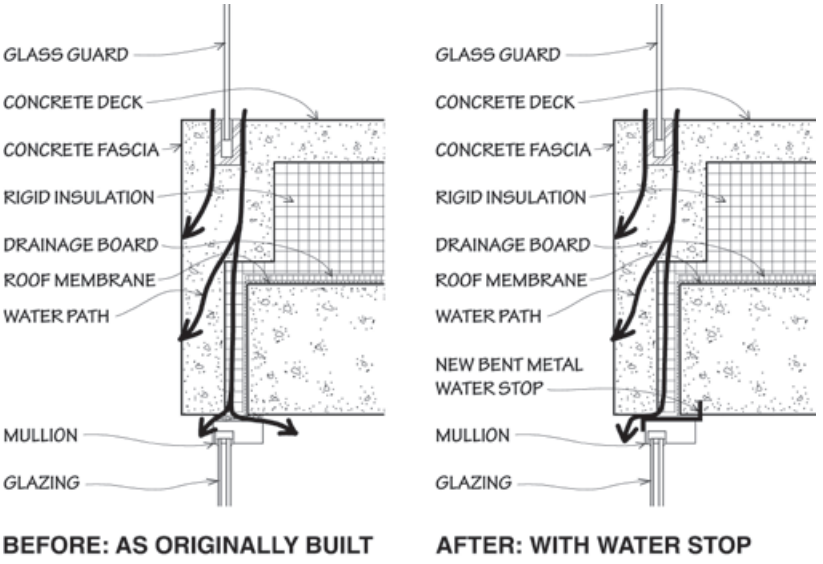
Figure 10.7. Water appears in the gallery in Milstein Hall and causes efflorescence to appear on the fascia and exterior glazing, presumably entering through cracks in the concrete deck, and working its way down to the top of the mullion (*left*); a bent metal water stop was inserted above the mullion, in 2012, to direct water reaching the mullion to the exterior (*right*). In these schematic sections, based on Milstein Hall working drawings, a second drainage board, that seems to have been installed above the insulation, is not shown.

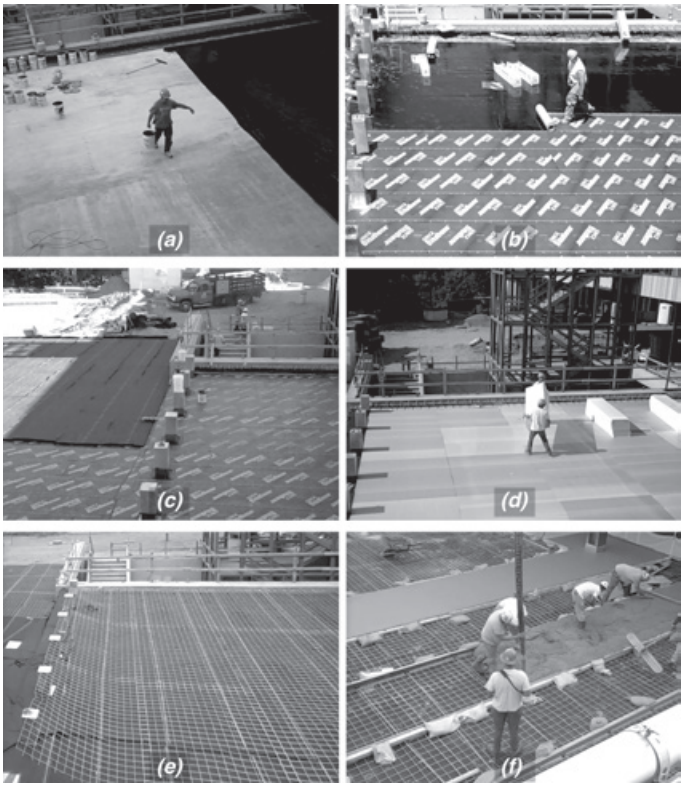
Figure 10.10. The plaza roof deck at Milstein Hall was constructed over a perfectly flat structural slab. All subsequent layers were also perfectly flat: (*a*) initially, some sort of mastic or primer was applied to the structural concrete slab; (*b*) next, a waterproof membrane was rolled out over the primer/mastic; (*c*) a drainage mat came next; (*d*) then three layers of rigid insulation were placed over the drainage mat; (*e*) a second drainage mat was placed over the insulation, along with welded wire mesh reinforcement for (*f*) the final perfectly flat layer, a concrete topping slab.

But the other five requirements for a slab deck over heated space were simply not specified in the design drawings and therefore were not implemented: there was no explicit drainage gap below the traffic surface; not only was the deck designed with no slope, but there was no drain specified for the plaza; with no drain specified, there could be no double-drain; because the water control layer did not slope, and therefore did not slope away from the edge of the deck, water was able to enter the fascia above the gallery windows and threaten the integrity of the concrete while staining the windows below; and finally, the intersection of the roof membrane and the brick wall of Sibley Hall was not properly flashed.

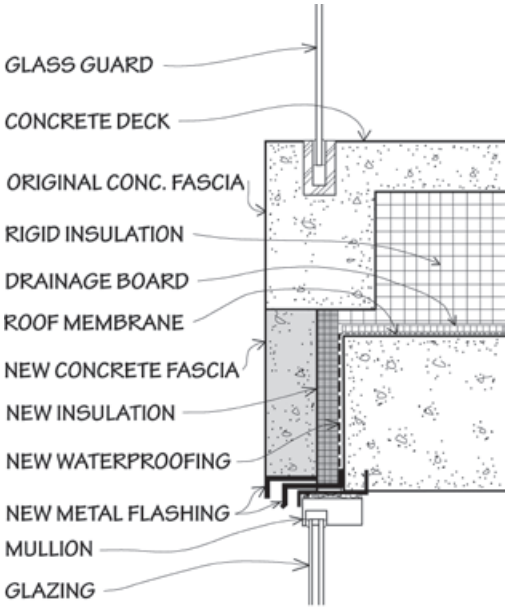
Figure 10.16. The second gallery reconstruction, in 2015, removed and replaced much of the concrete fascia, installed new waterproofing and insulation behind the new fascia panel, and placed two pieces of metal flashing above the bent metal water stop that had been inserted into the concrete ceiling above the mullion in 2012. Water entering the slab from the deck above and working its way down to the mullion will now be directed between the two pieces of flashing to the exterior. This is a speculative and schematic section based on my observations of the reconstruction that occurred in 2015.

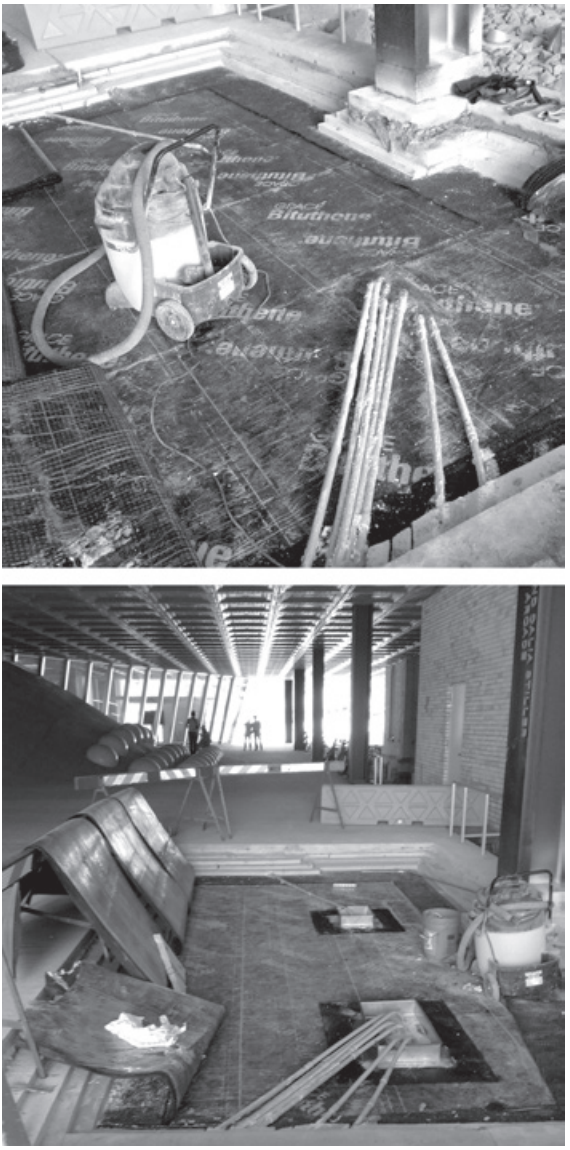
Figure 10.21. Electrical conduits are cast into the roof deck concrete slab under Milstein Hall's arcade; once over the basement electrical room, they penetrate through the structural concrete slab below the topping slab with only nominal attention to waterproofing, providing a pathway for rainwater to enter the electrical room (*top*). To repair this condition, the concrete topping slab, insulation, and drainage mats were removed so that metal "dams" could be placed around the areas where conduit penetrations occur (*bottom*). The drainage mats and insulation were then re-installed, and new concrete was cast to repair the topping slab.

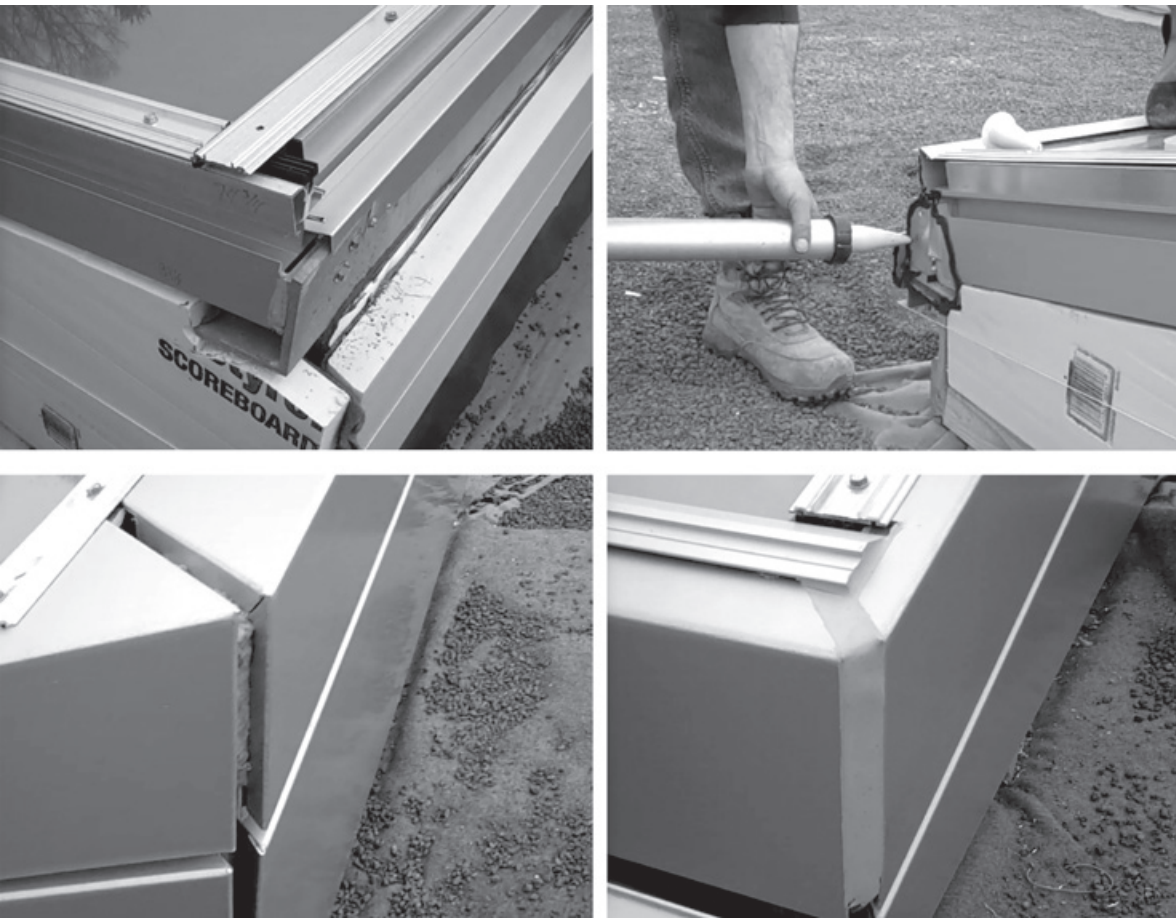
defects in the flashing strategy and/or execution both at skylights as well as at the joint between the roof and masonry walls of existing buildings—Rand Hall, in this case. Skylights appeared to be designed with large gaps, discontinuous insulation, and a reliance on sealants to close openings in aluminum cover plates (fig. 10.23).

Figure 10.23. Skylights in Milstein Hall have large openings where metal enclosure panels meet at the corners (*top left*); at some of these intersections, pieces of metal were "glued" in place with some sort of adhesive sealant (*top right*). Aluminum cover plates came together with mitered joints at the corner, leaving large gaps (*bottom left*) that were filled with sealant (*bottom right*).

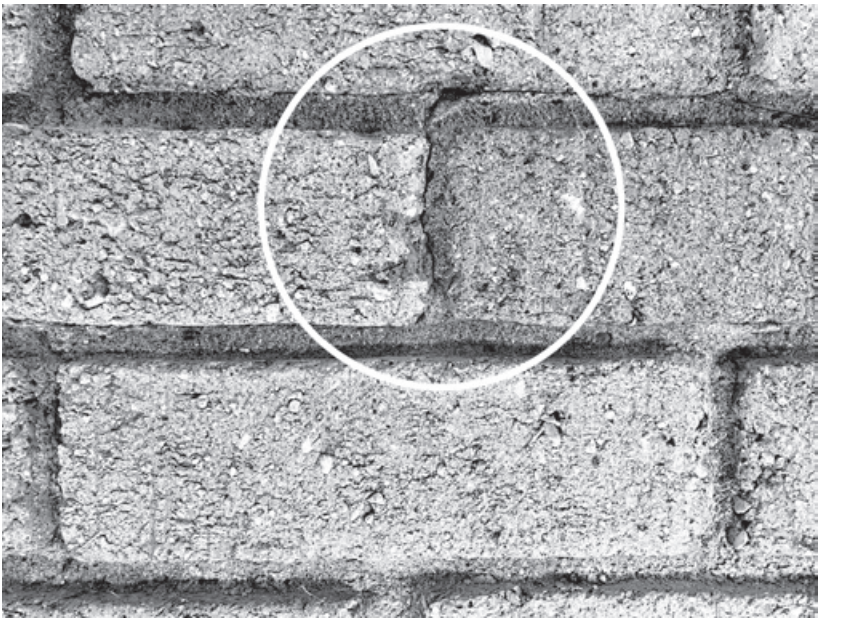
Figure 10.24. This detail of Rand Hall's facade shows a typical crack between brick and mortar through which water can enter the wall, bypassing flashing in saw-cut reglets.

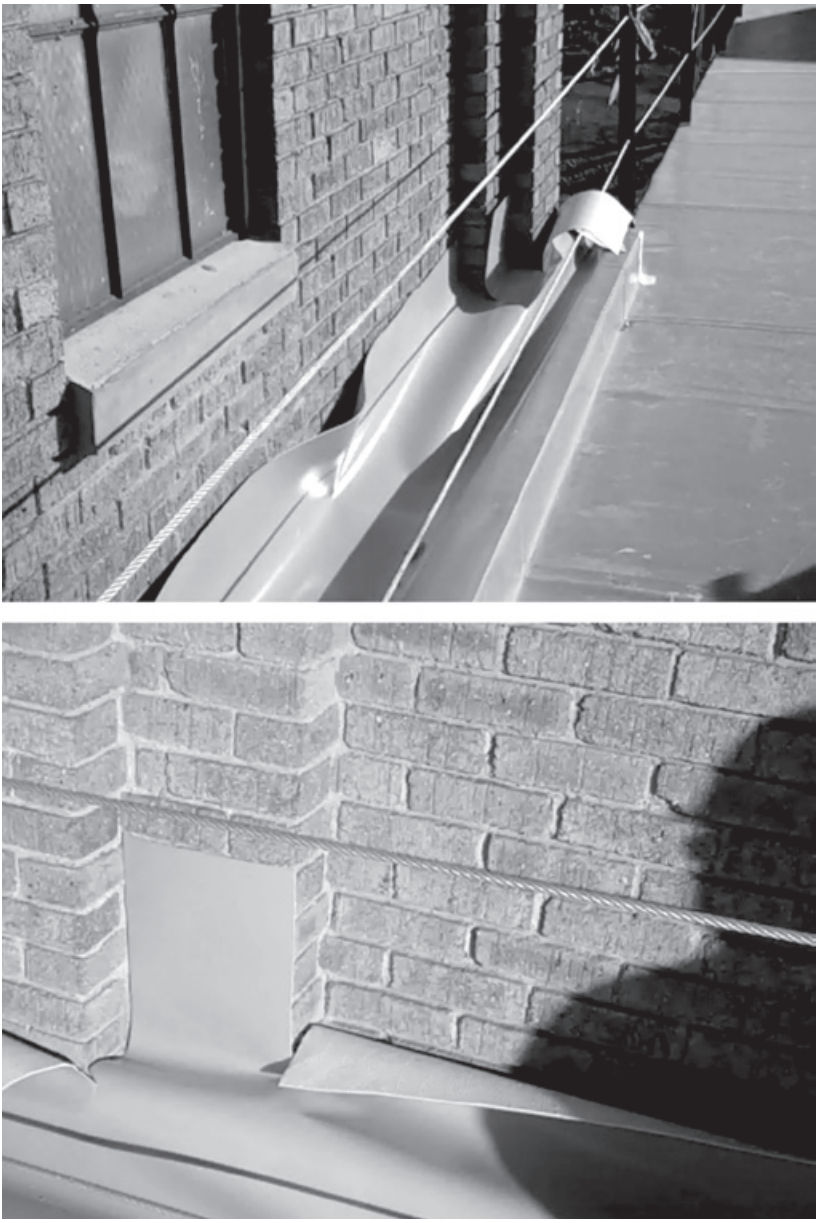
Figure 10.25. The intersection of Milstein Hall's roof with the brick cladding of Rand Hall was sealed with a seismic joint, similar to the joint at Sibley Hall illustrated schematically in Figure 9.6. Here, Milstein Hall's PVC roof membrane is shown prior to the creation of a reglet in the brick wall and the completion of a seismic joint (*top*) and at the challenging geometry where brick protrudes to cover Rand Hall's steel columns (*bottom*).

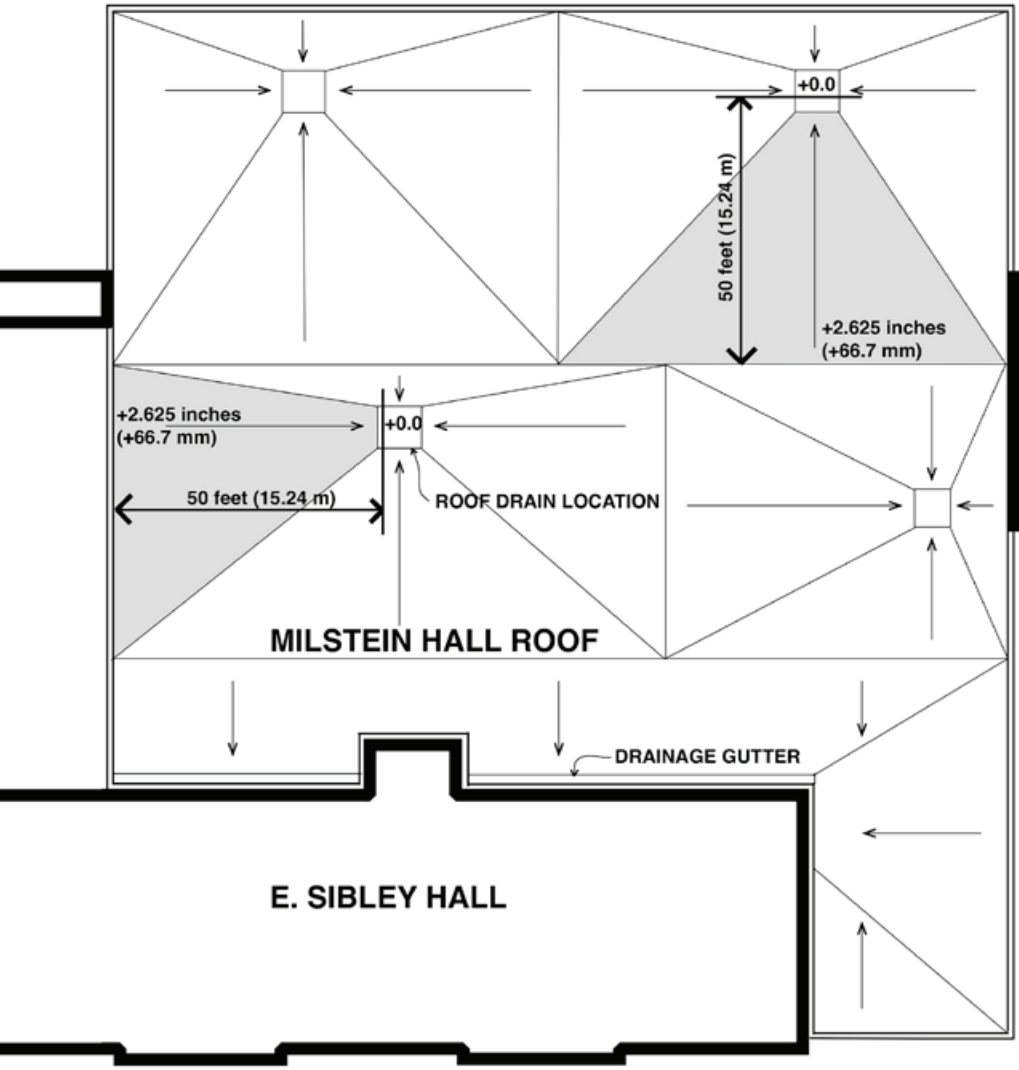
Figure 10.26. Milstein Hall's roof drainage plan, drawn without the skylights for clarity, shows a change in vertical elevation almost five times less than what is required by the *New York State Building Code*.

the horizontal distance between the roof high point and the roof drain is 50 feet (15.24 m) yet the vertical change in elevation is only 2-5/8 inches (66.7 mm). To comply with best practices (and with the requirements of the *New York State Building Code* for a two percent slope), this change of elevation should have been a minimum of 12-1/2 inches (317.5 mm)—almost five times greater than what was actually provided. This is evident in figure 10.27, which shows a roof slope being created with a topping slab poured over the flat structural concrete slab; the wood guide for the screeding operation is virtually horizontal!

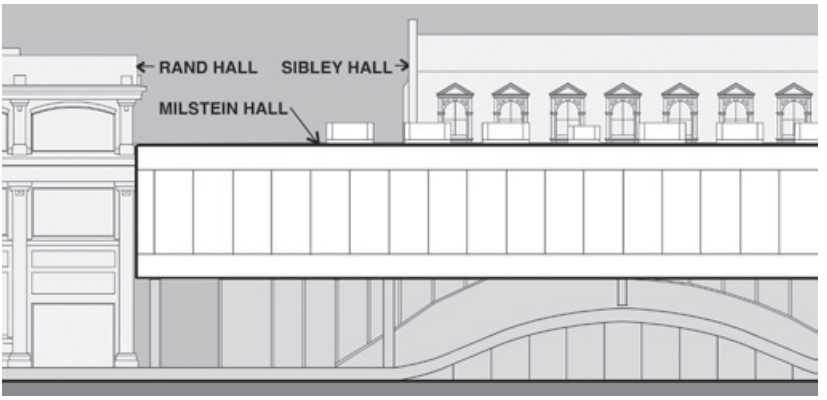
I can't say for sure why the architects chose to defy best practices and create a virtually flat roof with inadequate slope for drainage, but my best guess is that the decision was ideological rather than logical. The proposition that this roof is a *facade*—a canvas on which a colored circular sedum pattern can be metaphorically painted—is certainly compatible with the idea that such a canvas should be flat. But the Milstein Hall canvas isn't literally flat. The fact that it has a nominal, though inadequate slope, shows that the architects were aware that roofs must slope to drains. What really caused the slope to be inadequate and the green roof to be "extensive" rather than "intensive"—i.e., to have only about two inches (50 mm) of engineered soil medium supporting its sedum plants—almost certainly derives from Milstein Hall's initial diagrammatic cartoon and its spatial constraints, discussed earlier. Once a decision was made to place Milstein Hall's new second-floor plate, lifted off the ground, at the intersection of the east-west and north-south conceptual zones discussed in chapter seven and shown in figure 7.1, the second floor needed to be high enough to align with (and connect to) the floors of Sibley Hall and Rand Hall, while the roof of Milstein Hall needed to be low enough so that it would fit under the existing and historic third-floor windows of Sibley Hall. With these self-imposed constraints, there simply wasn't enough room to raise the height of the roof coping to accommodate an adequate (and required) slope for the roof membrane without coming into conflict with the third-floor windows in Sibley Hall (fig. 10.28).

Figure 10.28. The second floor of Milstein Hall needed to be high enough to align with (and connect to) the second floors of Sibley Hall and Rand Hall, while the roof of Milstein Hall needed to be low enough so that it would fit under the existing third-floor windows of Sibley Hall.
