OMA'S MILSTEIN HALL

A CASE STUDY OF ARCHITECTURAL FAILURE

JONATHAN OCHSHORN

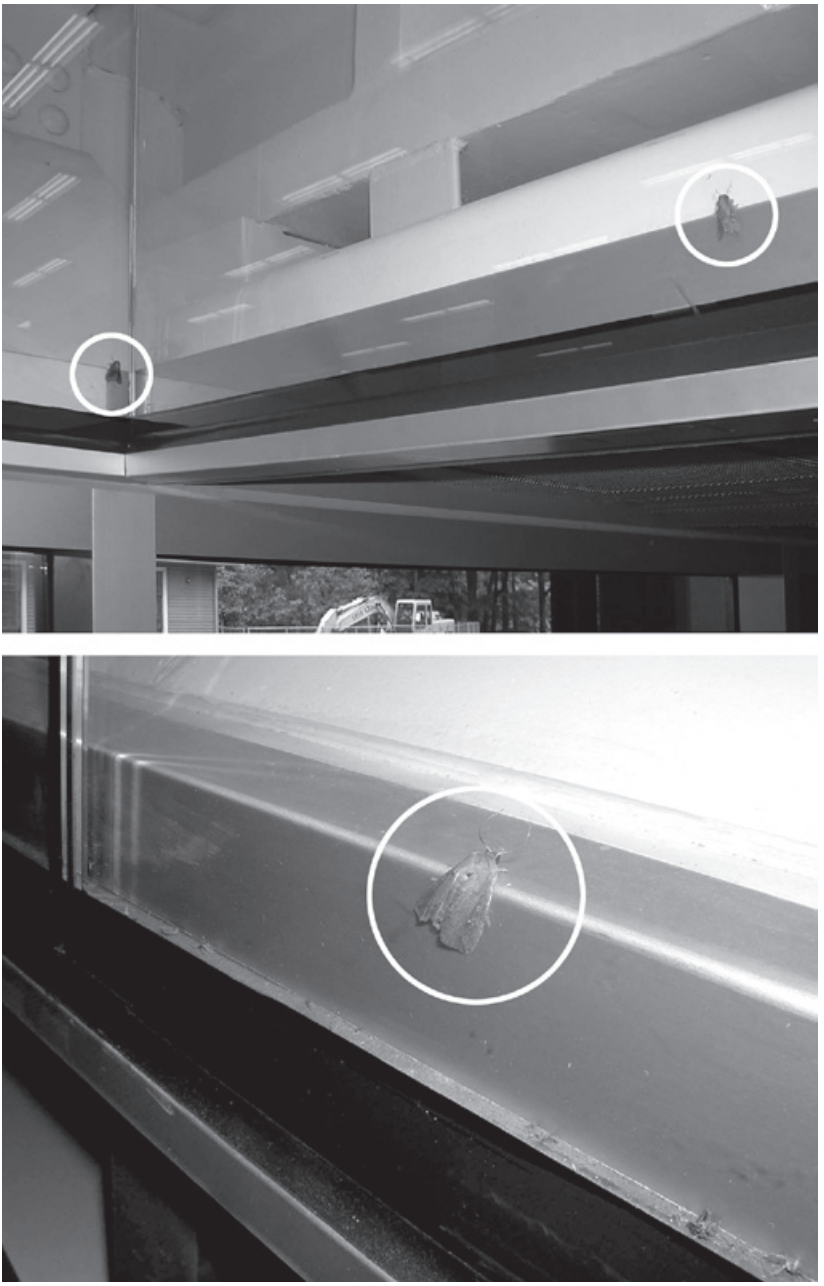
Figure 11.2. Moths and other insects and arachnids get in, but cannot find their way out, and so this glazed area—that reveals Milstein Hall's floor steel structure at the rectangular cut-out for the main entry (and egress) stair—has inadvertently become something of an entomological display case.

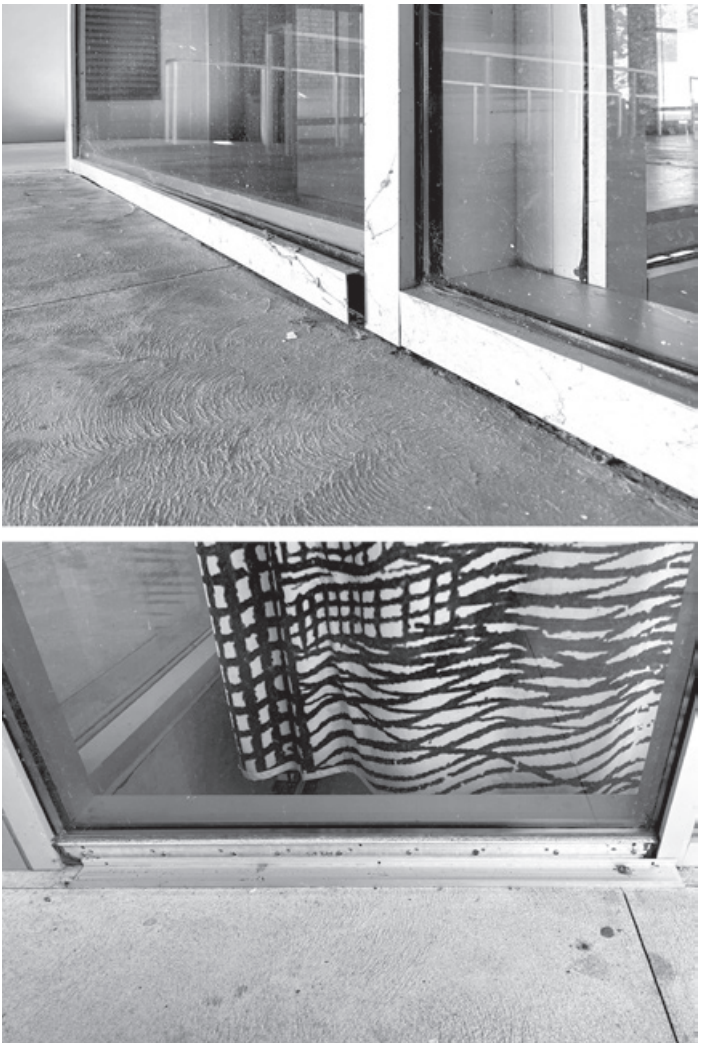
Figure 11.6. Curtain wall sill cover plates have partially or completely detached at the north side of Milstein Hall's lobby (*top*) and at the west side of the auditorium (*bottom*).

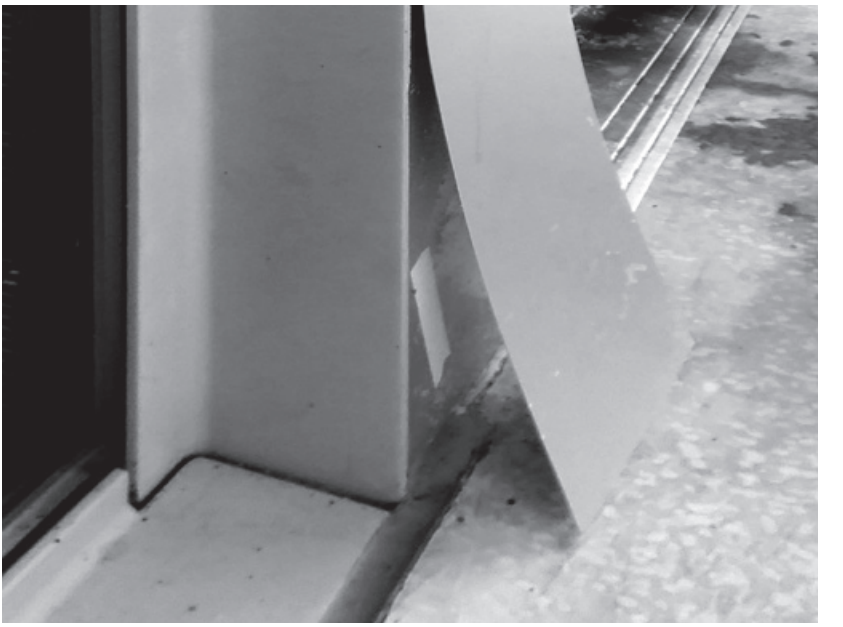
Figure 11.7. Poorly detailed metal cladding has delaminated near the exterior stair exit door on the second floor.

detailed metal cladding has delaminated, near the exterior stair exit door on the second floor (fig. 11.7), although it appears to have been eventually glued back in place.

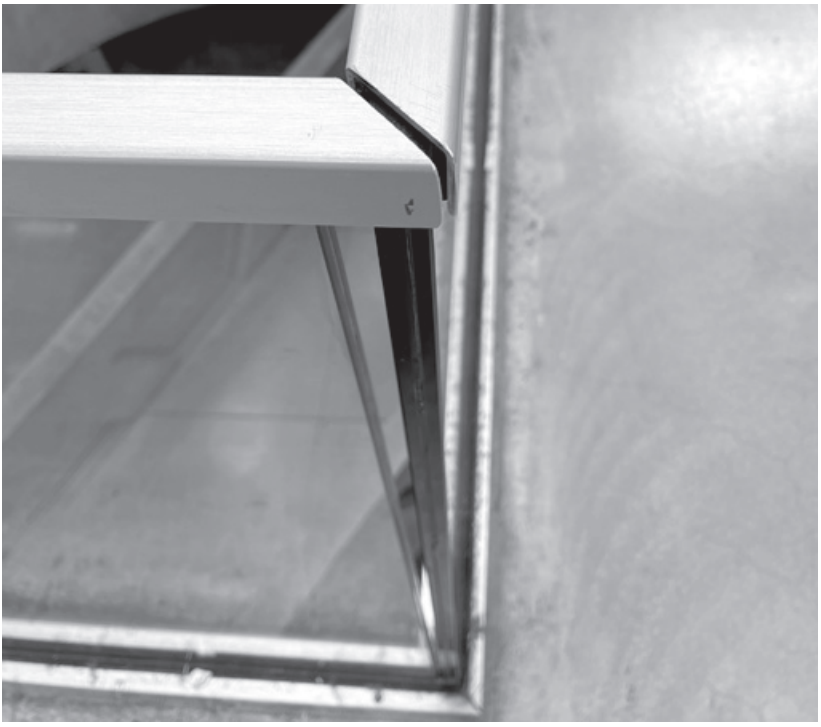
Figure 11.9. Aluminum trim at the top of interior guards in Milstein Hall, like the exterior trim, is also coming apart at the seams.

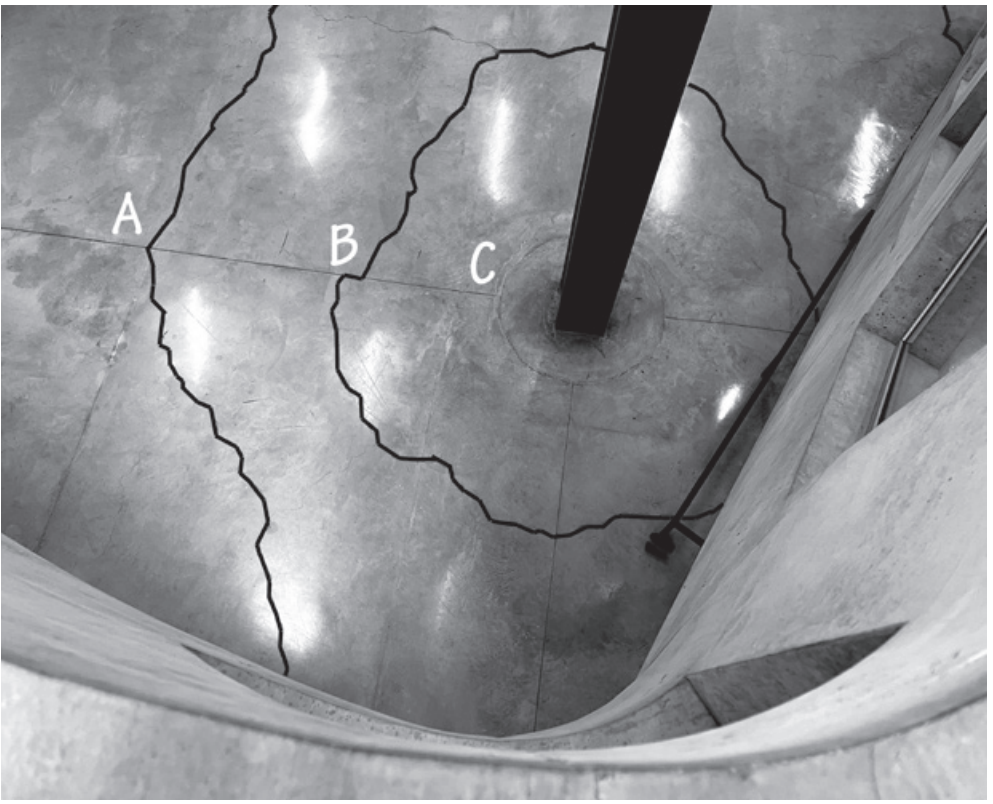
Figure 11.12. Concrete slab-on-ground cracks have occurred, not only in the general field, but especially around columns where control joints were not correctly detailed or constructed. Concentric cracks around a column in the Crit Room have been highlighted at *A* and *B*, while neither the "aesthetic" circular control joint around the column at *C*, nor the orthogonal grid of saw-cut control joints aligning with the centerline of the columns, proved effective at controlling cracks.

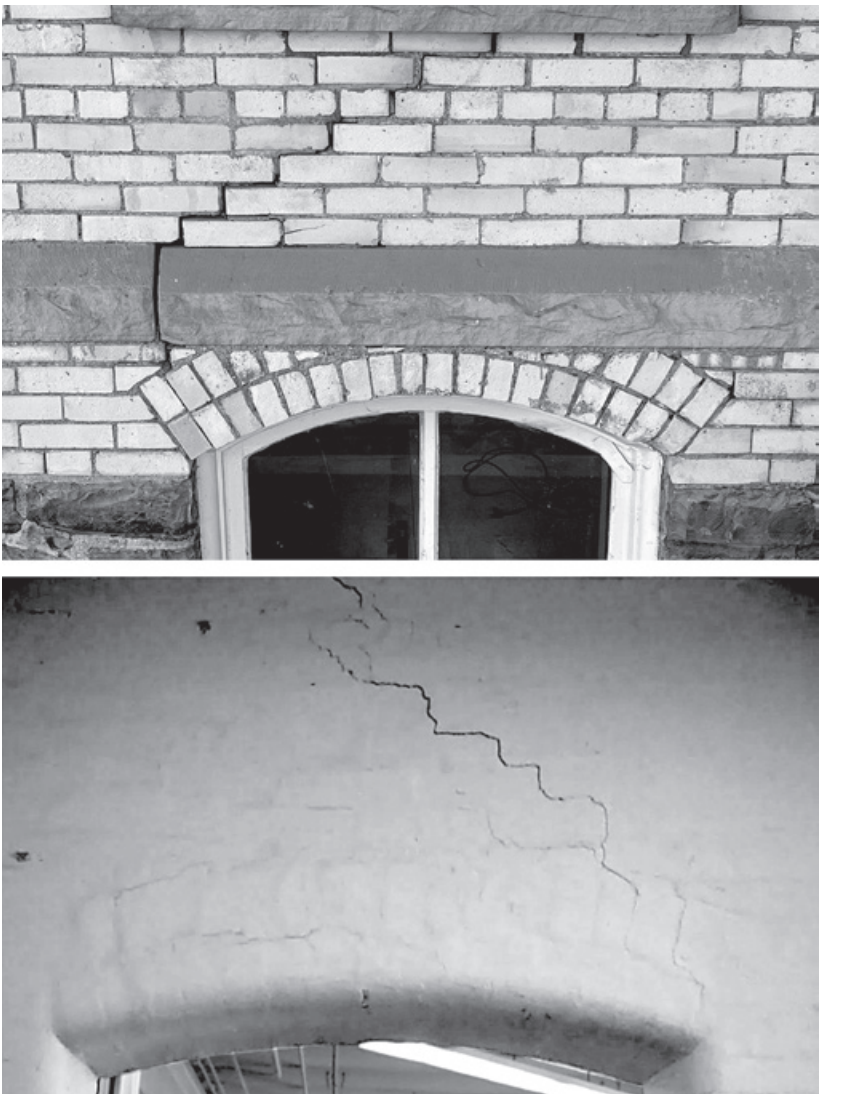
Figure 11.14. Cracking in the brick walls of Sibley Hall occurred after the foundations of Sibley Hall were underpinned and the Milstein Hall site was excavated.

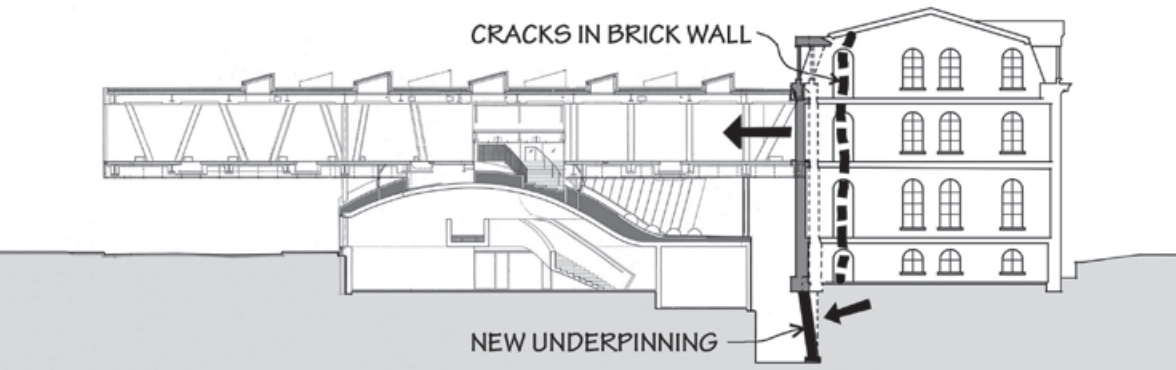
During the construction of—and excavation for—Milstein Hall, the century-old foundations on the north side of East Sibley Hall were underpinned by creating a new reinforced concrete foundation wall *under* the existing shallow foundation. This was necessary because the excavation for Milstein Hall was so deep, relative to the bottom of the Sibley Hall footings, that Sibley Hall itself would have become destabilized without extending the existing foundations deeper into the earth. However, no tiebacks were used to prevent lateral movement of the new underpinned foundation wall for Sibley Hall, so they were able to rotate in a northward direction—toward the excavation created for Milstein Hall (fig. 11.15).

Some combination of lateral thrust originating in the brick arches cut into the perpendicular (north-south) walls of Sibley Hall and from its Mansard roof above, along with vibrations from the drilling of caissons immediately adjacent to this new wall, may have triggered these substantial cracks in the perpendicular masonry walls of East Sibley Hall. In other words, the entire north wall of Sibley Hall appears to have moved laterally towards the excavated Milstein Hall construction site, because (1) the existing arches in Sibley Hall's perpendicular brick cross-bracing walls already provided a discontinuity—a line of weakness; (2) a horizontal force (thrust) was already present in those walls due to the action of the arches themselves as well as the geometry of the Mansard roof above; (3) the vibration of the masonry structure by caisson drilling facilitated the cracking of relatively weak brick mortar joints; and (4) the laterally-unbraced underpinned foundation wall was able to rotate on its footing since no horizontal tie-backs were provided.

Figure 11.15. Section through Milstein and Sibley Halls showing excavated area in front of underpinned foundation wall with assumed rotation of foundation underpinning causing cracking in the bracing walls of Sibley Hall.

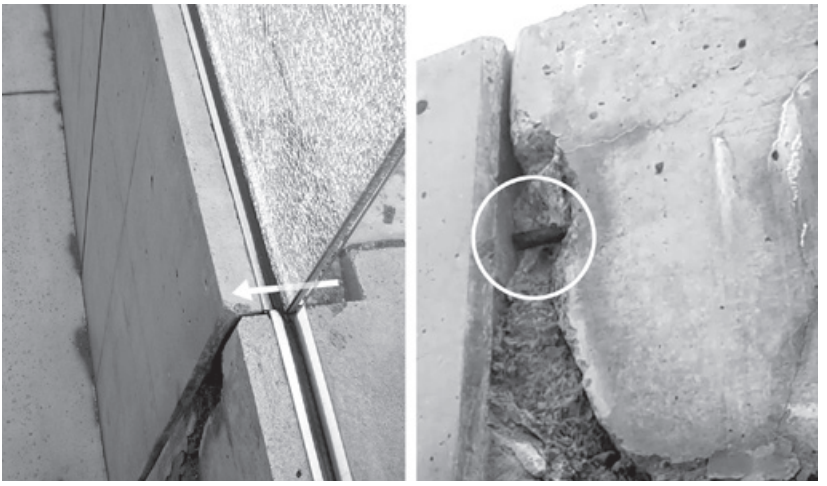
Figure 11.18. The glass guard panel between Milstein Hall's loading area and the accessible ramp from the parking lot (*left*), shown here in 2015, can be seen spanning over the joint between the displaced retaining wall and the building; spalling of the concrete could also have been triggered by corrosion of reinforcement, visible in the highlighted circle, placed between the retaining wall and the building (*right*).

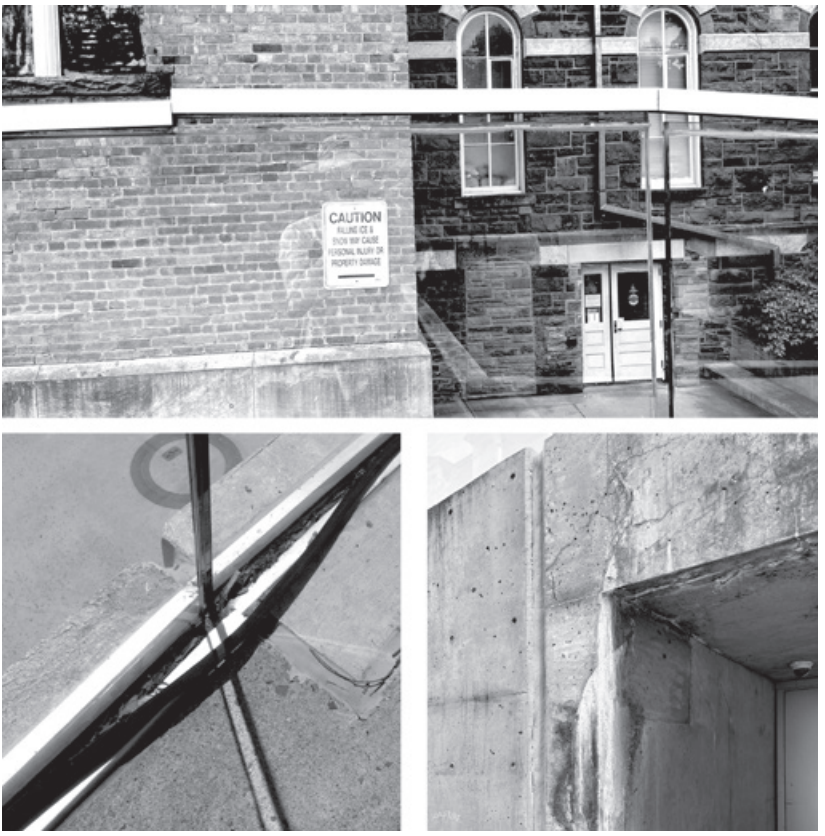
Figure 11.19. The glass guard panel between Milstein Hall's loading area and the accessible ramp from the parking lot, shown here with displaced trim in 2023 (*top*), a detached gasket in 2018 (*bottom left*), and continued efflorescence in 2023 (*bottom right*).

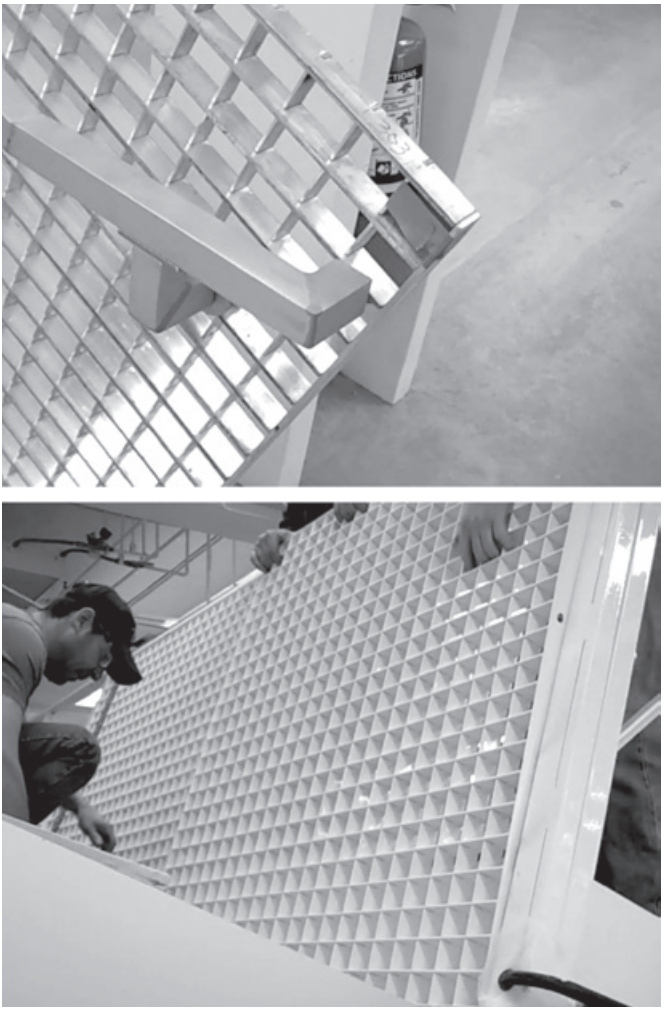
Figure 11.20. Milstein Hall's original aluminum guards were apparently too flexible (*top*) and were replaced with welded steel guards having a similar gridded design (*bottom*) just a few months after the building was occupied.

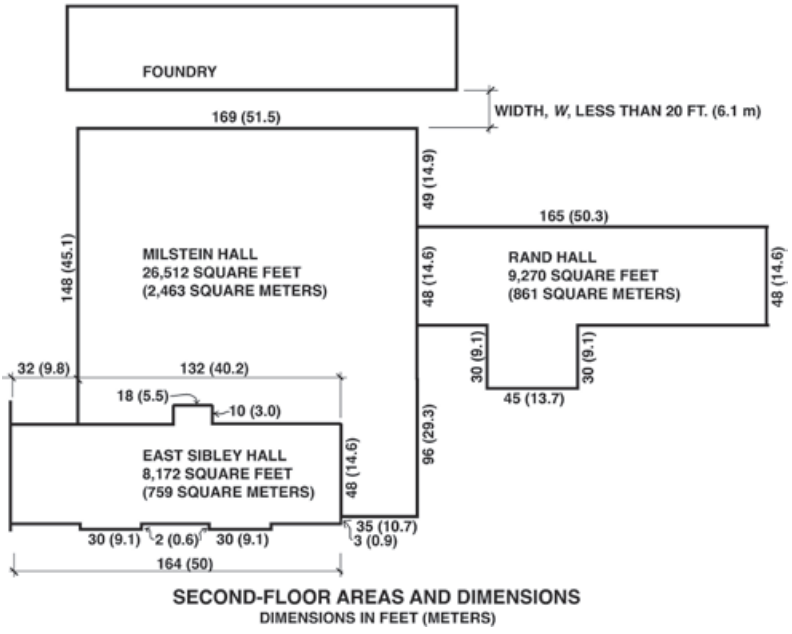
Figure 14.2. Schematic plan showing approximate dimensions and second-floor areas of Milstein, East Sibley, and Rand Halls.

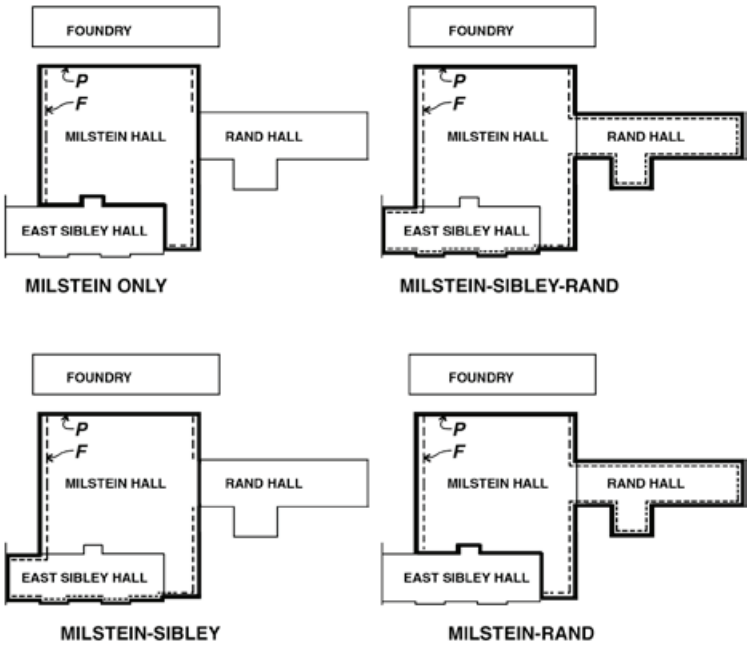
Figure 14.3. Milstein Hall's perimeter (*P*) and partial perimeter (*F*)—taken alone or combined with adjacent buildings—are shown with a heavy solid line and a dotted line, respectively, for the four scenarios outlined in Table 1. Approximate dimensions for perimeter segments are shown in figure 14.2.

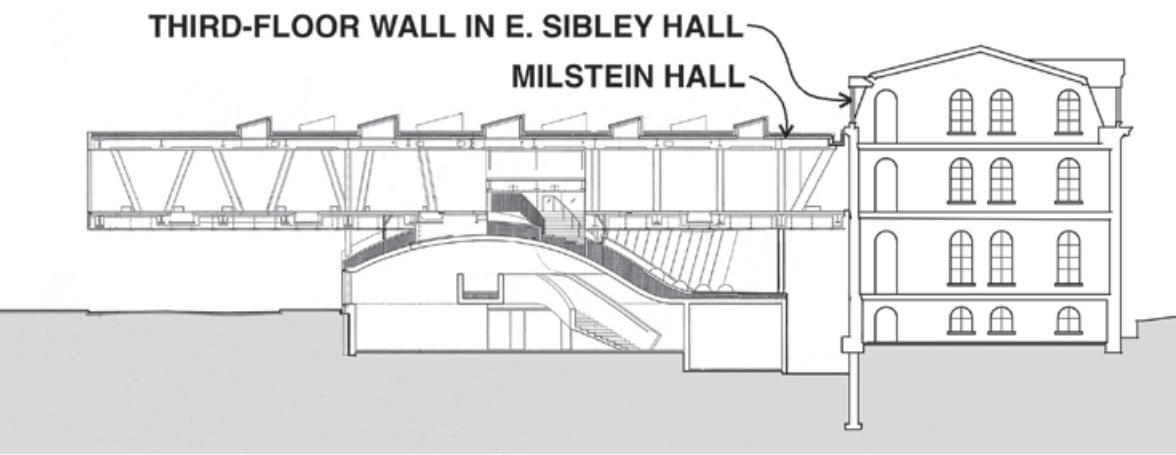
Not only would Sibley's third-floor windows require opening protectives, but the entire exterior wall on the third floor of Sibley (facing Milstein Hall) would need to be reconstructed with a 1-hour fire-resistance rating. Footnote *f* in Table 601 of the 2002 code (exterior bearing walls) requires that the fire-resistance rating of the wall be not less than that based on fire separation distance (Table 602). Table 602, in turn,

Figure 14.5. A section through Milstein and Sibley Halls shows that the position of the third-floor wood-framed wall in Sibley Hall relative to the non-fireproofed roof of Milstein Hall would be noncompliant if Milstein and Sibley Halls were considered as two separate buildings from a code standpoint.

requires a 1-hour fire-resistance rating for Occupancy Groups A or B if the fire separation distance is less than 5 feet (1.5 m). The fire separation distance between Sibley and Milstein Halls is 0 feet (0 m), since the two buildings are physically connected.

If a fire barrier between Milstein and Sibley Halls is seen as replacing a fire wall that "serves as an exterior wall for a building and separates buildings having different roof levels [as is the case with the Milstein-Sibley fire barrier—see figure 14.5], such wall shall terminate at a point not less than 30 inches [792 mm] above the lower roof level, provided the exterior wall for a height of 15 feet [4.6 m] above the lower roof is not less than 1-hour fire-resistance-rated construction from both sides with openings protected by assemblies having a 3/4-hour fire protection rating."[30] The third floor of Sibley Hall does not meet this criteria.

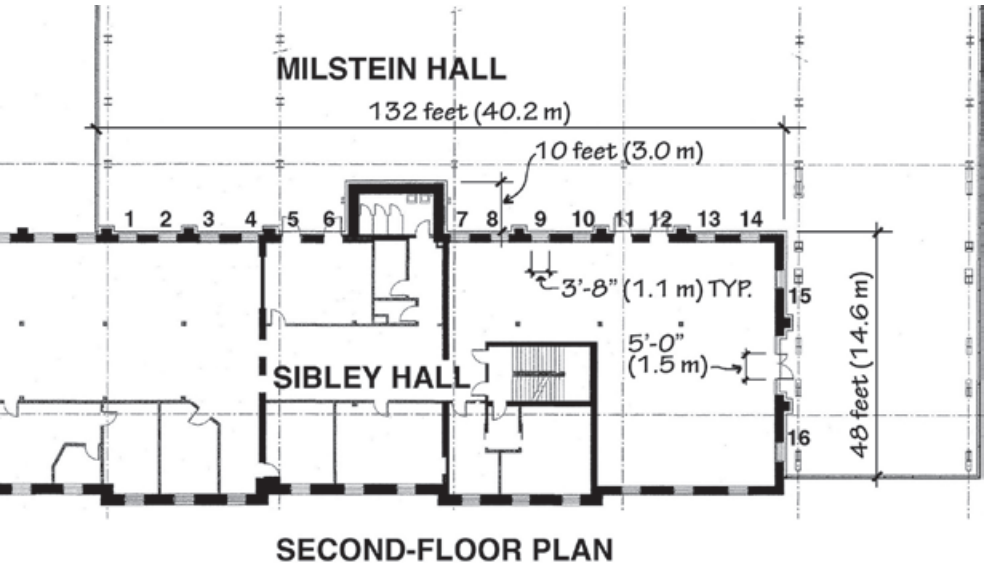
Figure 15.1. Fire barrier wall dimensions between Milstein and Sibley Hall are based on the dimensions shown in Figure 14.2. The aggregate opening width, consisting of 16 typical windows and doors, each 3'-8" (1.1 m) wide plus one special door 5'-0" (1.5 m) wide, exceeds 25% of the fire barrier width.

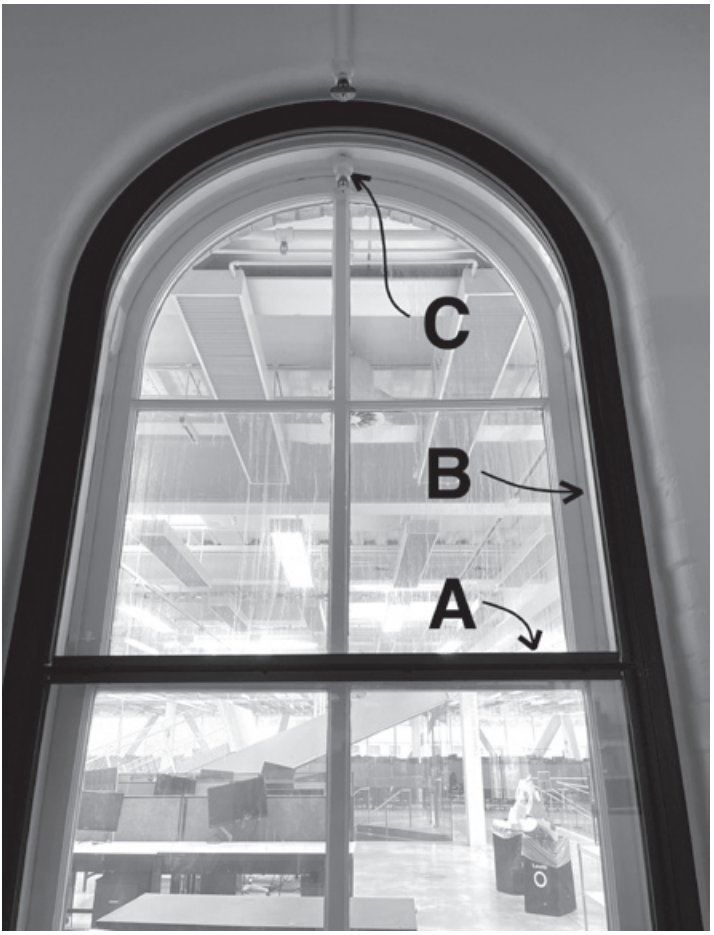
Figure 15.2. Installation of Tyco sprinklers violated the manufacturer's specifications in three ways: horizontal mullions are not permitted (*A*); combustible material is within 2 inches (51 mm) of fire-rated glazing (*B*); and sprinklers are sandwiched between fire-rated glazing and the existing window (*C*).

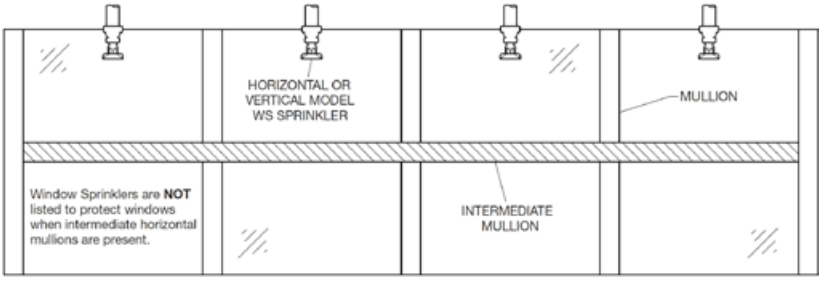
First, Tyco sprinklers cannot be used to protect windows when intermediate horizontal mullions are present: "Intermediate Horizontal Mullions were not tested with the Model WS Window Sprinkler. Their use is outside the scope of the 'Specific Application' Listing for the window sprinklers. Refer to Figure 3B-3."[4] Tyco's Figure 3B-3, reproduced in figure 15.3, reiterates that "window sprinklers are NOT listed to protect windows when intermediate horizontal mullions are present." In the Milstein Hall application, horizontal mullions are present in the fire-rated glazing (see fig. 15.2, item "A"). The problem with horizontal mullions is that they can interfere with the operation of the sprinklers by deflecting the stream of water away from the surface of the glass, thereby eliminating the intended cooling effect provided by the water which justifies the increased fire-resistance rating of the system.

Figure 15.3. Reproduction of Tyco's Figure 3B-3 prohibiting horizontal mullions (see notation in bottom left window pane).

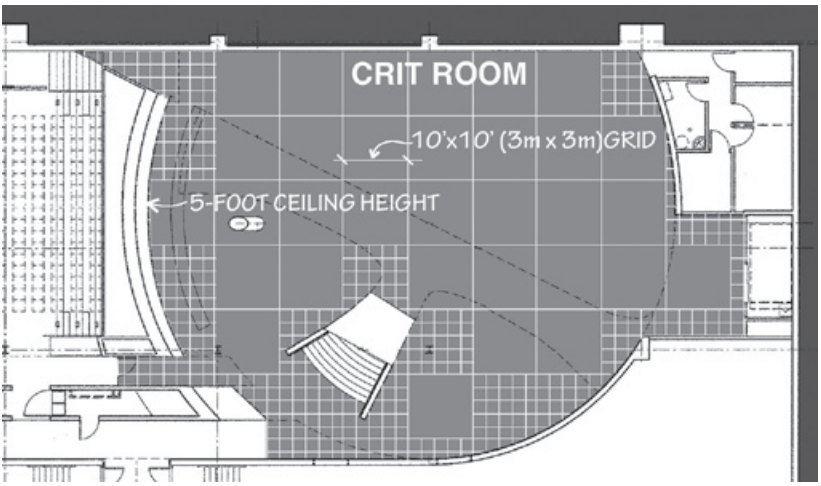
The Crit Room in Milstein Hall's lowest level, directly under its concrete dome, is an assembly space with an area of 4,506 square feet (419 square meters), as shown in figure 16.1.[1]

Figure 16.1. I computed the 4,506 square feet (419 square meters) floor area of the Crit Room in Milstein Hall by superimposing a 10-foot × 10-foot (3-m × 3-m) grid over the irregular floor plan, subtracting areas where the sloping ceiling is less than 5 feet (1.5 meters) from the floor.

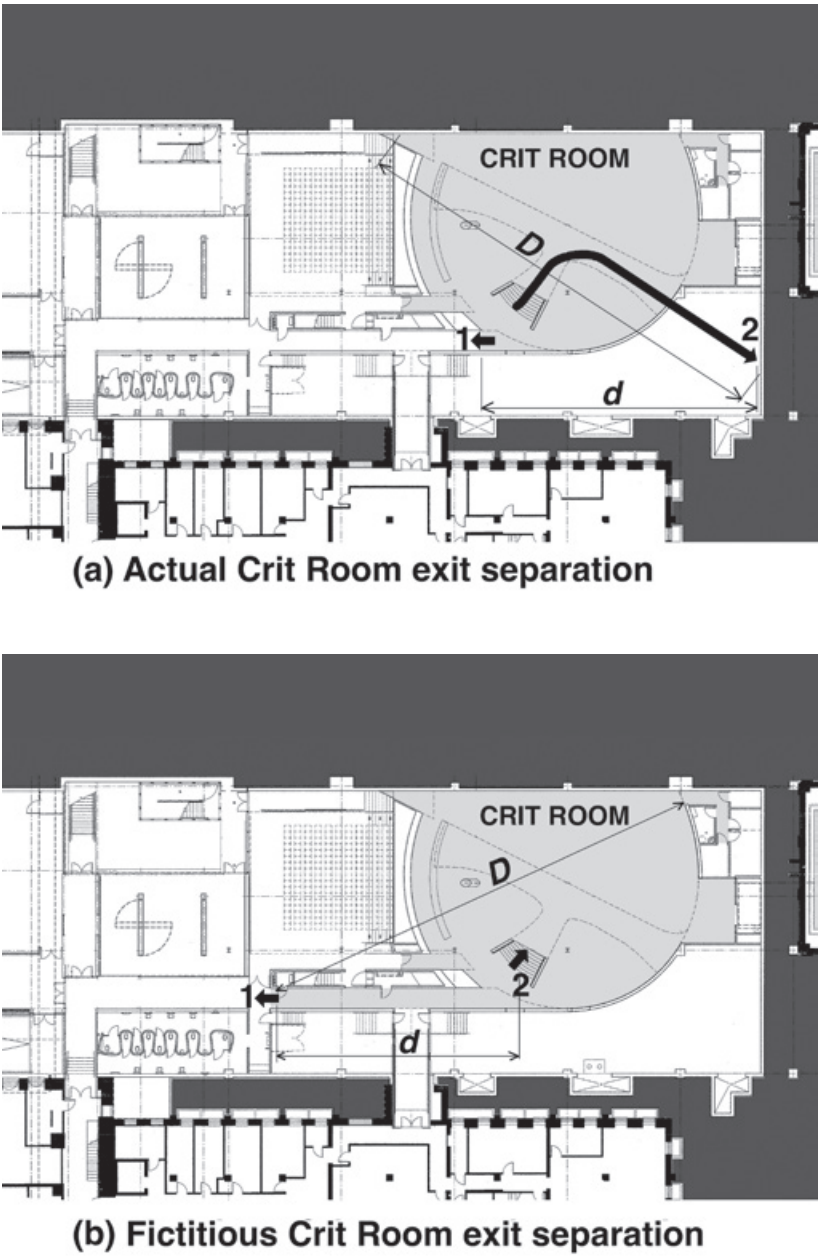
The other real exit access opening, marked "1" in Figure 16.4*a*, leads to an exit access corridor and, ultimately, to an exit near the gallery. The distance between these real Crit Room exits, as shown in the Figure 16.4*a*, is $d = 80$ feet (24.4 m). This separation distance is far greater than one-third of the diagonal length, $D = 125$ feet (38.1 m). Therefore, if

Figure 16.4. Exit separation requirements are based on two parameters shown for the Crit Room in Milstein Hall: the maximum diagonal length of the room (shown as dimension, *D*); and the actual separation between exits (shown as dimension, *d*). For exits to be compliant in a sprinklered building, d must be at least one-third the length of *D*.

As shown in Figure 16.4, exit separation requirements are based on two parameters: the maximum diagonal length of the room (shown as dimension, *D*); and the actual separation between exits (shown as dimension, *d*). For exits to be compliant in a sprinklered building, *d* must be at least one-third the length of *D*. The two Crit Room exits are marked "1" and "2" in figure 16.4. In the top plan (*a*), the actual required separation between exits is found by taking the diagonal length of the room, *D* = 125 feet (38.1 m), and dividing it by three to find the minimum required separation distance of 42 feet (12.7 m). The actual separation distance between the two exits, *d* = 80 feet (24.46 m), is compliant because it is greater than the required separation distance. In the bottom plan (*b*), the fictitious required exit separation is found by taking a diagonal length as if the corridor were part of the room, *D* = 130 feet (39.6 m), and dividing this length by three to find the minimum required separation distance of 43.3 feet (13.2 m). The separation distance between the stair and this fictitious exit, *d* = 70 feet (21.3 m), appears compliant because it is less than the fictitious required separation distance.

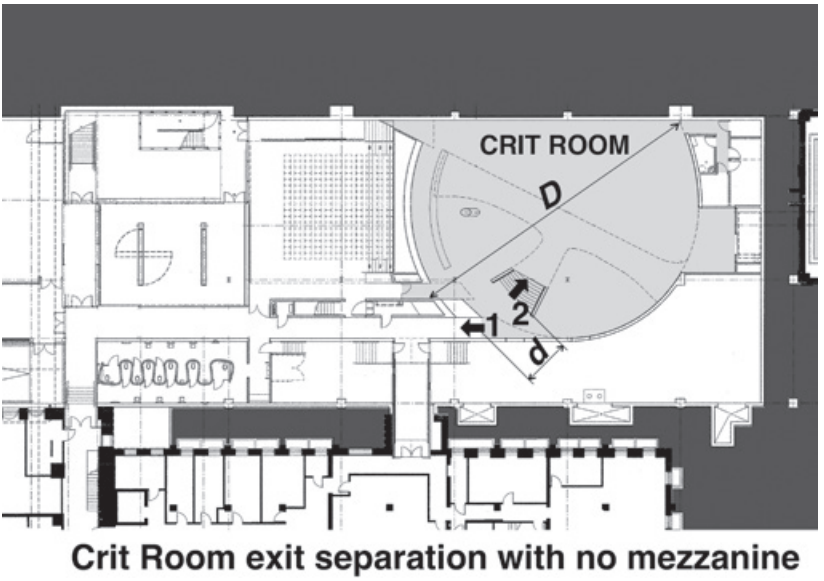
Even so, two code issues remain problematic: first, the proper number of exits is not provided and second, as we'll see below, the distance one needs to travel within the Crit Room before having access to *both* of these exits—the so-called common path of egress travel distance—is inadequate. And if the bridge and lobby do *not* meet the requirements for a mezzanine, then the exit access using the stair from the Crit Room would be placed at the bottom of the stair (fig. 16.5).

Figure 16.5. Without a mezzanine, the actual required separation between exits is found by taking the diagonal length of the room, D = 90 feet (27.4 m), and dividing it by three to find the minimum required separation distance of 30 feet (9.1 m). The actual separation distance between the two exits, d = 15 feet (4.6 m), is noncompliant because it is less than the required separation distance.

to Crit Room egress: not having four exits or exit access openings, not having adequate separation distance between the two exit access openings, and exceeding the allowable common path of egress travel distance. But before examining the common path of egress travel, a short digression concerning mezzanines is in order.

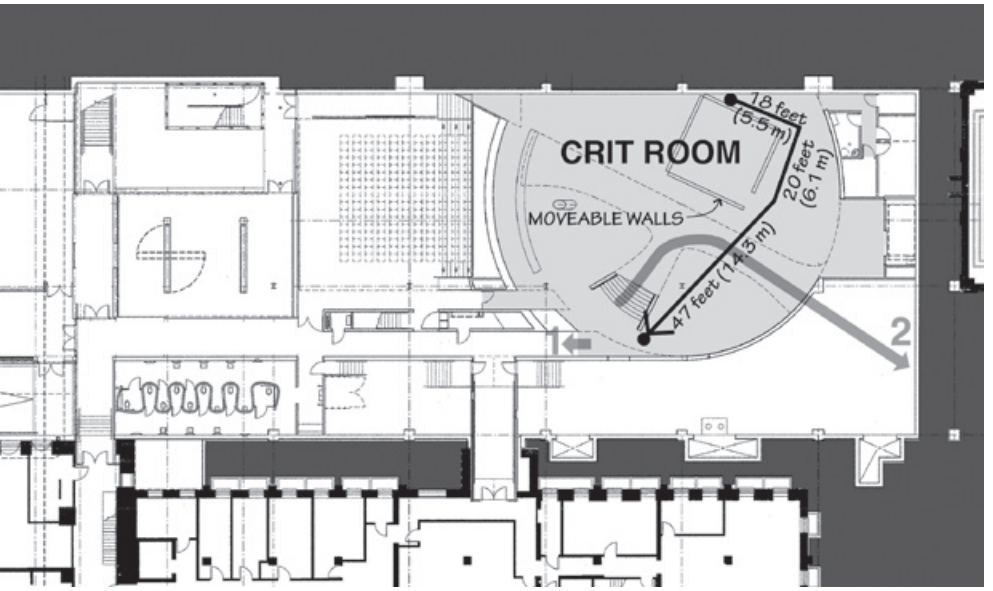
Second, and more importantly, it is simply not true that the 75-foot limit for common path of egress travel is satisfied in the Crit Room. As can be seen in figure 16.8, the distance from the most remote part of the room to a point where two separate paths of egress travel are available is 85 feet (25.9 m), and so the room is noncompliant on that basis alone.

Figure 16.8. Milstein Hall's Crit Room plan showing moveable walls and common path of egress travel, accounting for necessary movement around those partitions.

travel distance, the code requires that it must be "measured from the most remote point to the entrance to an exit *along the natural and unobstructed path* of egress travel,"[19] which is why it would be improper to use a straight-line ("as the crow flies") distance from a remote point in the room to a point where two separate exit paths become available. This requirement is discussed in the *Commentary* to the IBC:

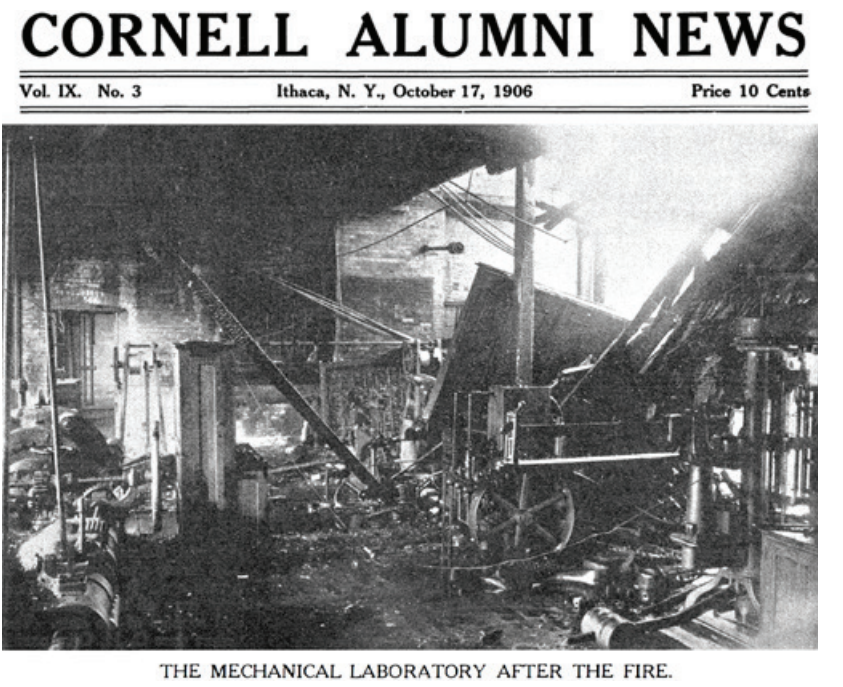
Finally, Sibley Hall, currently home to the College of Architecture, Art, and Planning, and now separated from Milstein Hall with a deficient fire barrier, also has experienced a damaging fire (fig. 18.1). The 1906 fire in Sibley was reported by the Cornell Alumni News:

Figure 18.1. Sibley Hall's "Mechanical Laboratory After the Fire" in 1906.

> Fire early last Friday morning caused damage of $5,000 [$168,960 in 2023 dollars] to the mechanical laboratory in the rear of Sibley College, and threatened to destroy the entire building. Good work by the Ithaca fire department, assisted by University officers and students, confined the flames to two rooms. The loss is covered by insurance.
>
> How the fire started is not known, but it is supposed to have been the result of a crossing of electric wires. … *Brick fire walls had kept the flames confined to this section*, and the firemen prevented it from spreading further. Pressure was obtained from the big pump directly west of the building. By 6 o'clock the fire was all out. …[17]

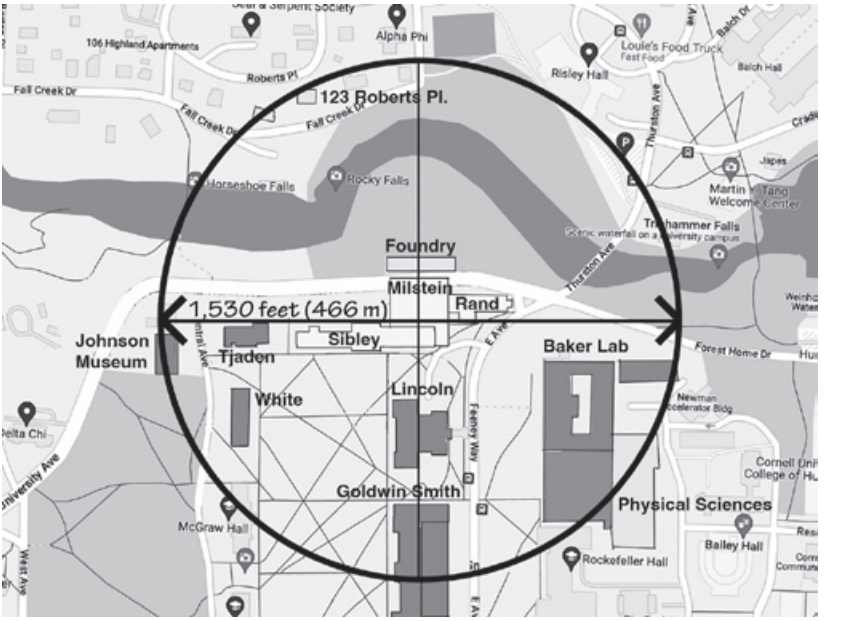
Figure 20.1. Milstein Hall and its larger "urban" context: the circle represents an area approximately 28 times that of the building site.

The regional site area is $\pi \times 765^2 = 1{,}838{,}540$ square feet, or 42.2 acres (170,806 square meters or 17 hectares). Therefore, the regional density is 855,000 square feet / 42.2 acres = 20,260 square feet per acre (4,651 square meters per hectare), which also does not meet the criterion. This is not particularly surprising since the Arts Quad at Cornell was not intended to be an "urban" space.

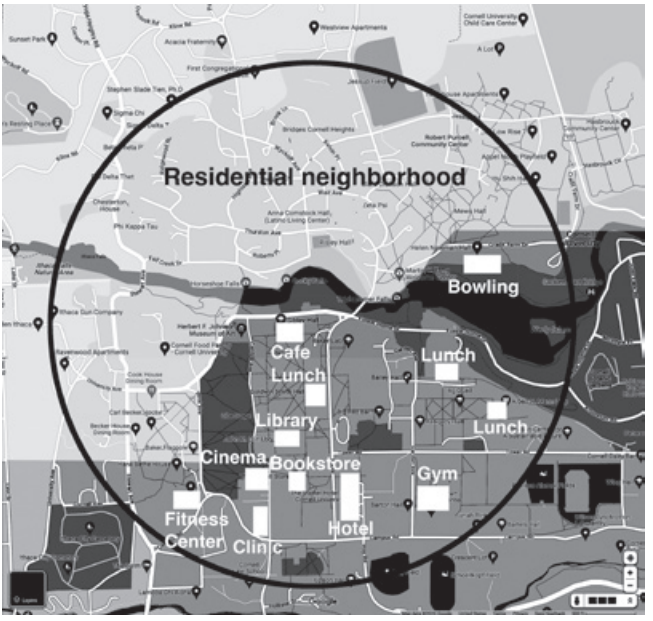
Luckily, there is another way to satisfy this credit. If the site is within 1/2 mile (0.8 km) of a residential area (Cornell Heights and Cayuga Heights, as well as all the Cornell dorms west and north of the site seem to qualify) and within 1/2 mile (0.8 km) of 10 "basic services" (things like banks, grocery stores, laundry, etc.), then you can still get the LEED point. As can be seen in figure 20.2, there is enough stuff within this 1/2 mile (0.8 km) radius actually on campus—including the Statler Hotel, Cornell Store, numerous eateries, fitness centers, and bowling—to satisfy the requirements for this LEED point.

Figure 20.2. Basic services and residential neighborhood within 1/2 mile (0.8 km) of Milstein Hall.

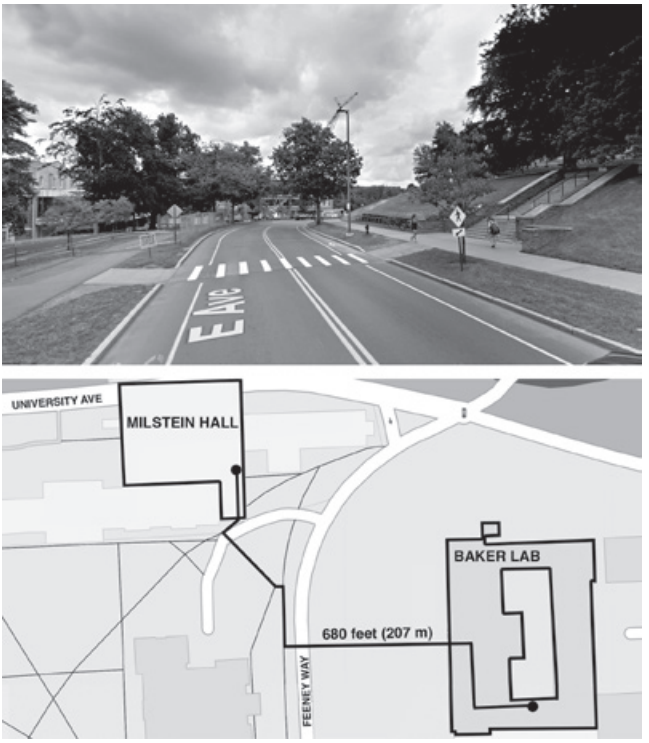
to satisfy the mandate of 20 divided by 200, or 0.1 required showers. Unfortunately, the shower room is more than 600 feet from the entrance to Milstein (fig. 20.6) so this additional criterion for the LEED point is also not met. And even if the distance limit were overcome, the remote shower would not qualify since the hours of operation of the building it is in do not match the 24/7 operating hours of the architecture studios in Milstein Hall.[6] In spite of this, Cornell has claimed the credit and LEED's reviewers have accepted the claim based on plans "provided showing the location of the shower/changing facilities and the bike storage facilities."[7]

Figure 20.6. The path from Milstein Hall's entrance to the LEED bike-point-required showers involves crossing Feeney Way, formerly East Avenue, and climbing the steps to Baker Lab (*top*); even so, the path distance exceeds the 600 feet (183 m) limit (*bottom*).

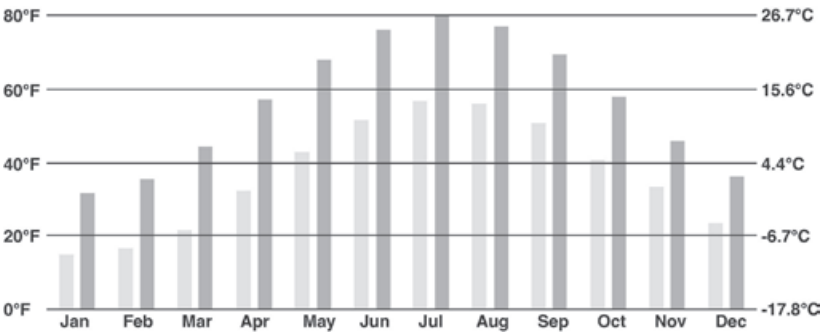
Credit 7.2. This is where a credit can be earned by having a vegetated roof. The green roof doesn't do much for stormwater control, and isn't at all necessary to reduce the heat island effect—any light colored roofing material would do as well or better. It's also not clear that having a light (cool) roof saves energy in this climate, where basically half the year is governed by heating rather than cooling loads (fig. 20.9). According to the U.S. Department of Energy: "Your climate is an important consideration when deciding whether to install a cool roof. Cool roofs achieve

Figure 20.9. Ithaca's climate graph (average highs and lows for each month) shows that roughly half the year is governed by heating rather than cooling loads.

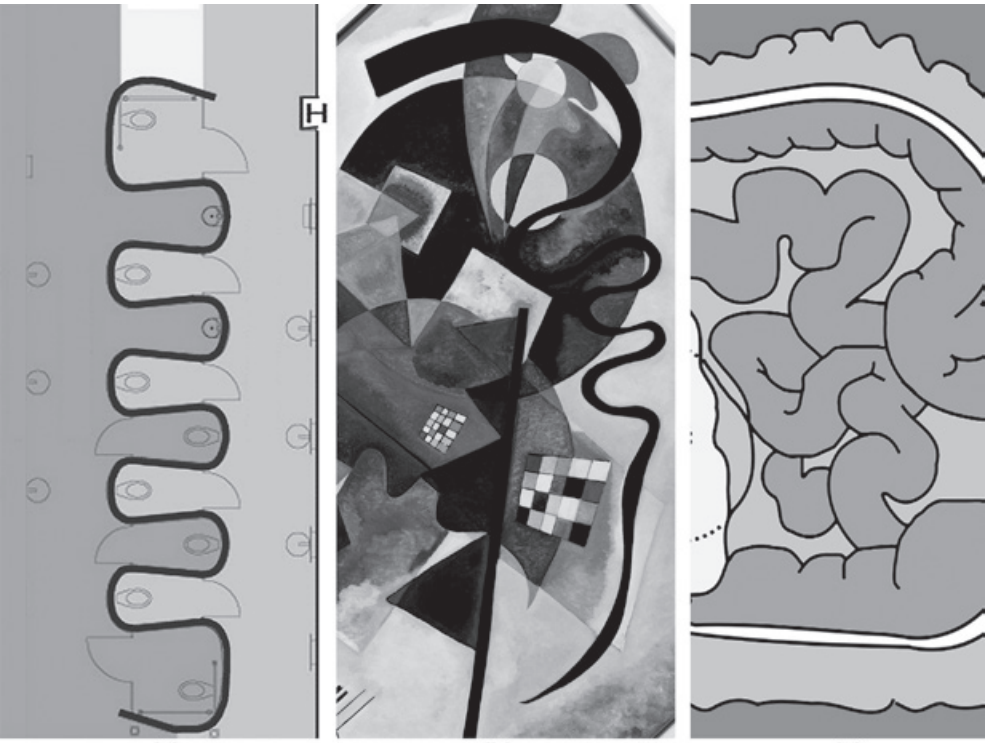
and build an expensive architectural joke whose subject could be construed to be human waste: the toilets and urinals for Milstein Hall are defined by a curving stainless steel wall reminiscent of certain paintings by Wassily Kandinsky or, more to the point, the interlocking geometry of the small intestine (fig. 21.1).

Figure 21.1. Toilets and urinals for Milstein Hall are defined by a curving stainless steel wall (*a*) reminiscent of the paintings of Wassily Kandinsky (*b*), or the interlocking geometry of the small intestine (*c*).

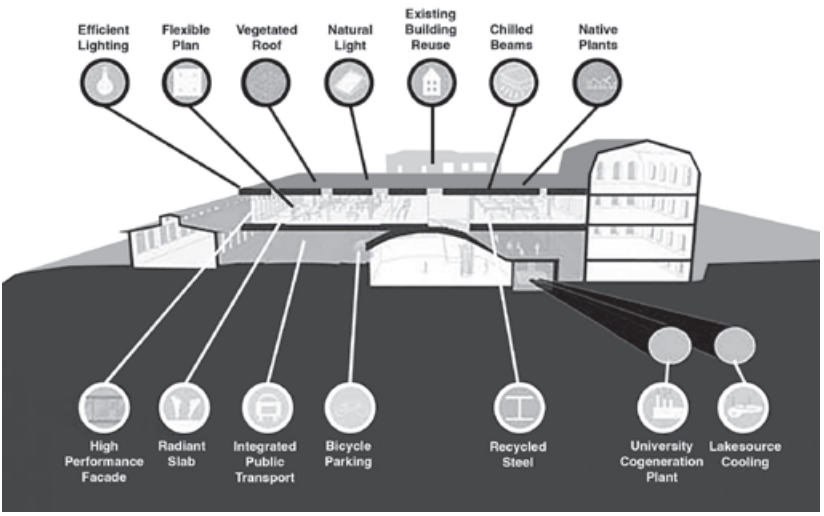
Cornell lists the "sustainable design initiatives" it has taken in the design and construction of Milstein Hall[1] and summarizes these initiatives with the image reproduced in figure 26.1. These initiatives are grouped by Cornell into eight specious claims, discussed below.

Figure 26.1. Milstein Hall's sustainable design initiatives (based on image from Cornell's Milstein Hall website; edited for clarity).

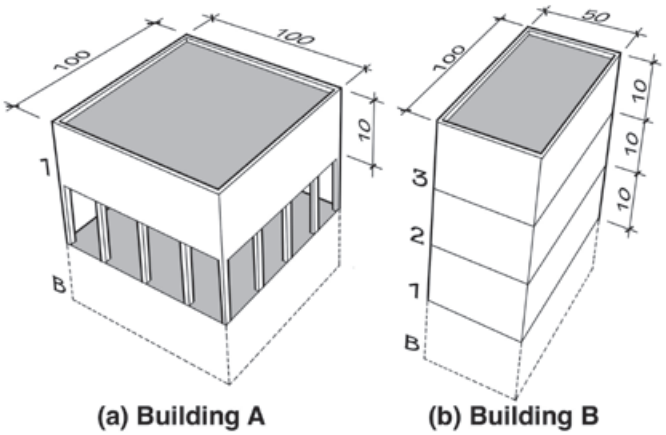
Figure 26.3. *Building A*, schematically representing the geometry of Milstein Hall, has much more exposed surface area—and therefore uses more energy and materials—than the more compact *Building B*.

square units of area (the actual units are not relevant here), *Building A* has 34,000 square units of exposed surface area (including the soffit), whereas *Building B* has only 14,000 square units of exposed surface area. Not only is *Building B* more efficient in terms of energy and materials, but its dimensions are likely to create a more flexible plan.
