Exhibit 2

Reasons why the determinations outlined in Exhibit 1 should be reversed.

Code sections referenced below are from the 2015 New York State Building Code unless otherwise noted.

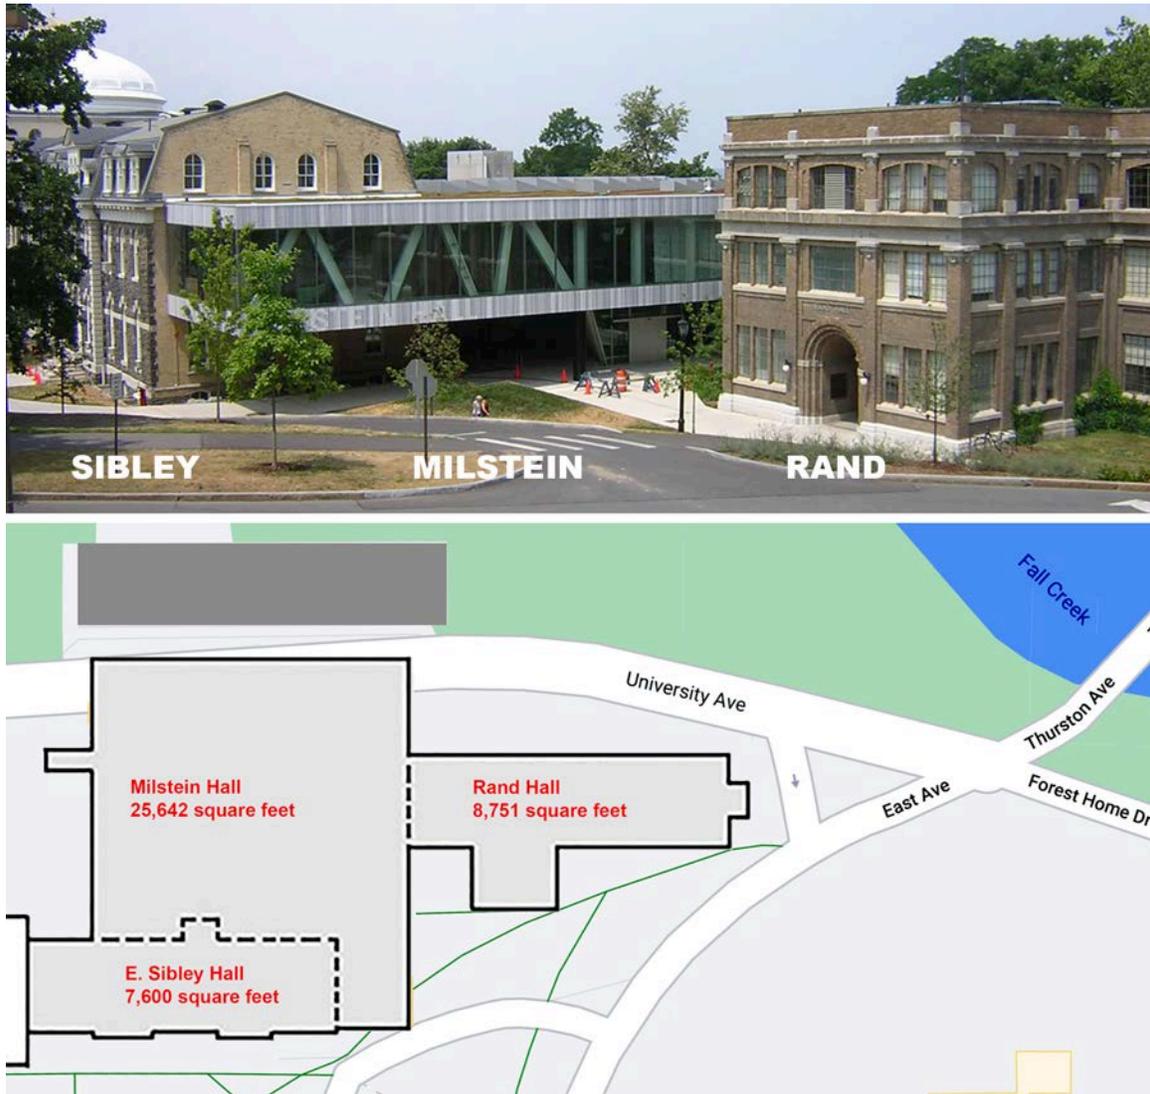
Before being connected to Milstein Hall in 2011, Rand Hall was a 3-story Type IIB non-fireproofed steel frame building and E. Sibley Hall was a 3-story Type VB building (with non-fireproofed wood exterior bearing walls at the third floor). Since the two buildings were connected to 2-story Milstein Hall without fire walls (Figure 1), Rand-Milstein-Sibley Hall became a *single building* with Type VB construction.

Figure 1. (a) View, from left to right, of interconnected Sibley, Milstein, and Rand Hall; and (b) second-floor plan showing net second-floor areas of Milstein, E. Sibley, and Rand Halls.
